CAMPAIGN BULLETIN

Automatic Transmission Dealer Inventory

Reference: PC561
Date: April 6, 2017

PC561 – TITAN (A61G, 2WD) MULTI-POINT INSPECTION

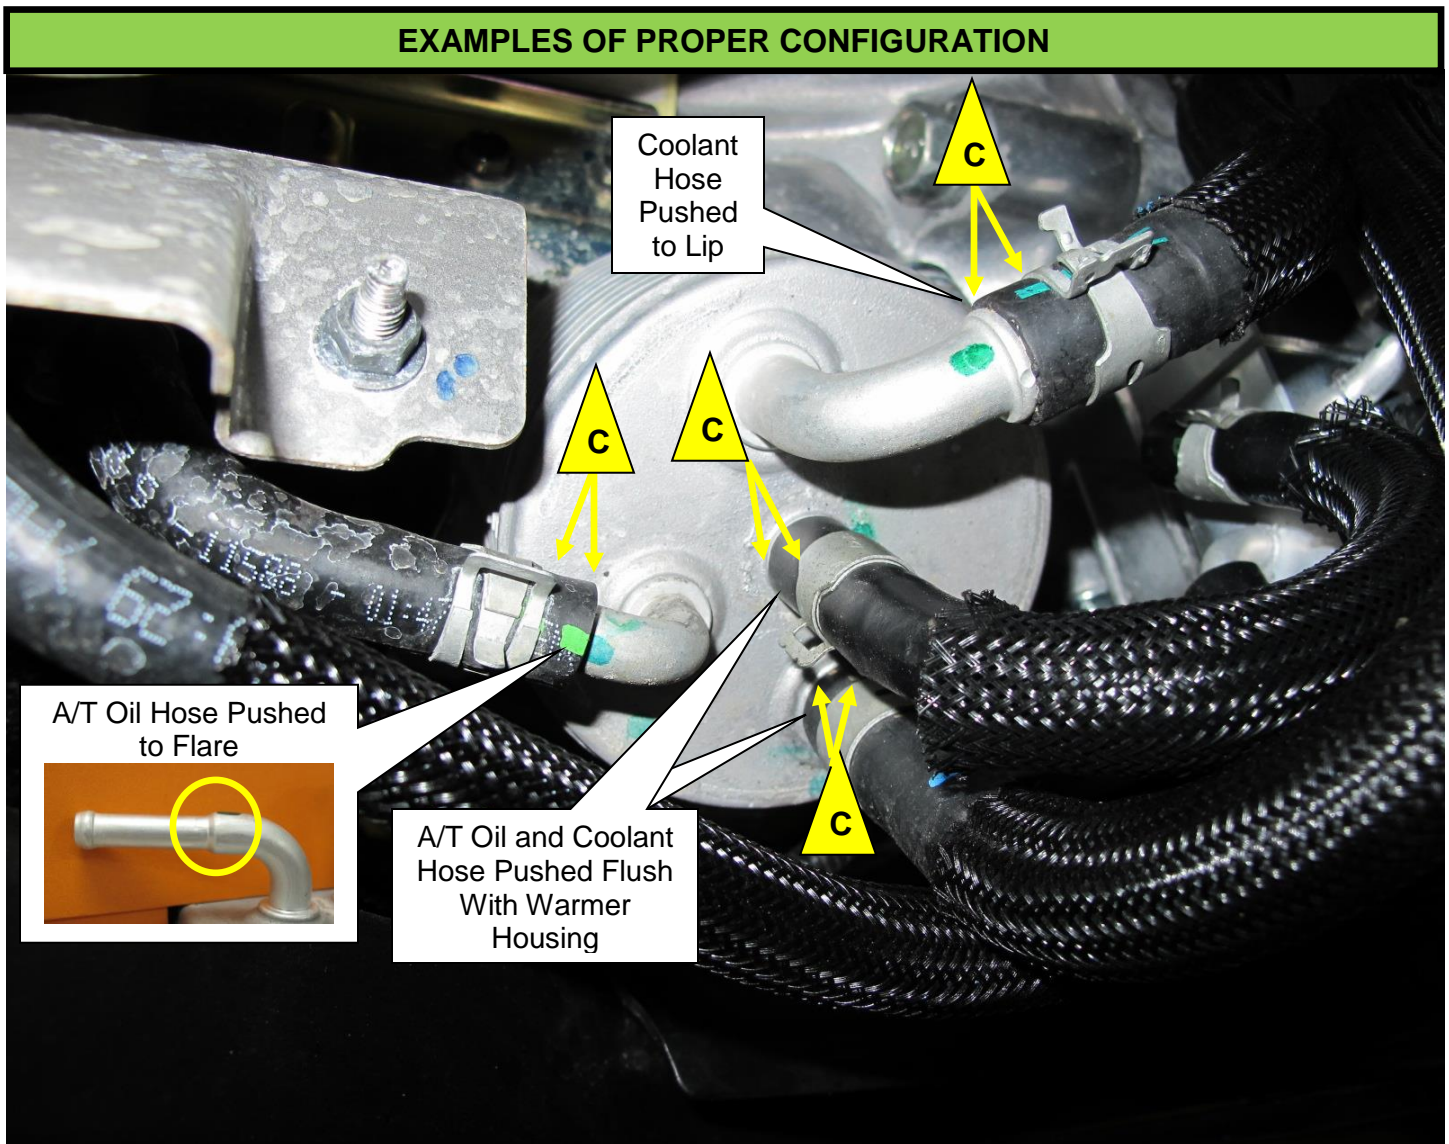
Figure 6

6. Inspect **four** A/T Warmer Hoses for proper configuration (Figure 6).

A. Straight tube hose placement: hose pushed all the way until flush with warmer housing.

B. Bent tube hose placement: hose pushed all the way to stop/lip or outward flare.

C. Clamp placement

; clamp located 5MM +or- 2MM (1/8th to 1/4 inch) from end of hose.

8. CORRECT ANY HOSES NOT PROPERLY INSTALLED, REFERENCE STEP 6 (FIGURE 6).

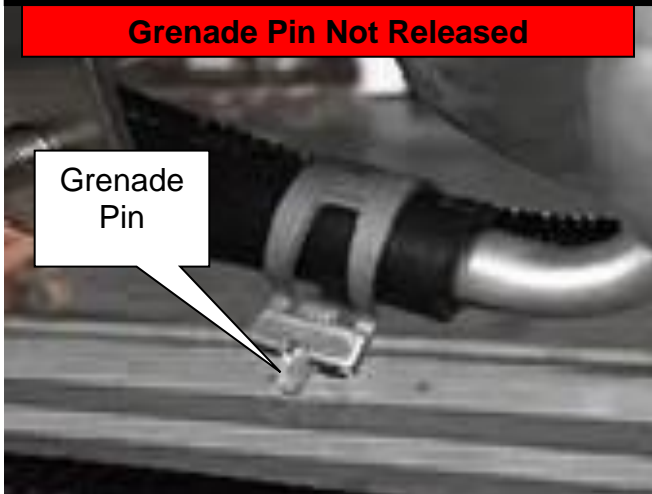
Figure 7

Grenade Pin Not Released

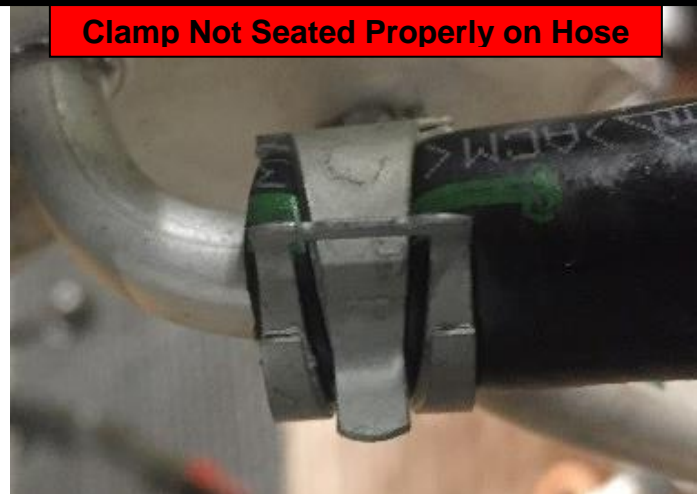
Figure 8

Clamp Not Seated Properly on Hose

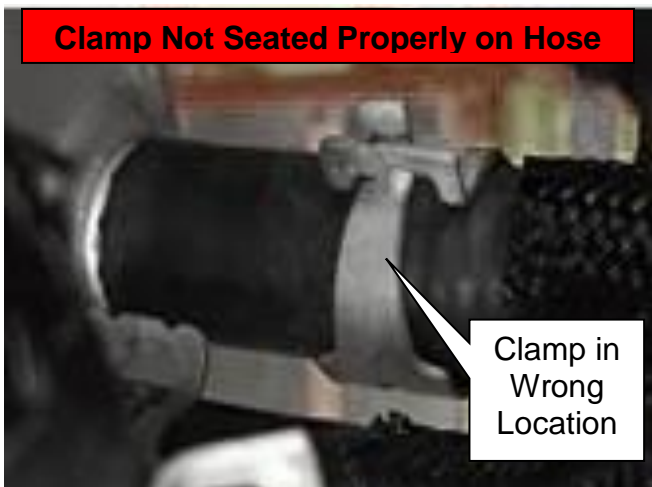
Figure 9

Clamp Not Seated Properly on Hose

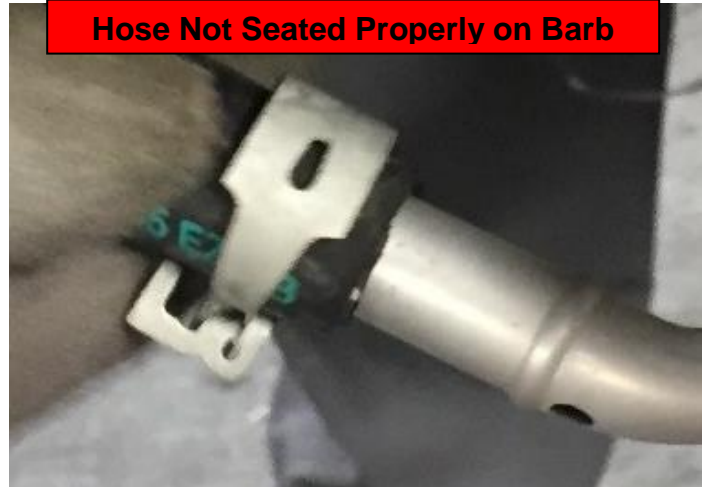
Figure 10

Hose Not Seated Properly on Barb

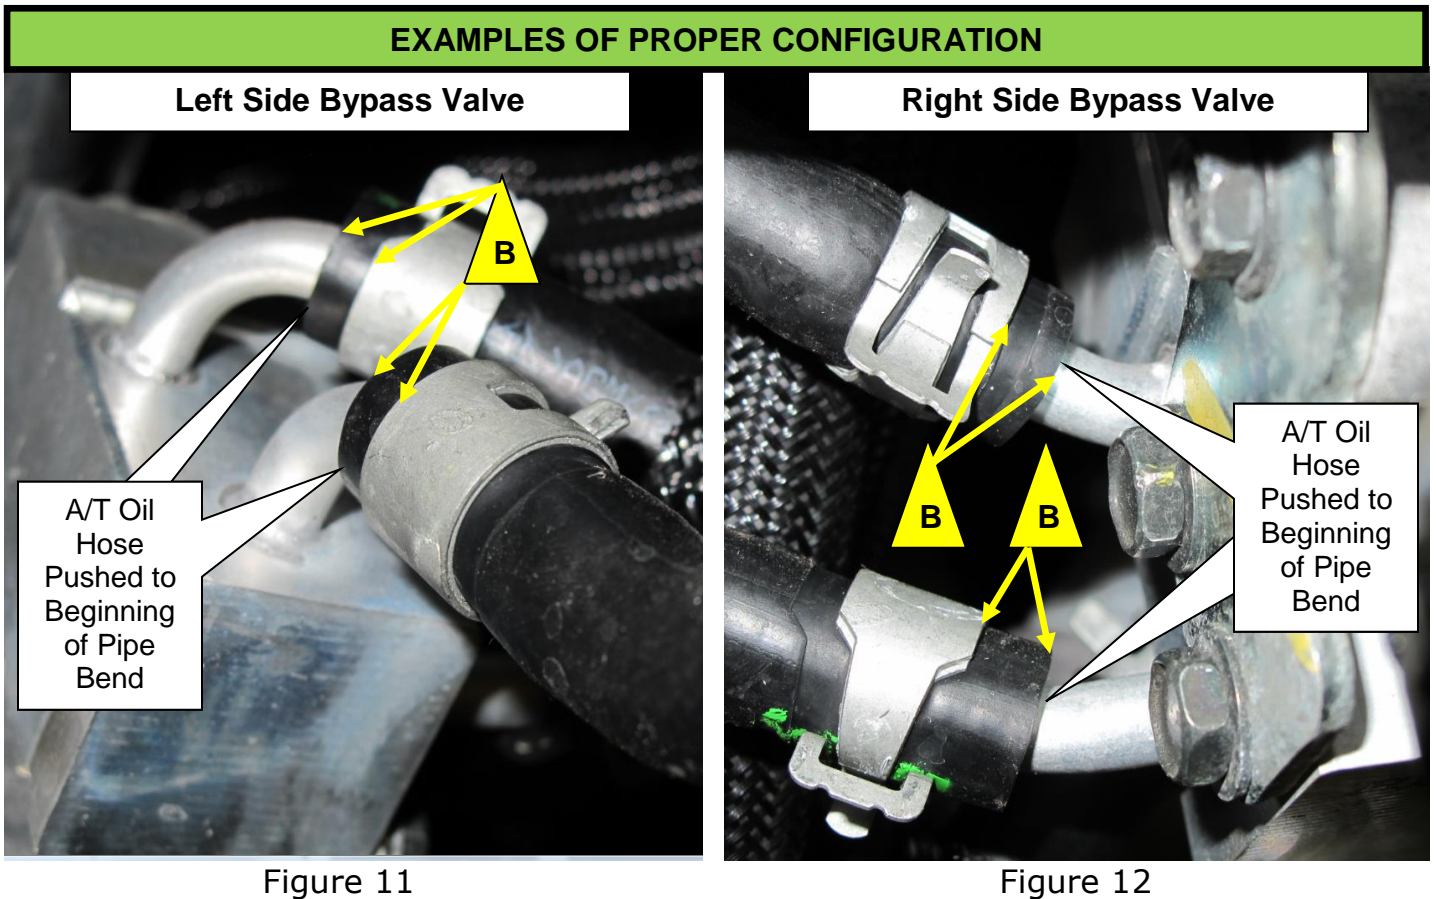
9. Inspect **four** bypass valve hoses for proper configuration (Figure 11, 12).

A. Bent tube hose placement: hose pushed to beginning of pipe bend.

B. Clamp placement **B**: clamp located 7.5MM +or- 2.5MM (3/16 to 3/8 inch) from the end of the hose.

11. **CORRECT ANY BYPASS VALVE HOSES THAT ARE NOT PROPERLY INSTALLED, REFERENCE STEP 9 (FIGURE 11, 12).**

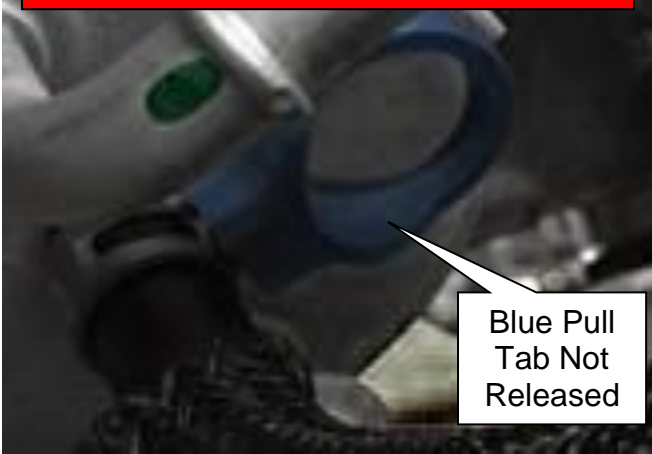
Figure 13

Blue Pull Tab Clamp Not Released

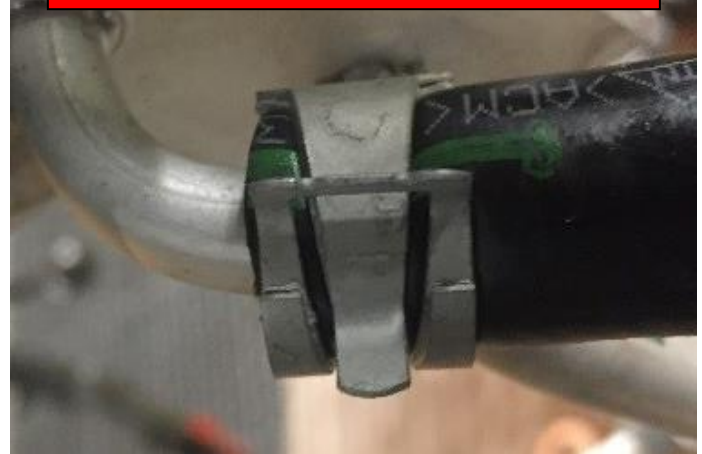
Figure 14

Clamp Not Seated Properly on Hose

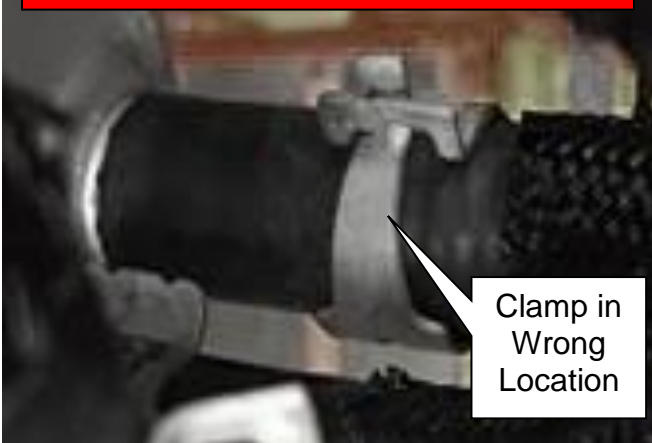
Figure 15

Clamp Not Seated Properly on Hose

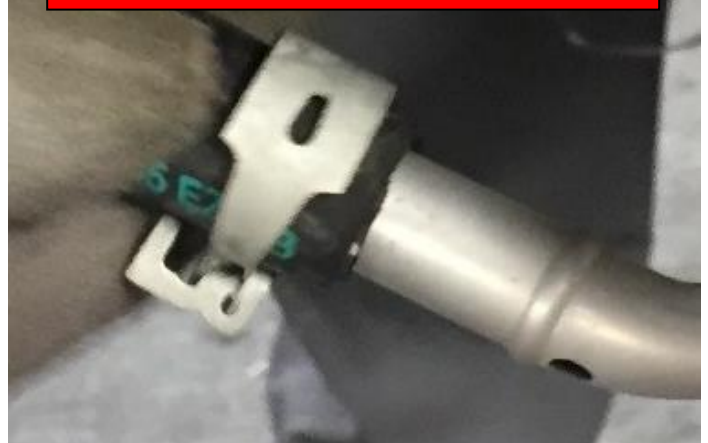
Figure 16

Hose Not Seated Properly on Barb

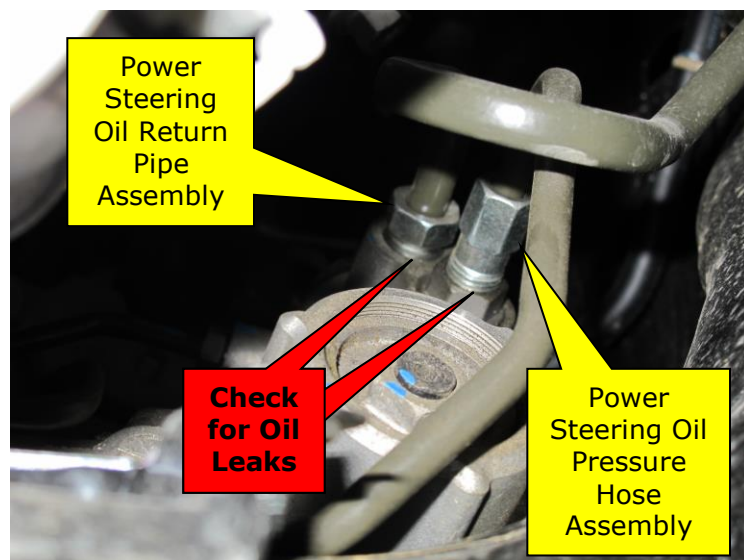
Figure 3

3. Inspect for **LEAKS** between the Steering Gear and Power Steering Oil Return Pipe and Power Steering Oil Pressure Hose connections (Figure 3).

- If **NO LEAK** found, inspection is complete, proceed to step 16.
- If **LEAK** found, proceed to step 4.

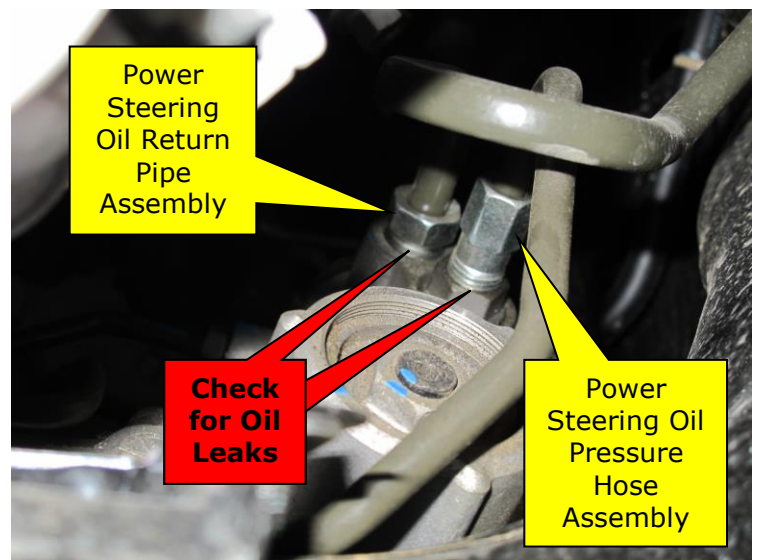
Figure 5

6. Inspect for **LEAKS** again between the Steering Gear and Power Steering Oil Return Pipe and Power Steering Oil Pressure Hose connections (Figure 5).

- If **NO LEAK** found, inspection is complete, proceed to step 16.
- If **LEAK** found, proceed to step 7.
