SERVICE BULLETIN

Classification: EC17-020	Reference: NTB17-080	Date: July 18, 2017
-----------------------------	-------------------------	------------------------

2014-2016 ROGUE; ROUGH IDLE ON START UP

APPLIED VEHICLE: 2014-2016 Rogue (T32)

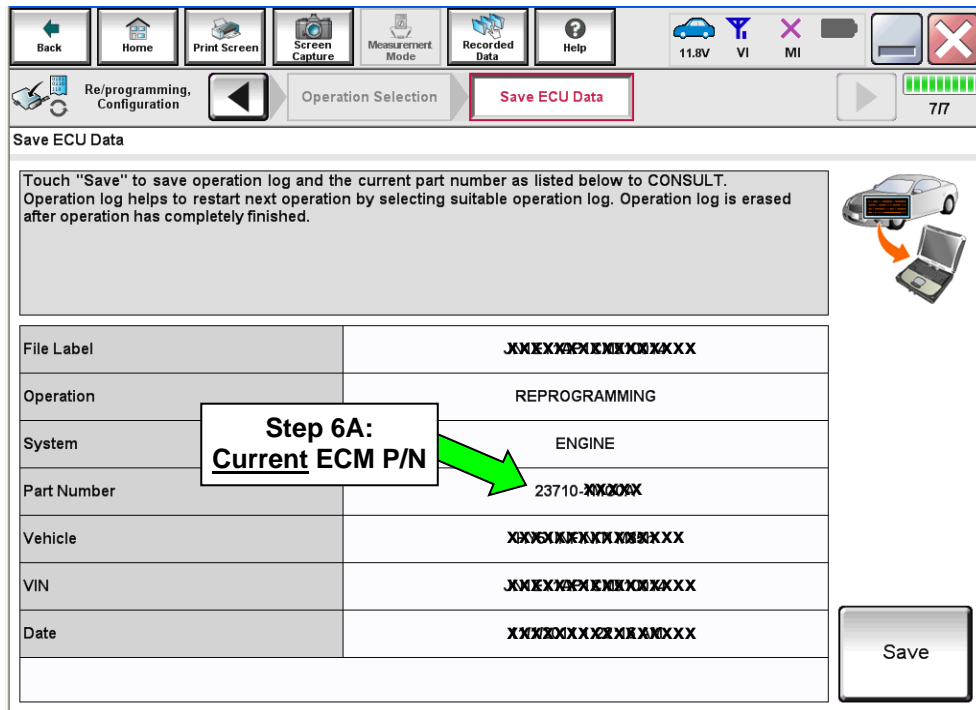
Figure 2

6. When you get to the screen shown in Figure 2, confirm this bulletin applies as follows.
- A. Find the ECM **Part Number** and write it on the repair order.

NOTE: This is the current ECM Part Number (P/N).

- B. Compare the P/N you wrote down to the numbers in the **Current ECM Part Number** column in **Table A** below.
- If there is a match, this bulletin applies. Continue with the reprogramming procedure.
 - If there is not a match, this bulletin does not apply. Close C-III plus and refer to ASIST for further diagnostic information.

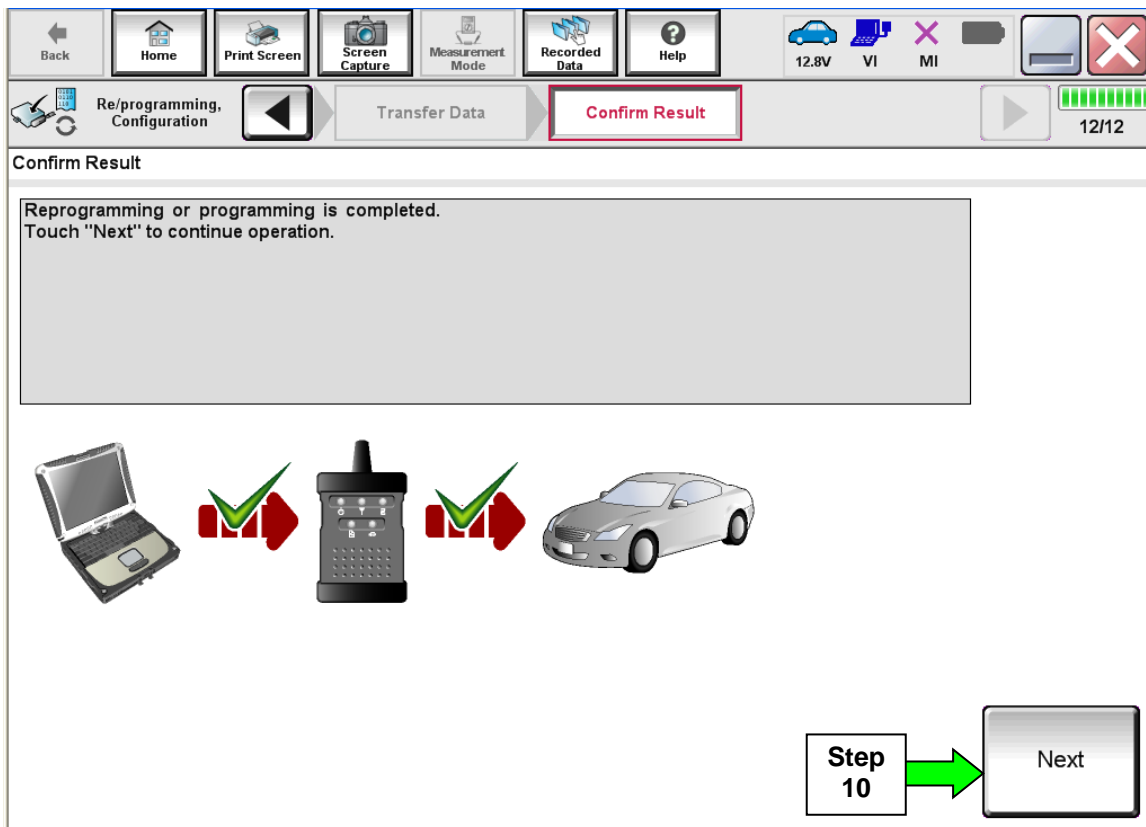
8. When the screen in Figure 4 displays, reprogramming is complete.

NOTE: If the screen in Figure 4 does not display (reprogramming does not complete), refer to ECM recovery on the next page.

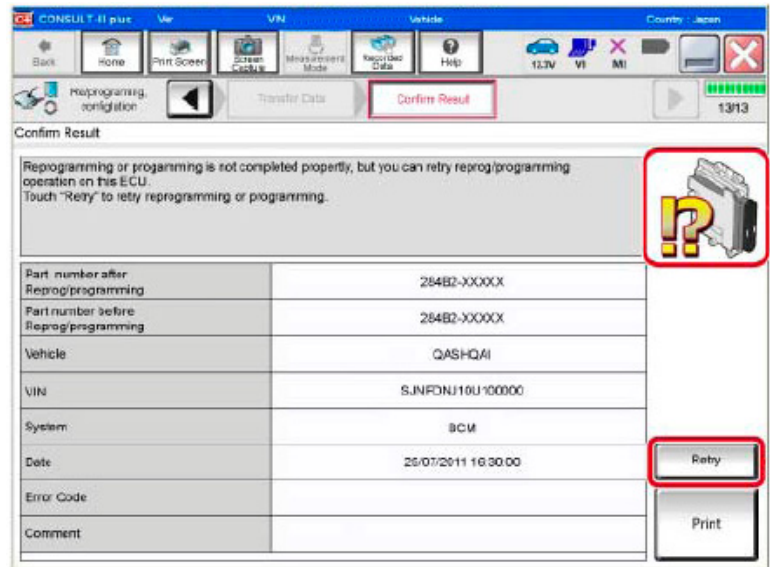
Figure 5

If reprogramming does not complete and the “!” icon displays as shown in Figure 5:

- Check battery voltage (12.0 - 15.5 V).
- Ignition is ON, engine OFF.
- External Bluetooth® devices are OFF.
- All electrical loads are OFF.
- **Select retry and follow the on screen instructions.**
- **“Retry” may not go through on first attempt and can be selected more than once.**

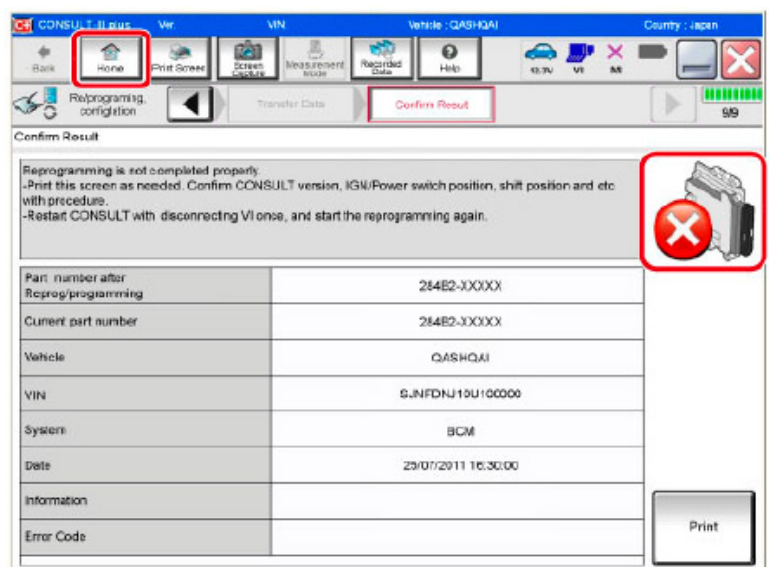
Figure 6

If reprogramming does not complete and the “X” icon displays as shown in Figure 6:

- Check battery voltage (12.0 - 15.5 V).
- CONSULT A/C adapter is plugged in.
- Ignition is ON, engine OFF.
- Transmission is in Park.
- All C-III plus / VI cables are securely connected.
- All C-III plus updates are installed.
- **Select Home, and restart the reprogram procedure from the beginning.**

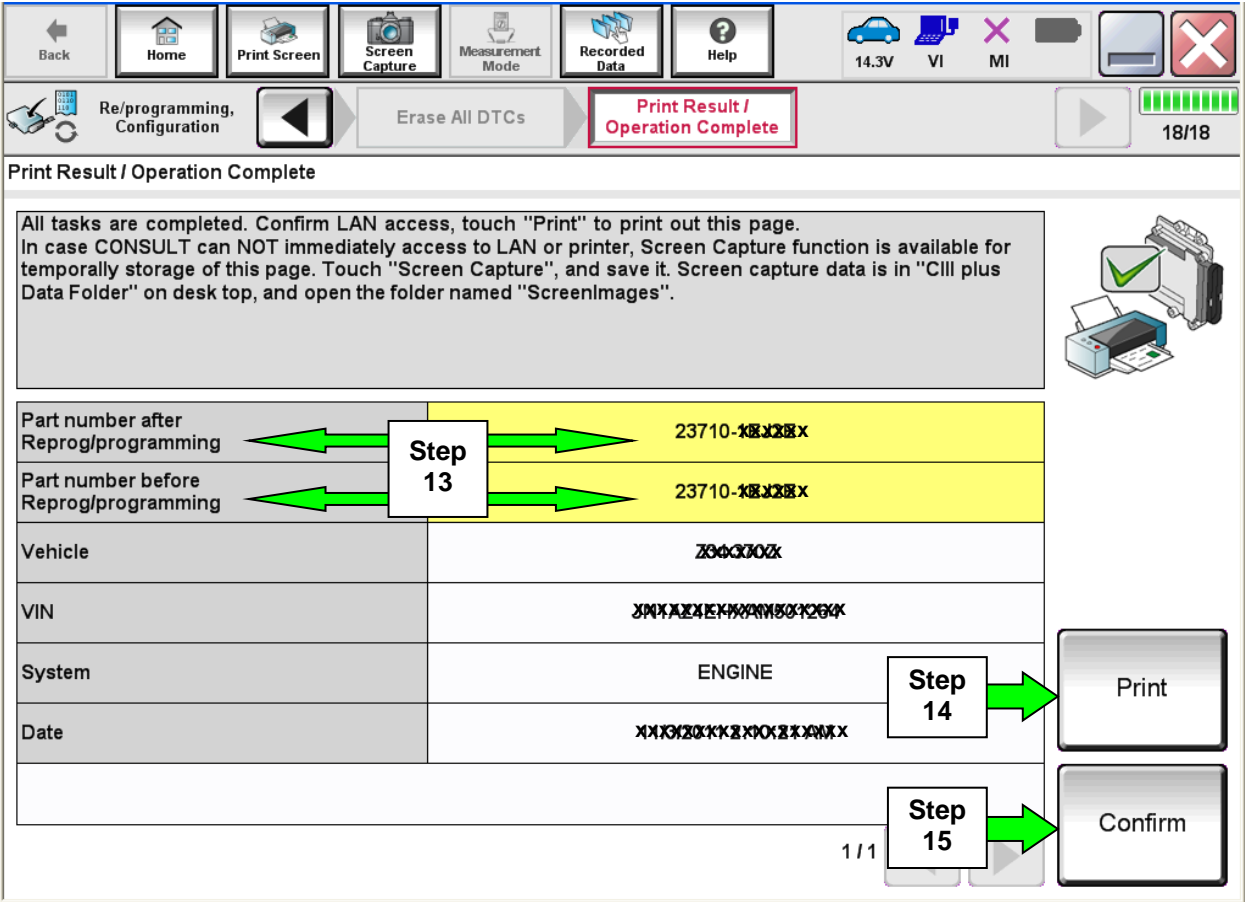
- 12. When the entire reprogramming process is complete, the screen in Figure 7 will display.
- 13. Verify the before and after part numbers are different.
- 14. Print a copy of this screen (Figure 7) and attach it to the repair order for warranty documentation.
- 15. Select **Confirm**.
