# SERVICE BULLETIN

Classification: EC16-034	Reference: NTB17-082	Date: July 21, 2017
-----------------------------	-------------------------	------------------------

## NISSAN; DTC P0456 CAUSED BY EVAP LEAK AT VENT CONTROL VALVE O-RING

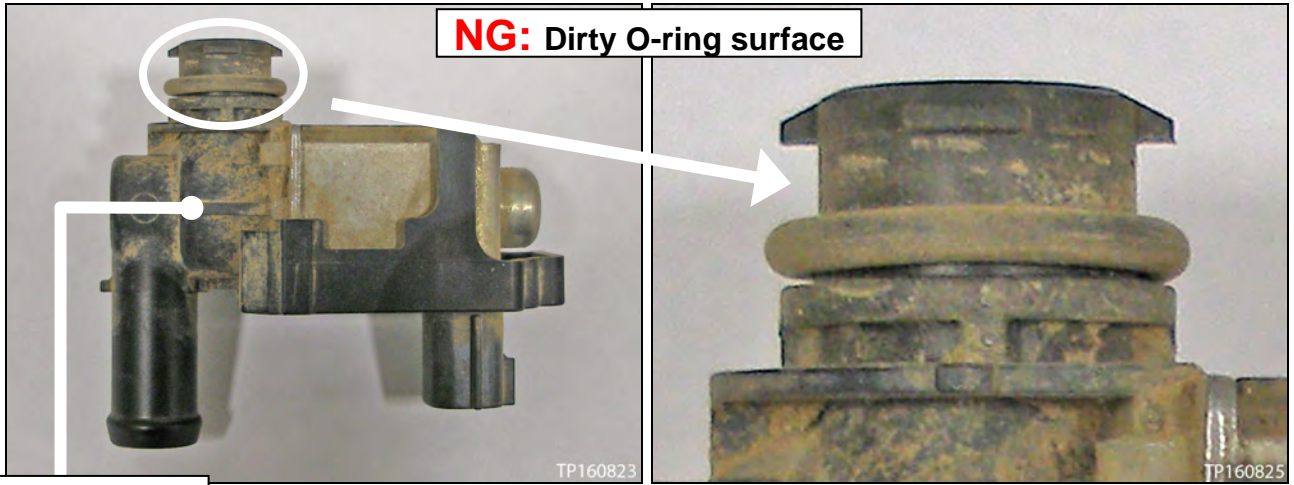
Vent control valve

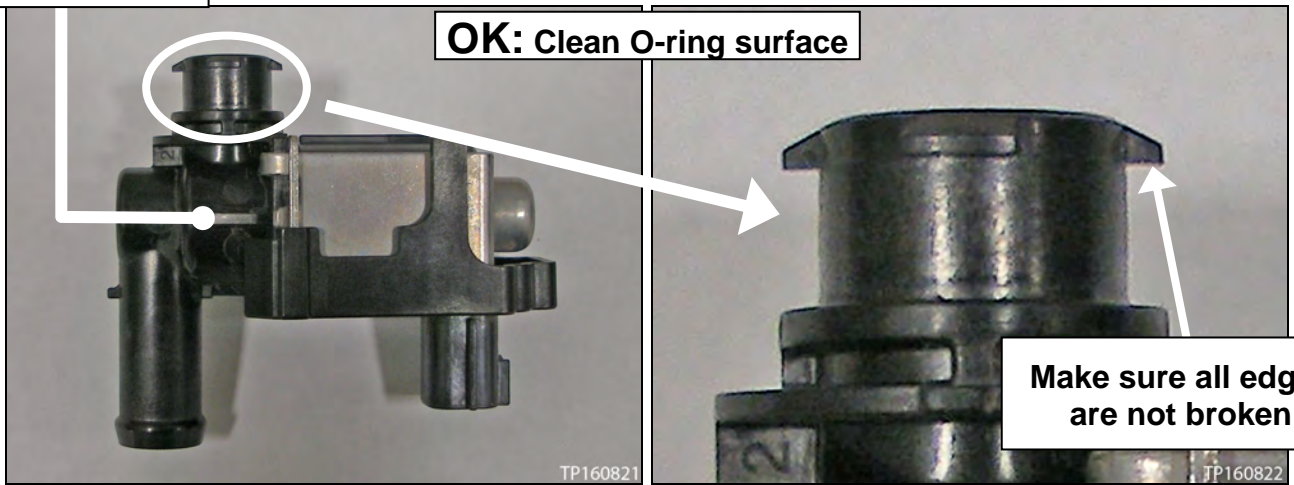
Where vent control valve mounts in canister

Canister

This surface must be clean all around
