WH19 - Reworking Routing of Wire Harness for PASM Valve Unit (Workshop Campaign)

Model Line: **Panamera (971)**

Subject: **Wire harness for PASM valve unit**

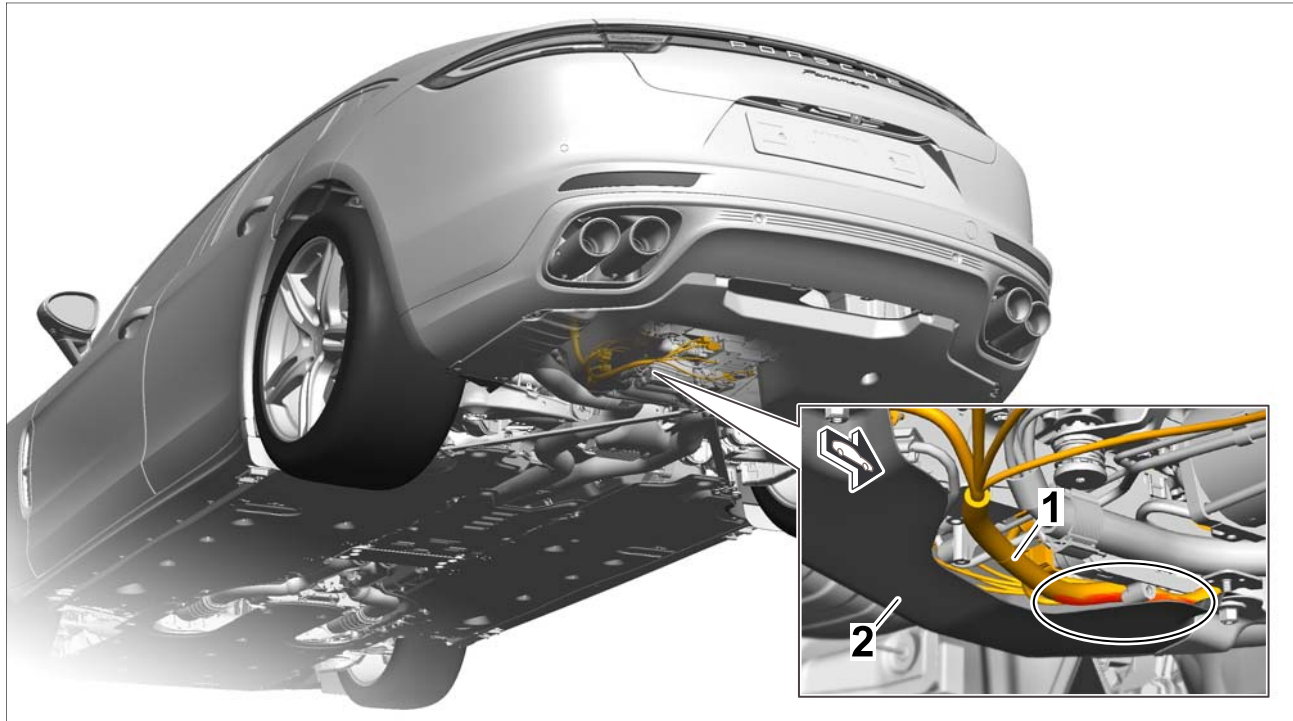
*Installation position of wire harness for valve unit*

Information: **The wire harness for the PASM valve unit is not routed correctly in the area around the heat protection panels for the valve unit on the affected vehicles.**

Due to relative movements while driving and if significant amounts of dirt get in, this can cause chafing on the wire harness and as a result, faults can be entered in the fault memory and the warning "Chassis system fault" may be displayed in the instrument cluster. As a result, the vehicle level can no longer be set.

1 – Wire harness for PASM valve unit (**check** and **secure** again)

2 – Heat protection panel, left

circle – Area of potential chafing

- Check wire harness for PASM valve unit and secure with additional tie-wraps.
- If the wire harness is already damaged, repair wire harness for PASM valve unit.

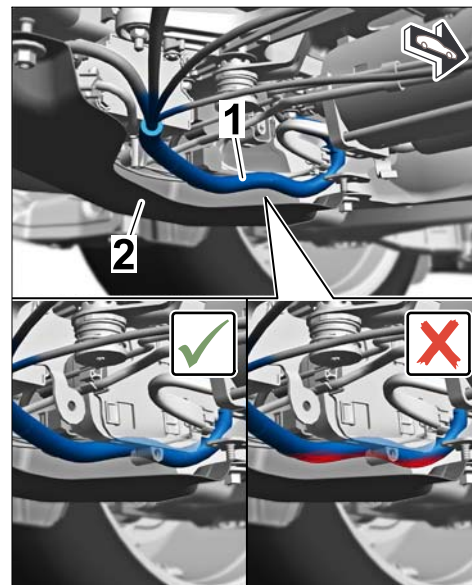
Checking wire harness for damage

Work Procedure: 1 Perform a visual inspection to see if the wire harness for the PASM valve unit ⇒ *Checking wire harness for damage -1-* shows signs of chafing or damage to the insulation on the line in the area around the heat protection panel.

- If there are **no** chafing marks or damaged areas visible on the wire harness, re-position the wire harness and secure it. To do this, continue with ⇒ *Technical Information 'WH1900 Reworking routing of wire harness for PASM valve unit'*.
- If there are visible **chafing marks** or **damaged areas**, the wire harness must be repaired. To do this, **continue with Step 2**.
