Eliminating Symptoms on Body Exterior - Reworking rear lid release switch (Rear lid release switch light does not function/SY4316)

Model Line: **Panamera (971)**

Model Year: **2017**

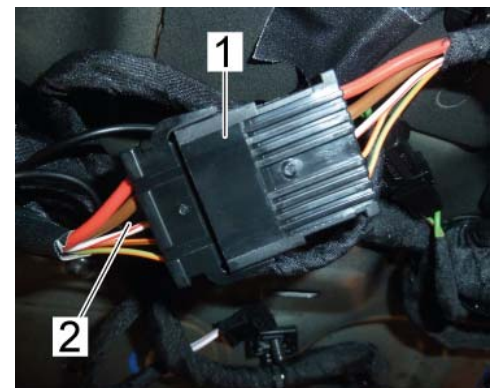
Disconnecting electric line

The unplugged electric line is live. The electric line must be insulated carefully.

- 6 Cut off disconnected electric line ⇒ *Disconnecting electric line -2-* and carefully insulate the remaining electric line using insulating tape.
