**PDK Transmission Diagnosis, Symptoms and Repair Procedures (43/10)**

Vehicle Type: **Panamera S/Panamera 4S/Panamera Turbo**

Model Year: **As of 2010 up to 2016**

Concerns: **PDK transmission/control unit for PDK transmission**

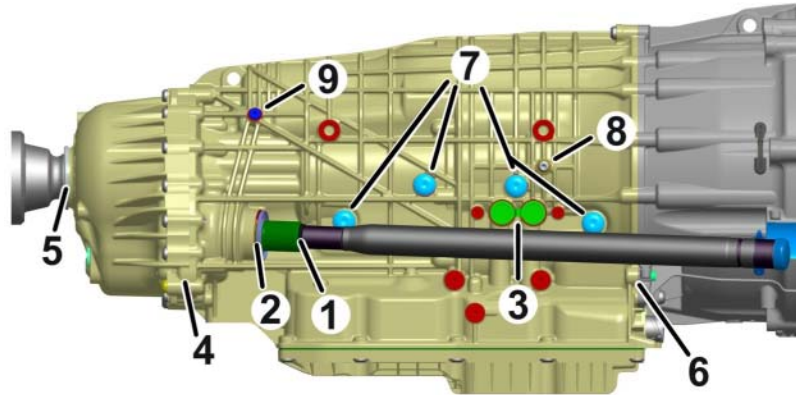
Figure 1

Item	Description	Possible cause(s)	Remedial action
1	Leak in the <b>side shaft and connecting shaft area</b> ⇒ <i>Figure 1 -item 1-</i>	O-ring on connecting shaft damaged	Replace O-ring on connecting shaft (Part No. 999.701.640.xx). For instructions on removing and installing the connecting shaft, see ⇒ <i>Workshop Manual '373419 Removing and installing Porsche Doppelkupplung (PDK)'</i> .
2	Leak between <b>transmission housing and side shaft</b> ⇒ <i>Figure 1 -item 2-</i>	Radial shaft seal damaged	Replace radial shaft seal (Part No. 970.302.885.xx) ⇒ <i>Workshop Manual '387055 Replacing sealing ring for output shaft'</i>
3	Leak around the <b>oil cooler connections</b> ⇒ <i>Figure 1 -item 3-</i>	O-rings on oil lines for oil cooler damaged	Replace O-rings (Part No. 999.707.647.xx) on the oil lines. For details, see ⇒ <i>Workshop Manual '386219 Removing and installing line for ATF cooling'</i> .

Oil line for oil cooler damaged	Replace oil line (Part No. 970.307.082.xx) ⇒ <i>Workshop Manual '386219 Removing and installing line for ATF cooling'</i> .
4	Leak between <b>distributor housing and transmission housing</b> ⇒ <i>Figure 1 -item 4-</i>  The exact site of the leak must be located. It is important to be sure that the leak is actually between the distributor housing and transmission housing and that the transmission fluid that is found is not coming	Housing screw(s) loose	Replace PDK transmission ⇒ <i>Workshop Manual '373455 Replacing Porsche Doppelkupplung (PDK)'</i> .
		Seal damaged

from leaks on other components (e.g. on the connecting shaft).		
5	Leak in the <b>output shaft/output flange area</b> ⇒ <i>Figure 1-item 5-</i>	Radial shaft seal for output shaft damaged	Replace radial shaft seal (Part No. 970.321.807.xx) ⇒ <i>Workshop Manual '387055 Replacing sealing ring for output shaft'</i> .
6	Leak between <b>transmission housing and clutch bell-housing</b> ⇒ <i>Figure 1-item 6-</i>  The exact site of the leak must be located. It is important to be sure that the leak is actually between the transmission housing and clutch bell-housing and that the transmission fluid that is found is not coming from leaks on other components.	Housing screw(s) loose	Replace PDK transmission ⇒ <i>Workshop Manual '373455 Replacing Porsche Doppelkupplung (PDK)'</i> .
		Seal damaged	
7	Leak around the <b>bearing pins</b> ⇒ <i>Figure 1-item 7-</i>	Bearing pins loose	Replace PDK transmission ⇒ <i>Workshop Manual '373455 Replacing Porsche Doppelkupplung (PDK)'</i> .

Seal on bearing pins damaged	
8	Leak around the <b>threaded joint on the half shell for reverse gear</b> ⇒ <i>Figure 1-item 8-</i>	Threaded joint loose	Replace PDK transmission ⇒ <i>Workshop Manual '373455 Replacing Porsche Doppelkupplung (PDK)'</i> .
		Seal damaged	
9	Leak around the <b>screw plug</b> ⇒ <i>Figure 1-item 9-</i>	Screw plug loose	Replace screw plug (Part No. 970.321.871.xx). <b>Tightening torque 10 Nm (7.5ftlb.) +/-0.5 Nm (+/-0.5ftlb.)</b>
		Seal damaged

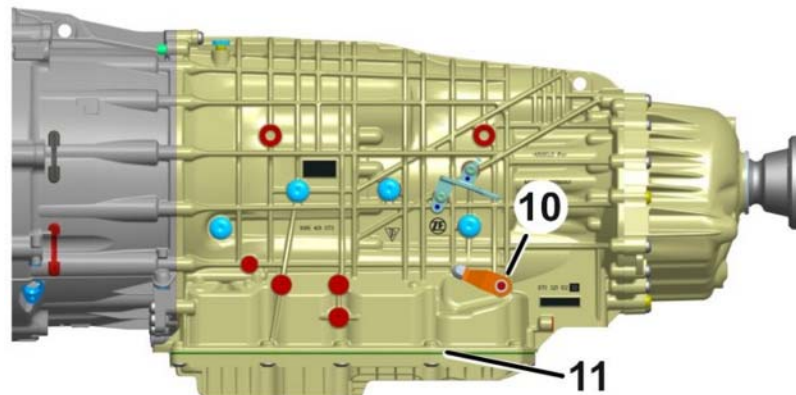
Figure 2

10	Leak around the <b>selector shaft/parking lock</b> ⇒ <i>Figure 2 -item 10-</i>	Radial shaft seal for selector shaft damaged	Replace radial shaft seal (Part No. 970.324.805.xx) ⇒ <i>Workshop Manual '373355 Replacing sealing ring for selector shaft'.</i>
11	Leak between <b>oil pan and transmission housing</b> ⇒ <i>Figure 2 -item 11-</i>	Oil pan seal damaged	Replace complete oil pan (Part No. 970.321.025.xx) ⇒ <i>Workshop Manual '375519 Removing and installing ATF pan'.</i>  If aluminium screws are used to secure the oil pan to the transmission housing, replace these with steel screws (Part No. 970.321.809.xx).

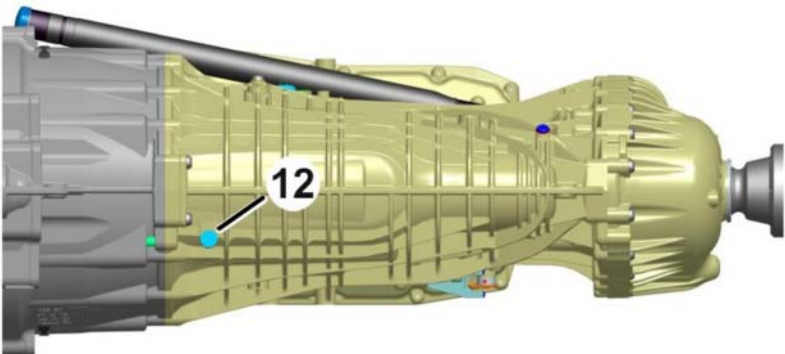
12	Oil leak from the <b>bleeder</b> ⇒ <i>Figure 3-item 12-</i>	Oil over-filled	Check the transmission oil level and top up if necessary ⇒ <i>Workshop Manual '370235 Checking and topping up ATF'</i> .
		Insufficient defoamer in transmission fluid	Change transmission fluid ⇒ <i>Workshop Manual '370255 Changing ATF'</i>
		Instructions on container (shake) not followed when changing fluid	
		Bleeder defective	Replace bleeder (Part No. 970.321.205.xx) and bleeder cap (Part No. 9G1.321.215.xx).

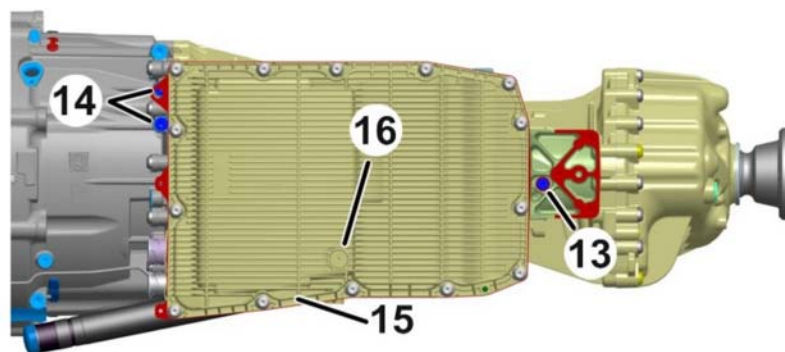
Figure 4

<p><i>Figure 3</i></p>			
13	Leak around the <b>screw plug</b> ⇒ <i>Figure 4-item 13-</i>	Screw loose	Replace screw plug (Part No. 970.321.871.xx). <b>Tightening torque 10 Nm (7.5ftlb.) +/-0.5 Nm (+/-0.5ftlb.)</b>
		Seal damaged	
14	Leak around the <b>screw plugs</b> ⇒ <i>Figure 4-item 14-</i>	Screw loose	Replace screw plug(s) (Part No. 970.321.813.xx).
		Seal damaged	
15	Leak around the <b>oil pan</b> ⇒ <i>Figure 4-item 15-</i>	Oil pan screws loose Oil pan seal damaged	Replace complete oil pan (Part No. 970.321.025.xx) ⇒ <i>Workshop Manual '375519 Removing and installing ATF pan'</i>  If aluminium screws are used to secure the oil pan to the transmission housing, replace these with steel screws (Part No. 970.321.809.xx).

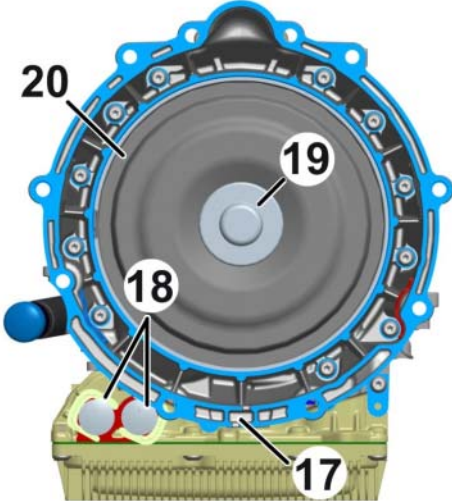
17	<p>Leak around the <b>clutch bell-housing</b> ⇒ <i>Figure 5 -item 17-</i></p> <p>The <b>exact site</b> of the leak must be found.</p>	Apparent preservative grease leak	<p>Check whether the leaking fluid is preservative grease or oil.</p> <p>If preservative grease is leaking out, no further action is required.</p>
		Engine leaking	Find and repair leaks on the engine.
		Radial shaft seal on coupling hub damaged	<p>Replace radial shaft seal (Part No. 9G1.116.807.xx) ⇒ <i>Workshop Manual '386955 Replacing sealing ring for Porsche Doppelkupplung'</i></p>
		<p>O-ring on clutch cover damaged</p> <p>It is important to be sure that the leak is <b>actually</b> on the clutch cover and is not due to an apparent leak caused by preservative grease on the clutch cover.</p>	<p>Replace PDK transmission ⇒ <i>Workshop Manual '373455 Replacing Porsche Doppelkupplung (PDK)'</i>.</p>
18	<p>Leak around the <b>connectors</b> for the hydraulic switch unit and sensor unit ⇒ <i>Figure 5 -item 18-</i></p> <p>– Outer connector: Wire harness for hydraulic switch unit</p> <p>– Inner connector: PDK sensor unit</p>	O-rings on connectors damaged	<p><b>Outer connector leaking:</b> Replace wire harness for hydraulic switch unit (Part No. 970.317.615.xx).</p> <p><b>Inner connector leaking:</b> Replace PDK sensor unit (Part No. 970.317.085.xx).</p> <p>For instructions, see ⇒ <i>Workshop Manual '381819 Removing and installing wire harness in transmission'</i>.</p>

19	<p>Leak around <b>PDK shaft seal</b> ⇒ <i>Figure 5 -item 19-</i></p> <p>The <b>exact site</b> of the leak must be found.</p>	Radial shaft seal on coupling hub damaged	<p>Replace radial shaft seal (Part No. 9G1.116.807.xx) ⇒ <i>Workshop Manual '386955 Replacing sealing ring for Porsche Doppelkupplung'</i></p>

20	<p>Leak around the <b>clutch cover</b> ⇒ <i>Figure 5 -item 20-</i></p> <p>The <b>exact site</b> of the leak must be found.</p> <p>It is important to be sure that the leak is <b>actually</b> on the clutch cover and is not due to an apparent leak caused by preservative grease on the clutch cover (see 17).</p>	O-ring on clutch cover damaged.	Replace PDK transmission ⇒ <i>Workshop Manual '373455 Replacing Porsche Doppelkupplung (PDK)'</i> .

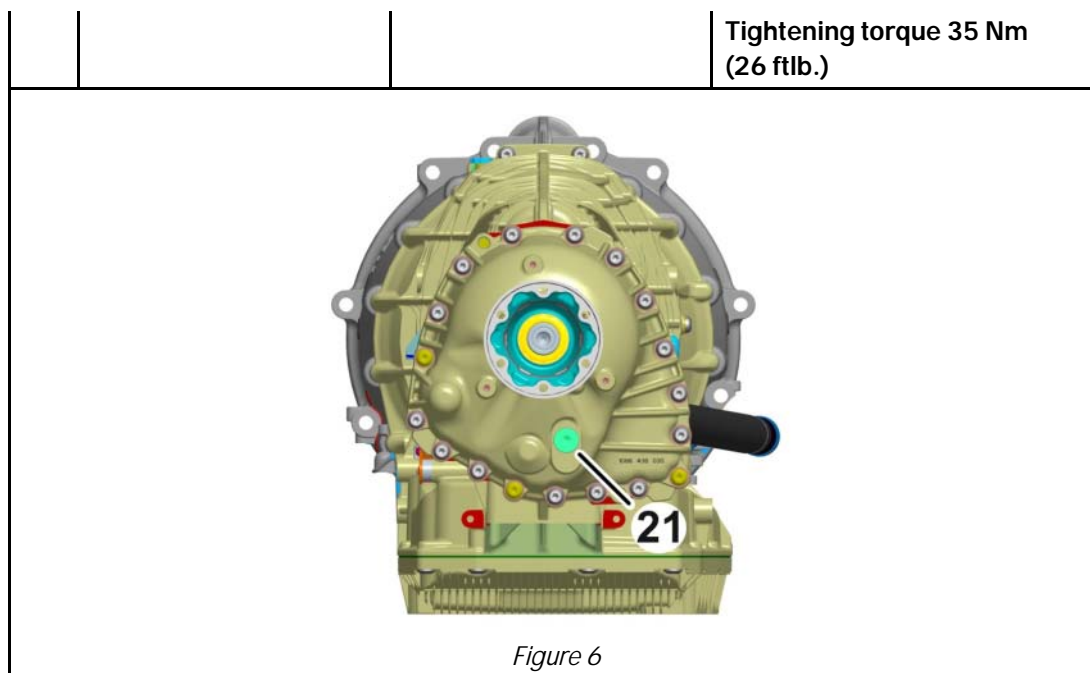
<p><i>Figure 5</i></p>			
21	<p>Leak around the <b>oil filler screw</b> ⇒ <i>Figure 6 -item 21-</i></p>	<p>Oil filler screw loose</p> <p>Sealing ring on oil filler screw damaged</p>	<p>Check the oil level and correct it if necessary. Then replace the oil filler screw with a sealing ring (Part No. 970.321.805.xx) ⇒ <i>Workshop Manual '370235 Checking and topping up ATF'</i>.</p>
