Technical Bulletin

24 17 01 January 04, 2017 2045138

MIL ON DTCs P2004, P2014 and or P2015 Stored in ECM Fault Memory

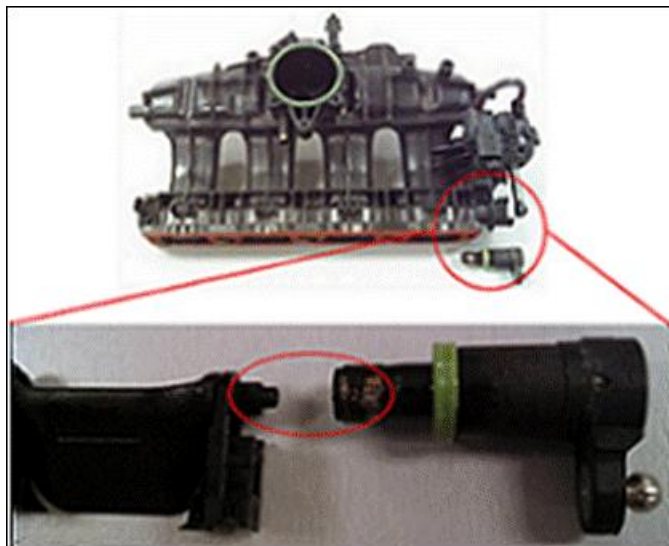
The intake manifold flap can separate internally and will not operate correctly with the regulator valve. See Figure 1. and 2. for an example of a damaged flap disassembled.

Check intake manifold flaps and if necessary replace intake manifold.

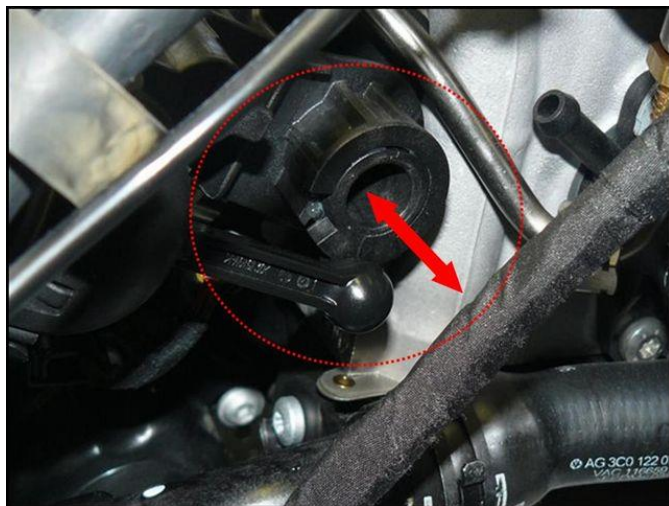
Figure 3.

- Remove the engine cover. See Repair Group 10 Engine Assembly in Elsa.
- Move the carrier plate by hand in an axial direction (Figure 3, red arrow) to check if the carrier plate can be pulled out.

If the carrier plate can be pulled out, the flap has separated and the intake manifold must be replaced. See Repair Group 24 Multiport Fuel Injection in Elsa.
