NUMBER: 23-039-17

Rear Door Fixed Glass Cover is Loose

This bulletin involves rework to the rear door fixed glass cover trim.

2016 - 2017	(D2)	RAM 3500 Pickup
2016 - 2017	(DD)	RAM 3500 Cab Chassis
2016 - 2017	(DF)	RAM 3500 <10K LB Cab Chassis
2016 - 2017	(DJ)	RAM 2500 Pickup
2016 - 2017	(DP)	RAM 4500/5500 Cab Chassis
2016 - 2017	(DS)	RAM 1500 Pickup
2016 - 2017	(DX)	RAM Truck (Mexico)
2016 - 2017	(DS)	RAM 1500 Pickup

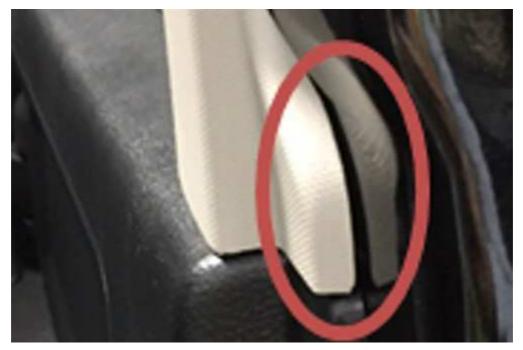
The customer may notice the glass cover trim is loose or shows a gap on either of the rear door (Fig. 1) .

Fig. 1
Gap Identified at Door

If the customer describes the symptom/condition listed above, perform the Repair Procedure.

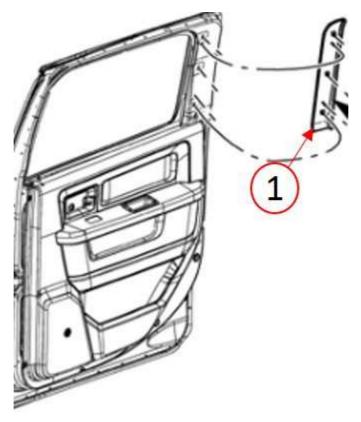
Fig. 2 Trim at Door

1 - Door Glass Trim

1. Remove the rear door glass fixed trim (Fig. 2) using trim stick C-4755 or equivalent, release the upper trim bezel.

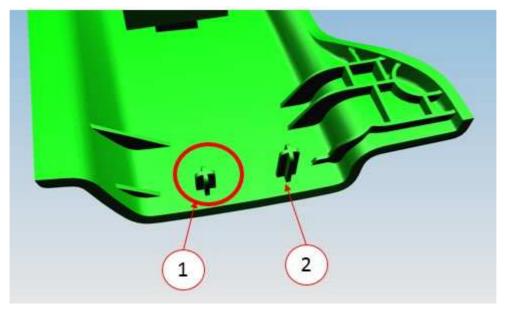
Fig. 3
Short Locator to be Removed

2. After the trim piece is removed use a sharp knife or equivalent to remove the forward/short locator (Fig. 3), remove the locator down to the substrate surface.

NOTE: Do not remove or modify the rear/long locator (Fig. 3).

- 1 Locator to be Removed
- 2 Do Not Remove this Locator
- 3. Install the rear door glass fixed trim (Fig. 2) .
