NUMBER: 23-040-17

Gap at Center Stack at the Instrument Panel

This bulletin involves rework to the center stack trim at the instrument panel.

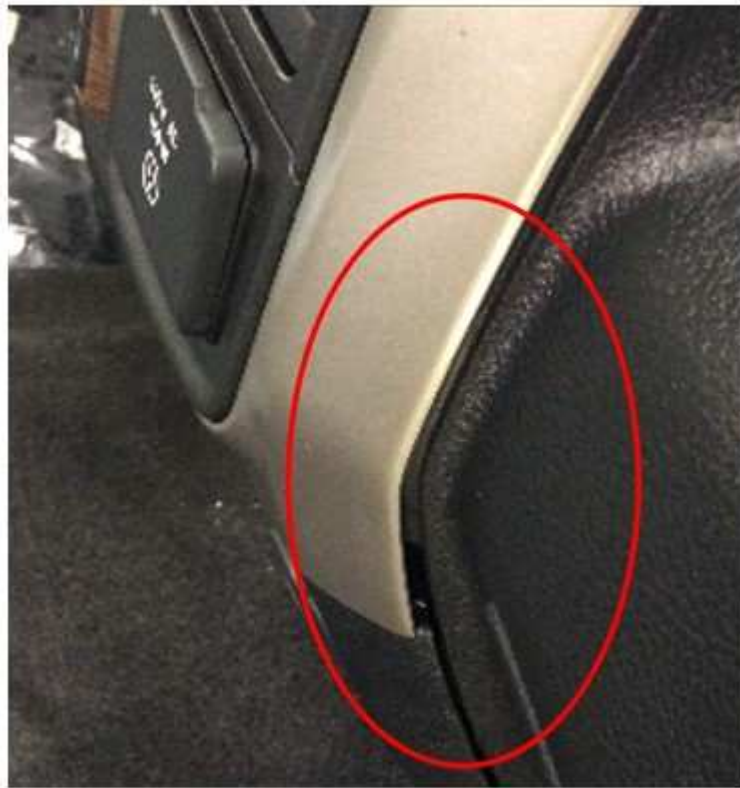
The customer may notice a large gap where the center stack meets the instrument panel (Fig. 1) .

Fig. 1
Gap at Center Stack Trim

If the customer describes the symptom/condition listed above, perform the Repair Procedure.

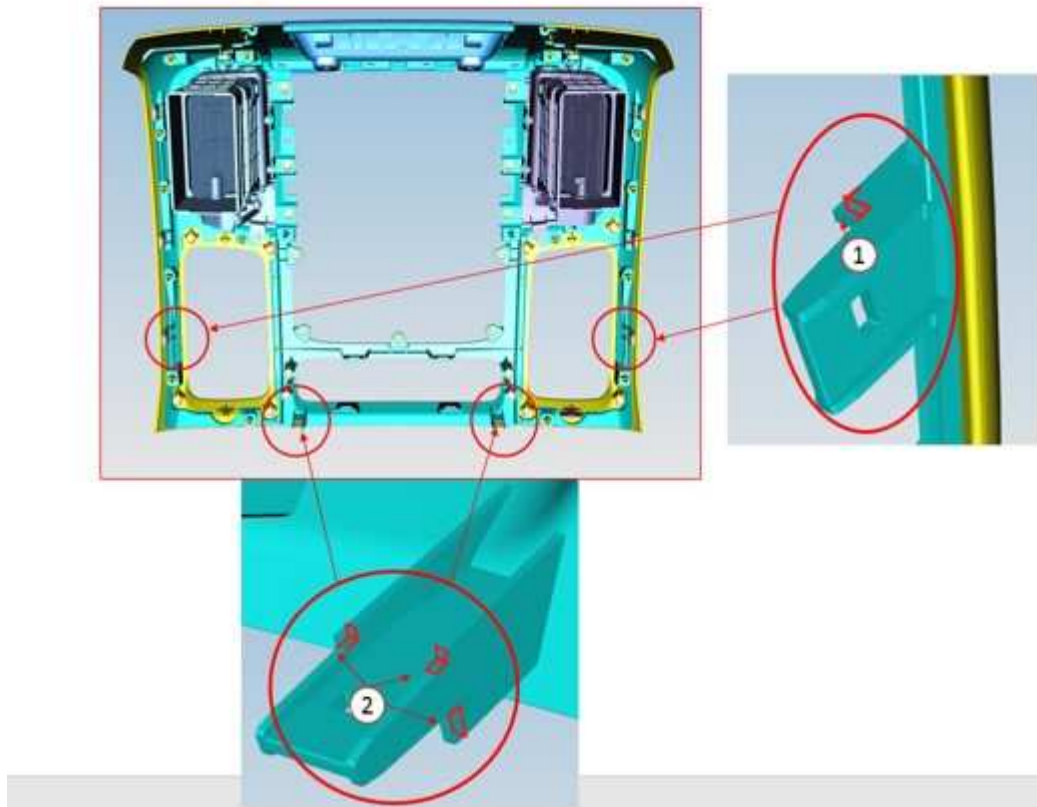
Fig. 2
Trim Locations on Center Stack Trim

-
- 1 - Ribs on the lower 2 Clip Towers Four to be Trimmed on Each Clip
 - 2 - Ribs on the lower side 2 Clip Towers Two to be Trimmed on Each Clip

1. Remove the center stack trim from the instrument panel. Refer to the detailed service procedures available in DealerCONNECT> TechCONNECT under: Service Info>23 - Body/Instrument Panel/Bezel, Instrument Panel, Center/Removal.
2. After the trim piece is removed use a sharp knife or equivalent to remove 1 mm (.039 in) from the trim stand off ribs on clip towers (Fig. 2) .

NOTE: There will be four ribs on the lower clip towers and two ribs on the lower side clip towers.
