NUMBER: 23-034-17 REV. A

GROUP: 23 - Body

Clicking Noise When Opening/Closing Power Sliding Backlite

2017 (DS) RAM 1500 Pickup

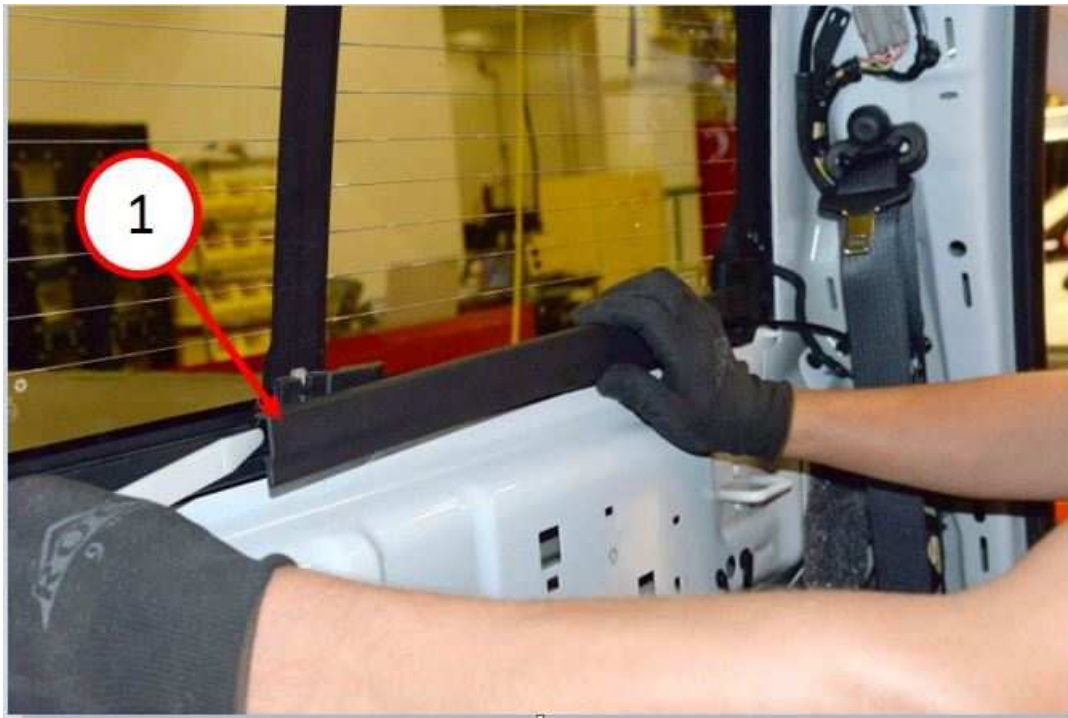
Fig. 1

Use Trim Stick to Remove Ribbon Cable Shield

1 Backlite Ribbon Cable Shield

NOTE: When removing backlite ribbon shield, be careful not to damage defroster connectors on right side of shield (Fig. 1) .

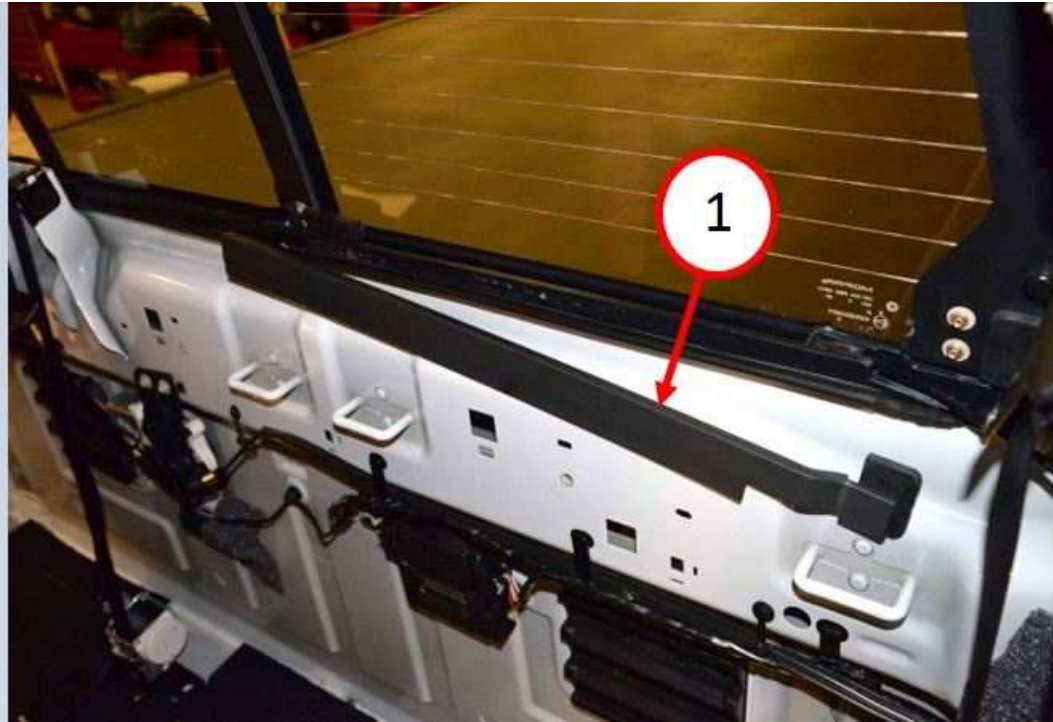
Fig. 2
Ribbon Cable Shield

1 - Support and Secure Ribbon Cable Shield After Removal

CAUTION! After removing ribbon cable shielding, position shield out of the way and secure with tape or equivalent to prevent stress and possible breakage of ribbon cable (Fig. 2) .

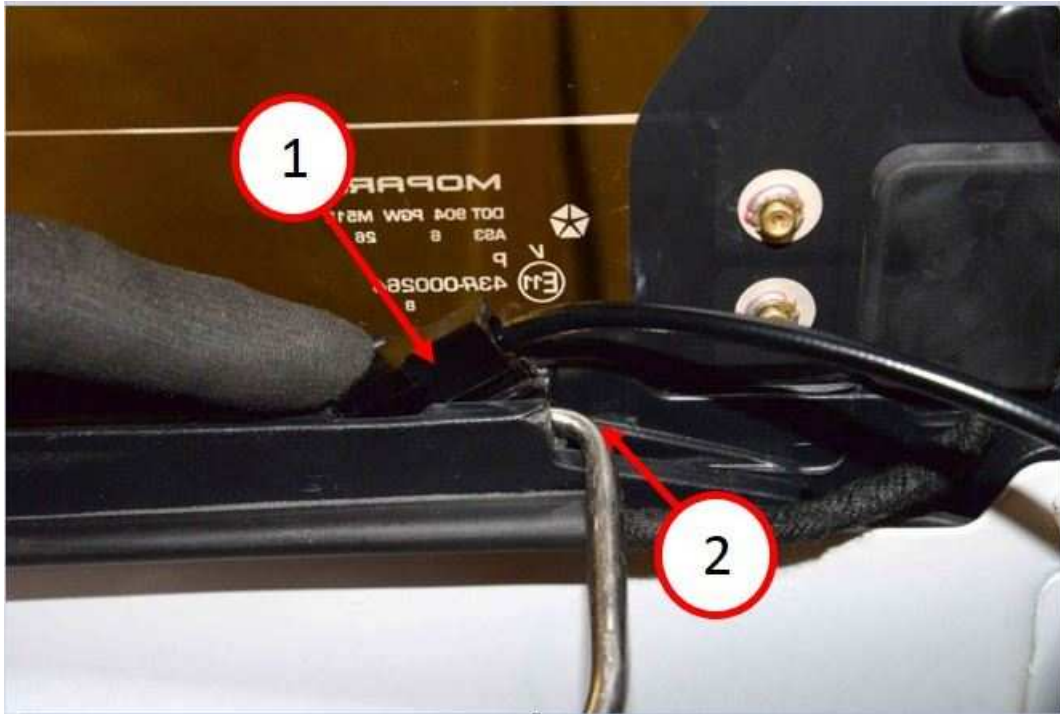
Fig. 3

Remove the Backlite Cable Retainer

- 1 - Backlite Cable Retainer
- 2 - Hook Tool Inserted Between Cable Retainer and Lower Channel

NOTE: Backlite cable retainer clips are glued into place. Be careful to not damage lower channel when removing cable retainers (Fig. 3) .
