NUMBER: 08-089-17

DATE: September 12, 2017

Horn Replacement

2017 (WK) Jeep Grand Cherokee

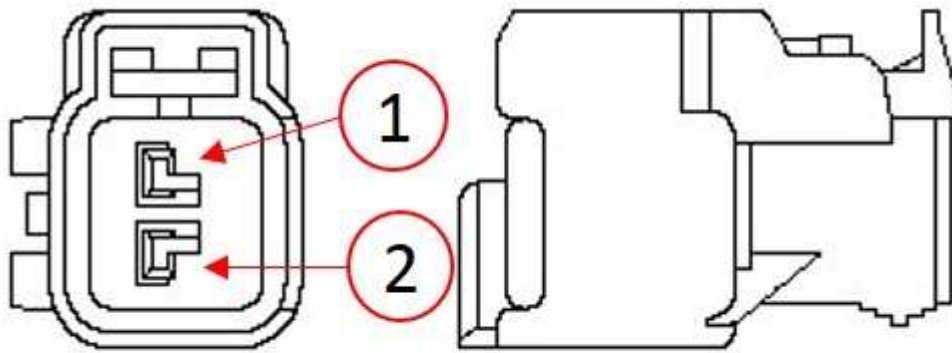
Fig. 1
Horn Electrical Connector

Some customers may comment that their horn sounds muffled.

1 - Ground Cavity
2 - 12V Cavity

2. Cut the old electrical wiring harness connectors from both horns and dispose.
3. Use connector kit #68018954AA and replace both horn electrical connectors (Fig. 1) . Insert Dark Blue wire into Cavity 1 and then splice into Black Ground vehicle harness wire. Refer to the detailed service procedures available in DealerCONNECT> TechCONNECT under: Service Info>29 - Non-DTC Diagnostics/Circuit Testing Procedures/Standard Procedure>Wire Splicing.

4. Insert Dark Blue wire into Cavity 2 and then splice into Grey with Yellow tracer vehicle harness wire. Refer to the detailed service procedures available in DealerCONNECT> TechCONNECT under: Service Info>29 - Non-DTC Diagnostics/Circuit Testing Procedures/Standard Procedure>Wire Splicing.
