NUMBER: 23-043-17

Grease Stain on the Second Row Quad Seat Trim Covers

2017 (RU) Chrysler Pacifica

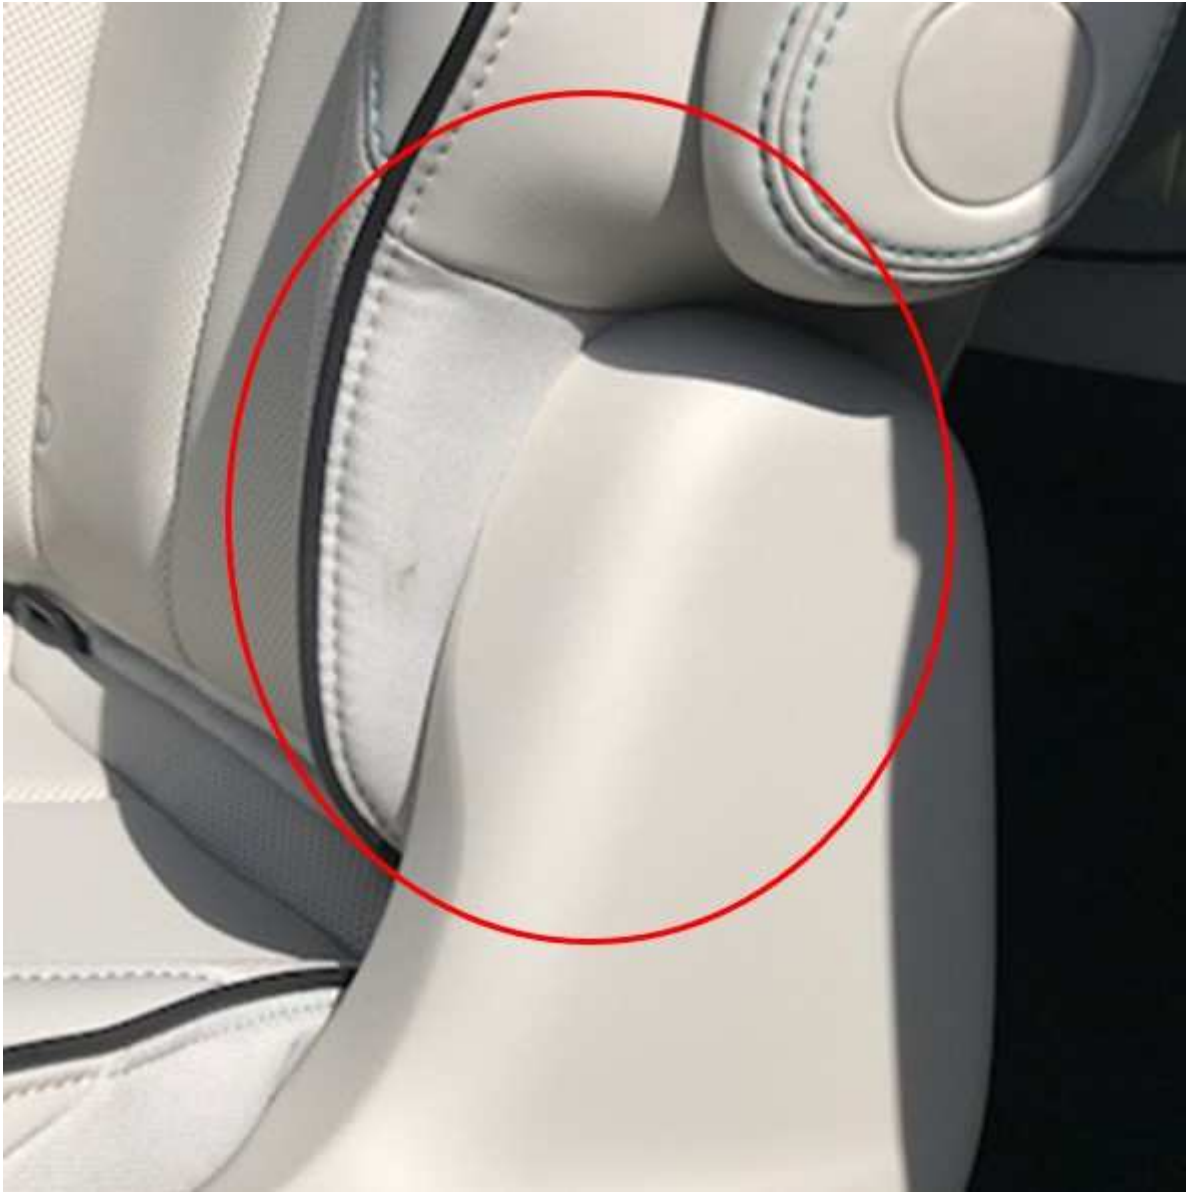
Fig. 6
Inspect for Grease

The customer may describe a grease stain on either of the outboard lower seatback trim covers side facing the seat recliner pivot point.

6. Raise the seat to the upright position and inspect for grease on the side of the seat cover (Fig. 8) and clean if required using (Mopar Total Clean #04897840AB).

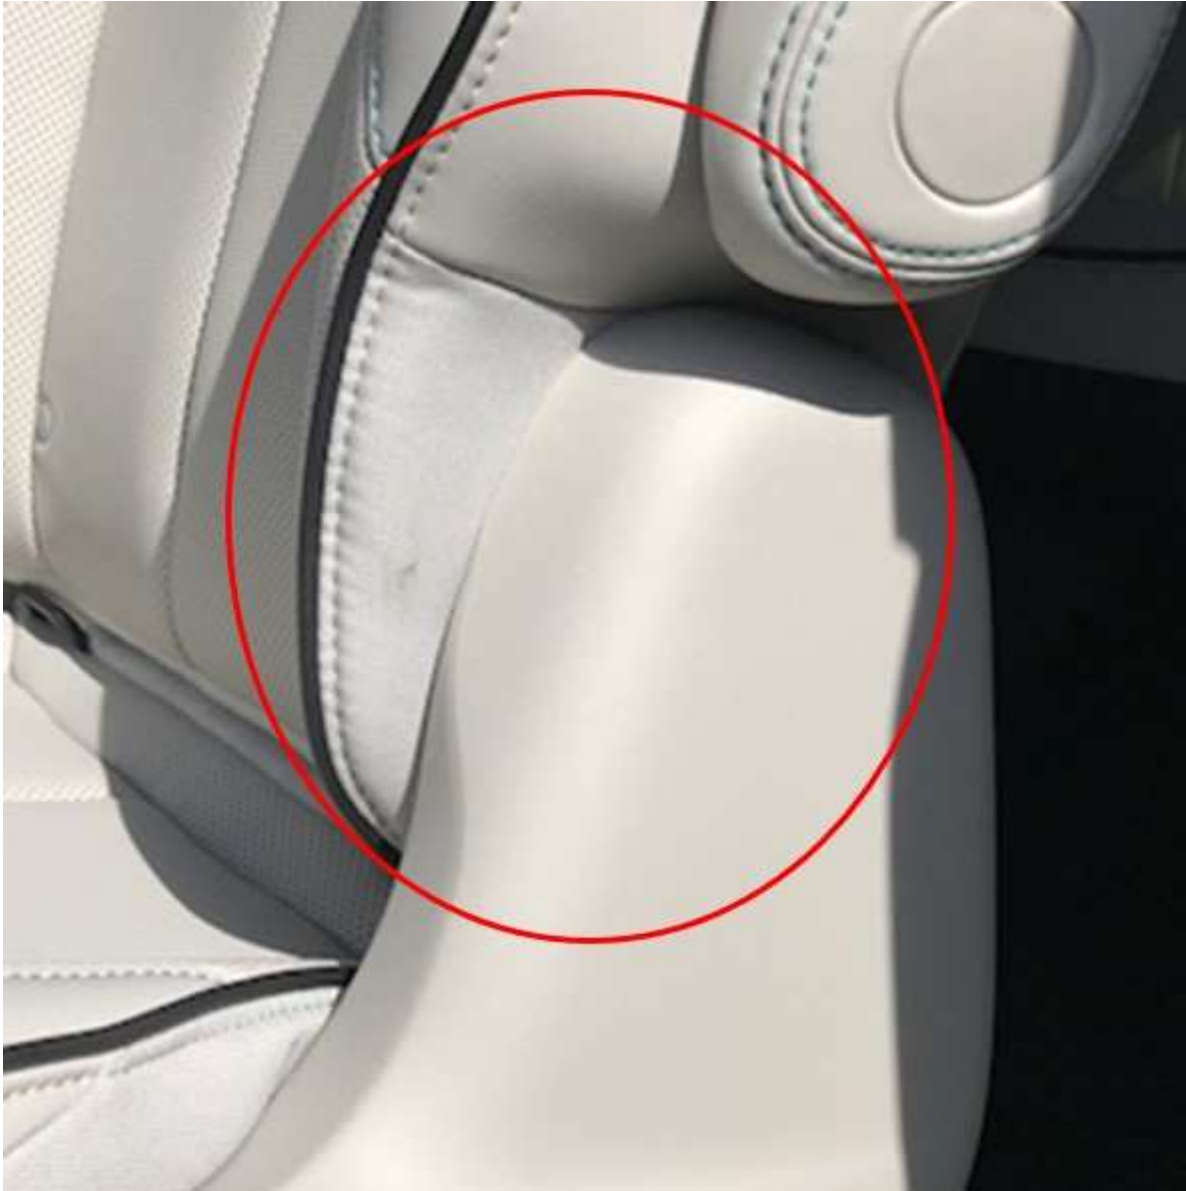
Fig. 8
Inspect for Grease

8. Did grease reappear on the side of the seat cover (Fig. 8) ?

- a. YES>>> Repeat [Step 3](#).
 - b. NO>>> Repair is complete.
9. Repeat [Step 1](#) for the other side if necessary.
