**NUMBER:** 08-007-17 REV. G

**GROUP:** 08 - Electrical

***SUBJECT:***

UAS, UCQ, UDQ, UJQ and UAQ Radio Enhancements

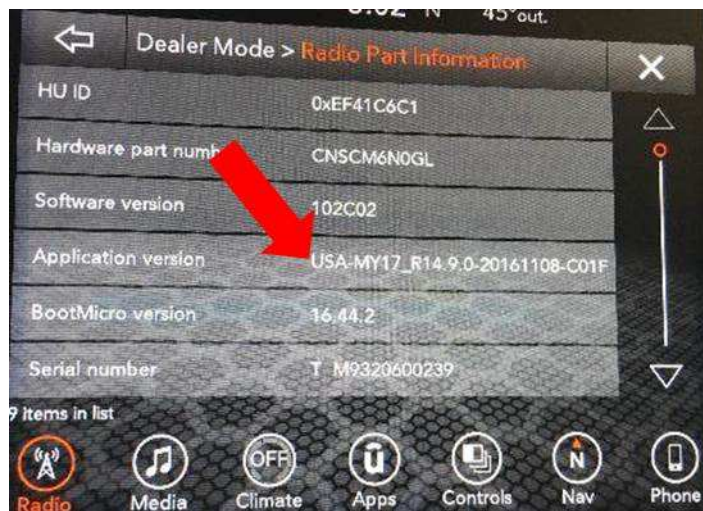
**Fig. 1**  
**Radio Software Level Screen**

1. Verify the radio software version. Radio must be in Dealer Mode to verify by following these steps:
  - a. Push and hold the Front Defrost, Driver Temperature Up and Temperature Down buttons simultaneously until the Dealer Mode screen appears (approximately seven seconds). Release buttons.
  - b. Select "Radio Part Information". The software version will be listed next to "Application Version".
2. Is the radio currently at software level 16.11 or higher (Fig. 1) ?
  - YES >>> The radio software is already up to date. This bulletin has been completed, use inspect LOP (18-60-02-LT) to close the active RRT.
  - NO >>> The radio software needs to be updated. Back out of Dealer Mode and proceed to [Step 1](#) of the Repair Procedure.

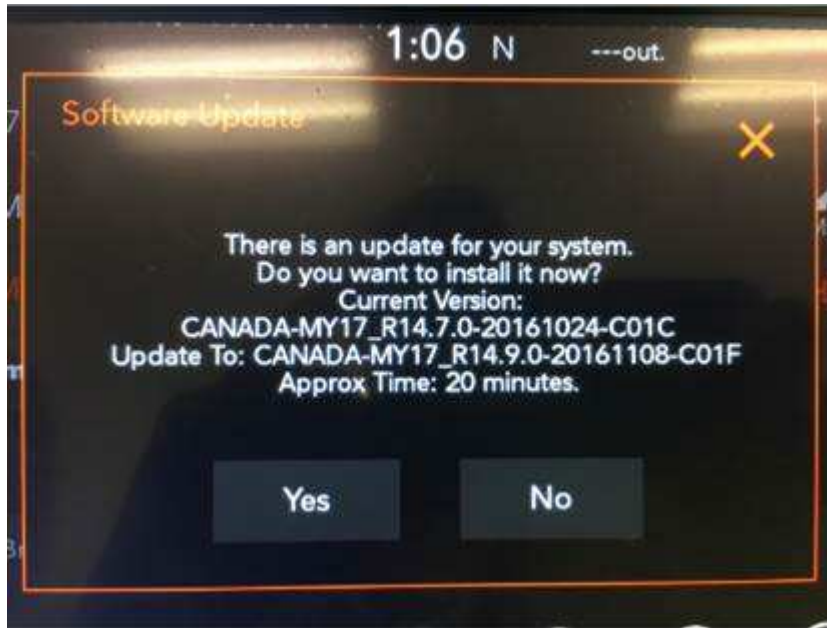
Fig. 6

**Software Levels (The figure is for reference only, actual software levels will be 16.8 to 16.11)**

11. The next screen display will have the old and new software levels (Fig. 6) . The radio will be updated to 16.11.
