**NUMBER:** 23-037-17 REV. A

Odor Coming from Engine Compartment

2017 (GA) Alfa Romeo Giulia

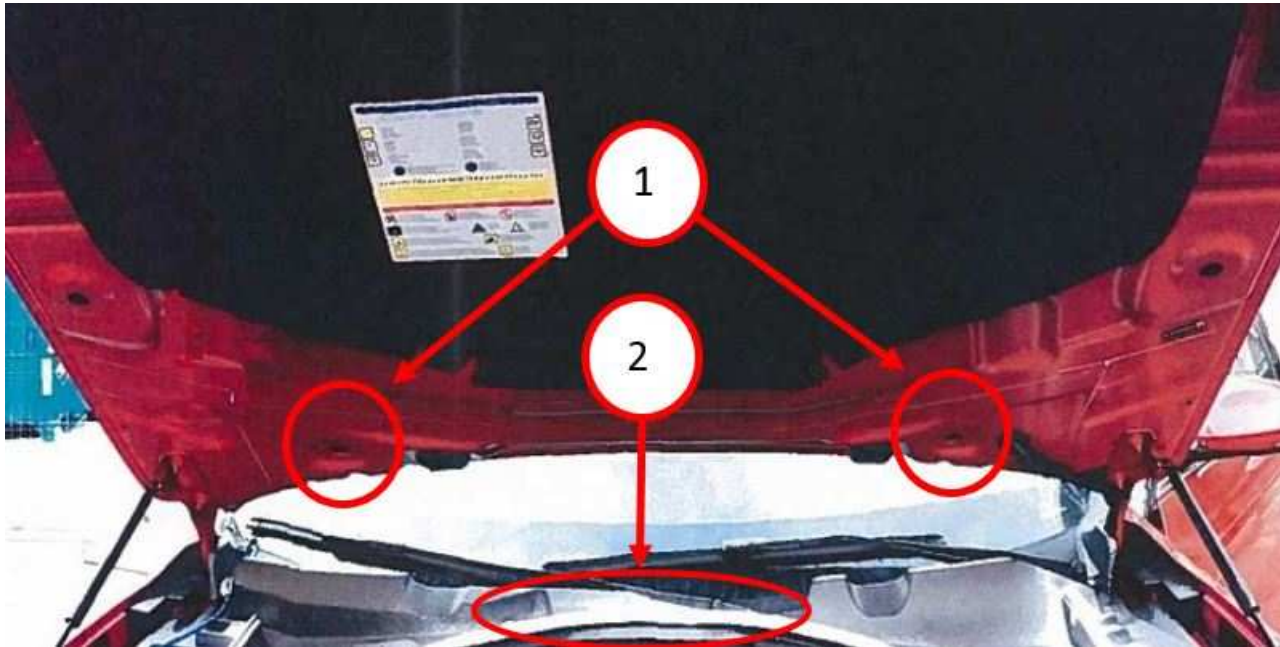
Fig. 1  
Underhood View

Customers may notice a smell in the passenger compartment while operating the vehicle in traffic conditions (Stop and Start, 2nd and 3rd gear and parking maneuvers).

- 1 - Vent Holes  
2 - cowl Seal Gasket

1. Open hood and locate the cowl seal gasket (Fig. 1) . Replace the gasket with the revised part listed in Parts Required. Verify seal makes contact to hood.

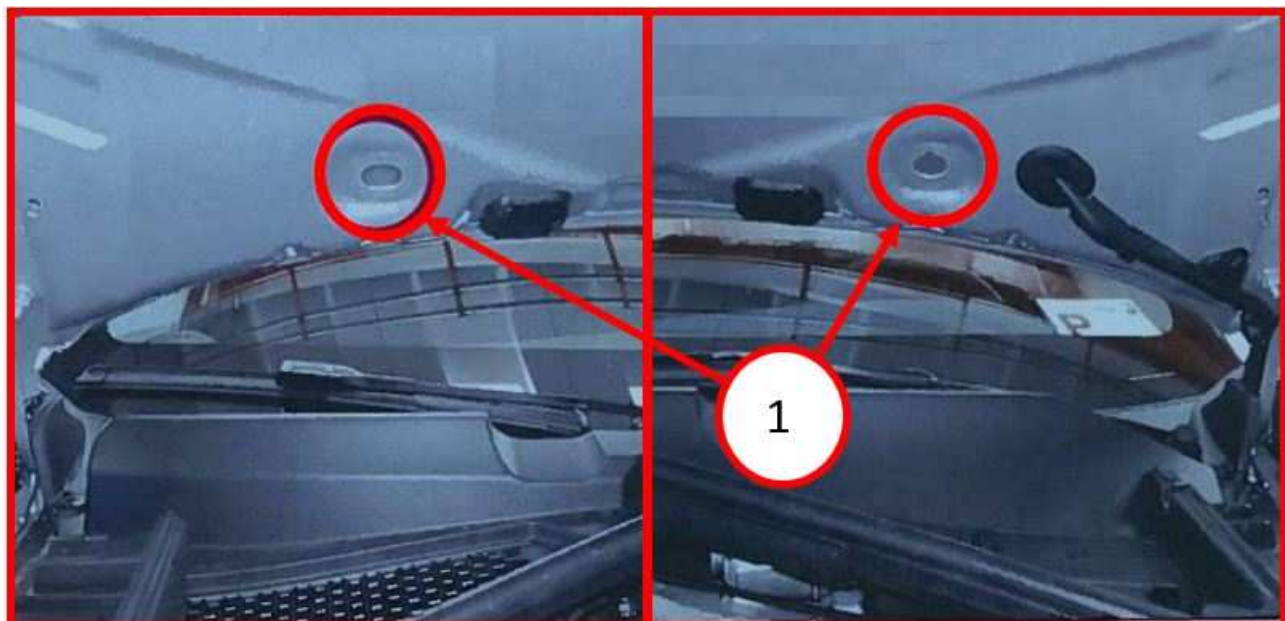
Fig. 2  
Hood Vent Holes

- 1 - Vent Holes

2. Clean area around vent holes (Fig. 2) with isopropyl alcohol to allow insulating tape to stick to surface.

3. Apply the insulating tape to cover vent holes.
