# Service Information Letter

Date: September 19, 2017

Units Affected: TDA58 units built from serial number 0914GC0101 (September 2014) through 0217GC0198 (February 2017) (see attached list)

## Unit Improvements

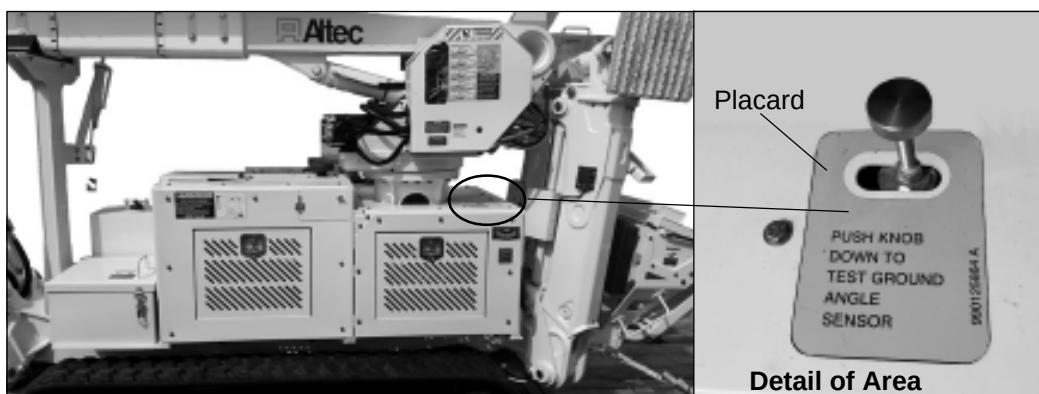
**Figure 1 — Ground Angle Sensor Placard Location**

- The slope alert system has been changed to have the tilt sensor signal and high speed track motion lockout activate at a lower angle of tilt. This change will help reduce the possibility of tipping the unit when operating over rougher ground. Look at the top of the carrier on the curbside for the knob and the Ground Angle Sensor Test Placard, part number 990125864 (refer to Figure 1). If that placard is NOT on the unit, order Tilt Sensor Assembly Kit, part number 990141011.

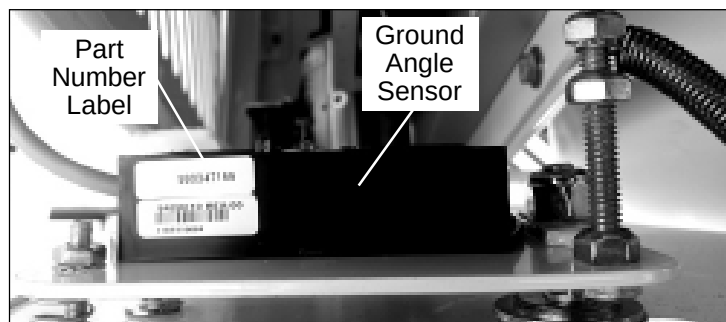
**Figure 2 — Ground Angle Sensor Part Number**

If the knob and the Ground Angle Sensor Test Placard are on the unit, remove the five cap screws holding the cover. Remove the cover and look at the side of the ground angle sensor for the part number (refer to Figure 2). If the sensor part number is not 990347155, order the Tilt Sensor Only Kit, part number 990347155. Reinstall the cover and tighten the cap screws securely.

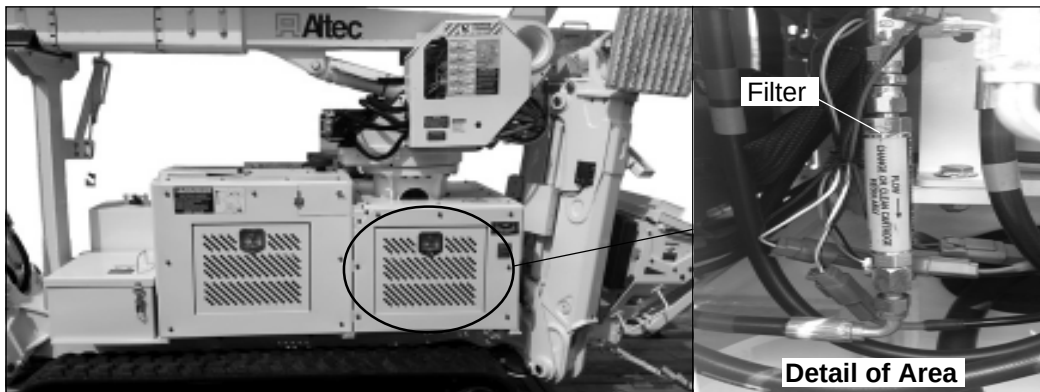
**Figure 3 — Filter Location**

- A filter has been added to the load sense hose to the pump to protect the pump compensator from contamination. It is located behind the curbside hydraulic access door (refer to Figure 3) to the lower left of the valve. It is an in line filter with a yellow label. If it is not in the hydraulic system at that location, order the Load Sense Filter Kit, part number 990377536.

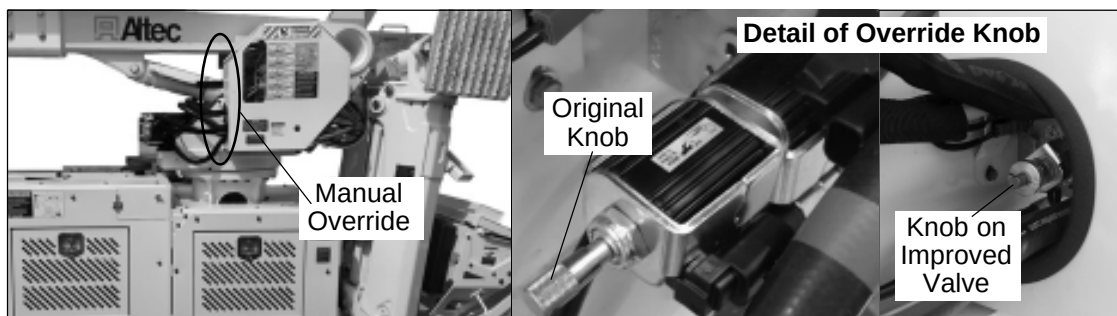
**Figure 4 — Manual Override Location and Knob**

- An improved manual override has been developed to be more reliable in operation. The manual override is located on the left side of the turntable valve cover. The original control has a gold-colored knob (refer to Figure 4). If a gold-colored knob is visible, order the Manual Override Kit, part number 990371943.

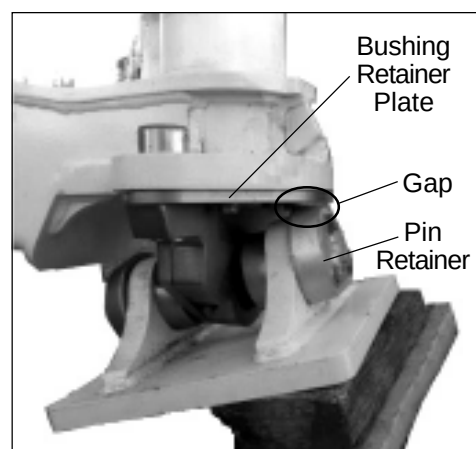
**Figure 5 — Outrigger Foot Position**

- A shim may need to be added to the outrigger to prevent the swivel outrigger foot from damaging the pins used to mount the outrigger leg to the frame if the outrigger foot bottoms out at an extreme angle. Engage the unit's hydraulic system and extend each outrigger so the outrigger foot presses at an angle on a wheel chock or other angled surface (refer to Figure 5). Look to see if there is any gap between the outrigger foot pin retainer and the bushing retainer plate. If there is a gap, also look at the end of the outrigger foot kingpin assembly to see if it is bent, if the weld is damaged or cracked, or if the assembly is not even on both guide pins (refer to Figure 6).

If there is a gap between the outrigger foot pin retainer and the bushing retainer plate (refer to Figure 5) order the Outrigger Shim Kit, part number 990415643. The shims must be added to all outriggers if one has a gap. If any of the kingpins are damaged, order the kingpin assembly, part number 970455213.
