Subject: Field Repair 517-3: SmartNav Software Update

**517-3**

SmartNav Feature Updates and New OTA Supplier - Movimiento

10/25/2017

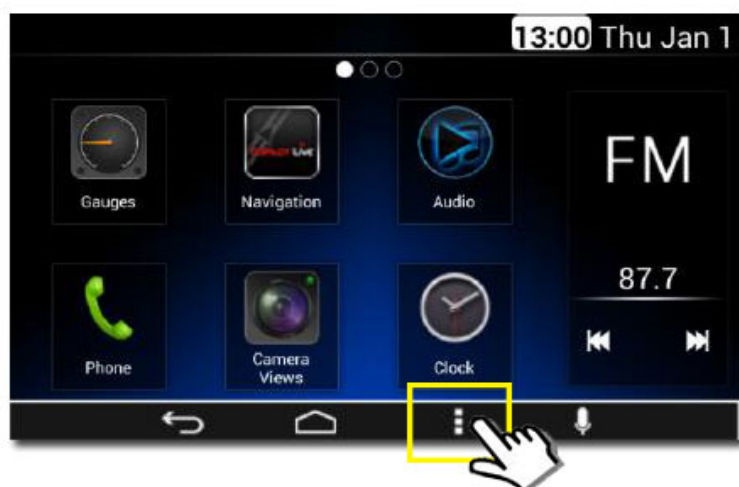
Select the vertical dots

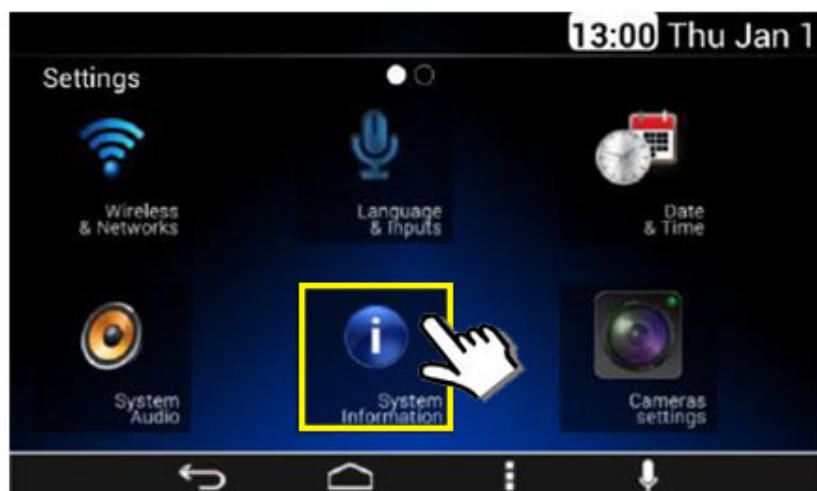
Select System Information Icon

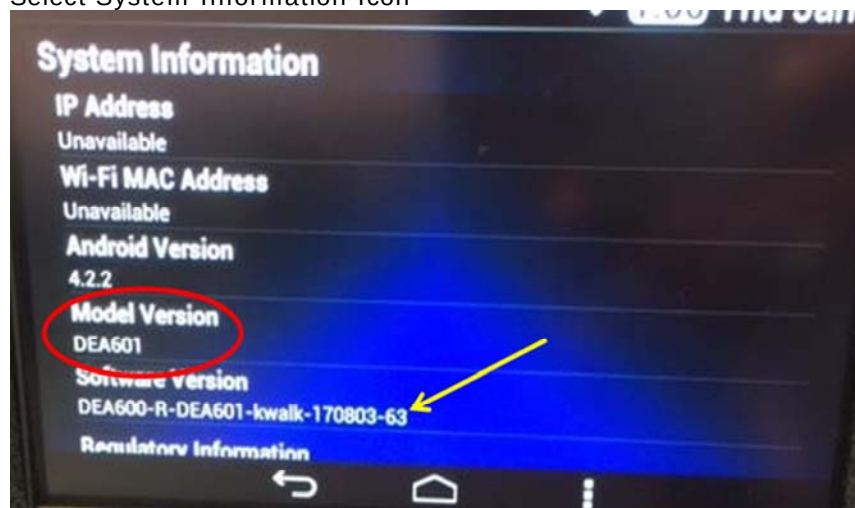
If the software version is "63" or higher, the USB download has already been performed, if it is lower follow the steps below.
