Subject: Field Repair 317-2 –Model 579/567 Outside Air Temperature Sensor in Lang Mekra Mirror  
EXPIRATION DATE: NONE  
*The VINs are listed on the back of this page*

**317-2**

Model 579/567 Outside Air Temperature Sensor in Mekra Lang Mirror

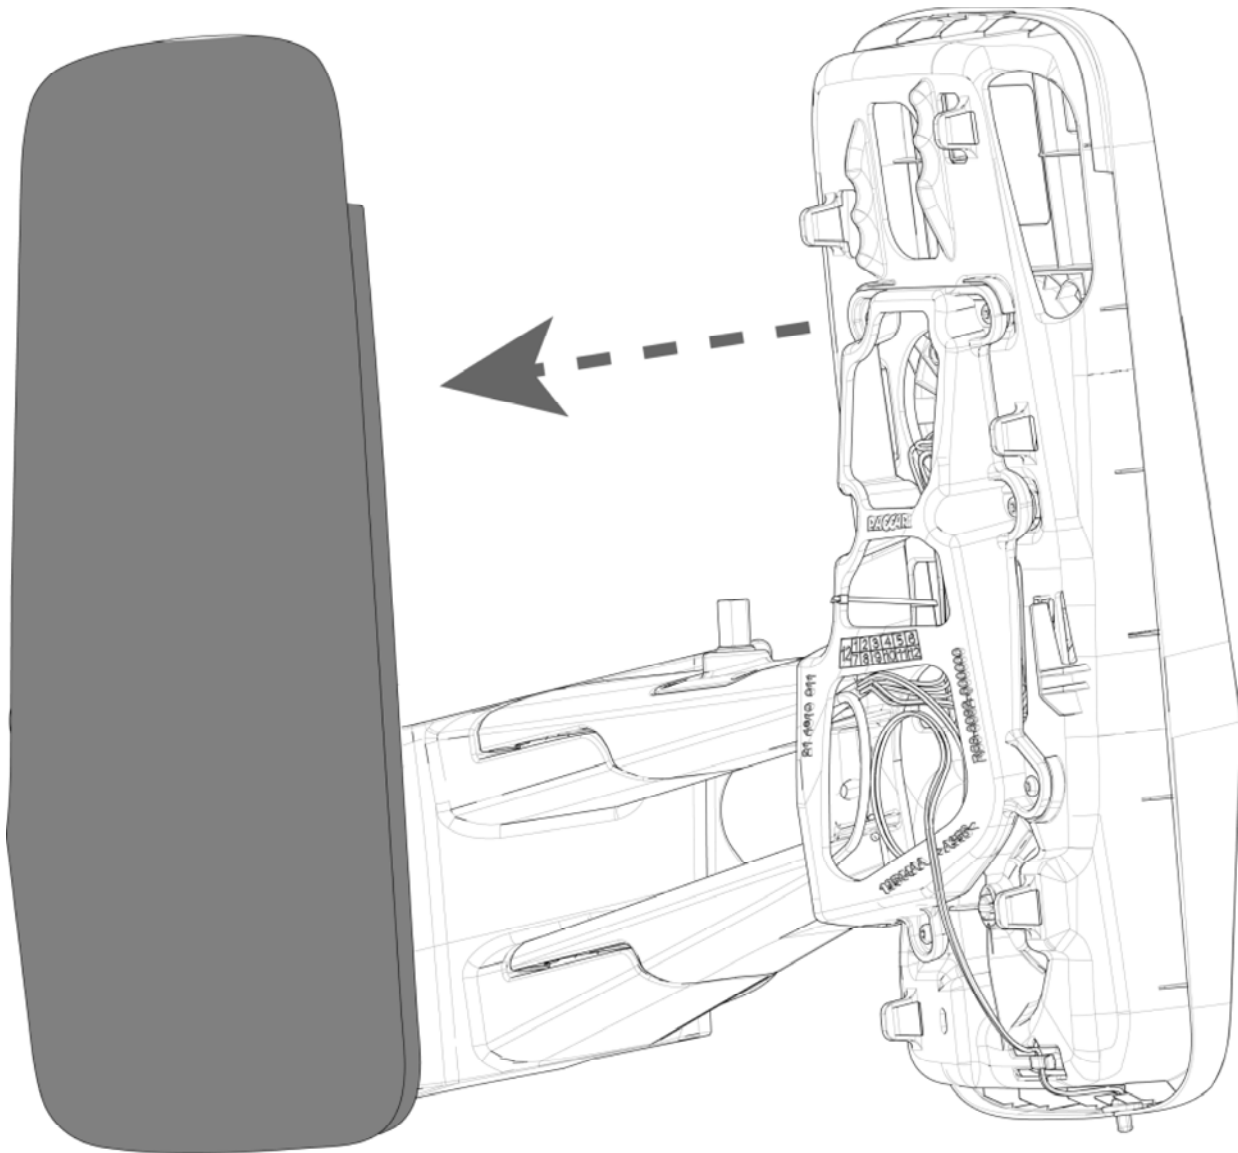
Peterbilt has determined that certain Model 579/567 vehicles built with a Mekra Lang driver's side mirror with an outside air temperature sensor between 01/15/2015 and 02/02/2017 manufactured with a PACCAR MX or Cummins engine. The outside air temperature sensor may fail with DTCs P0072, P0073, and/or P009a.

1. Remove the mirror cover.
