Solenoid Bracket, Replacement
 VN, VHD, VAH

FSB 373-024, Solenoid Bracket, Replacement

(October 2017)

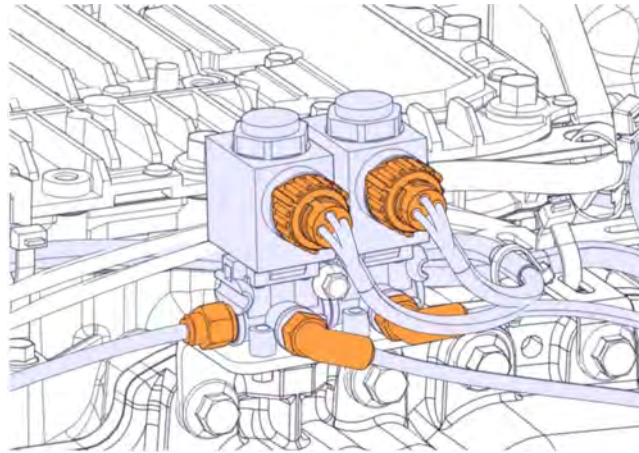
W4128709

- 1 Drain the air system.
- 2 Disconnect the electrical connectors and airlines.

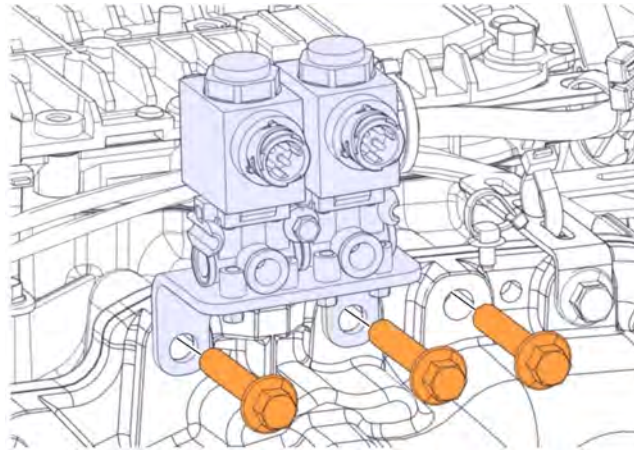
W4128710

- 3 Place tape over the exposed electrical connectors and caps over the ends of the airlines to protect against dirt or dust intrusion.
- 4 Remove the bolts used for securing the original bracket, and an additional bolt that will be used for securing the new bracket as shown.

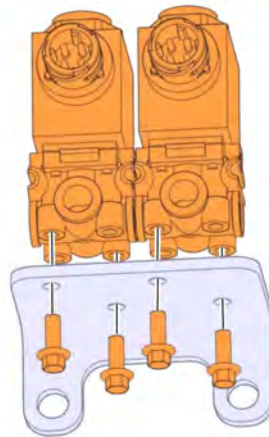
W4128711

- 5 Remove the bolts securing the solenoids to the bracket.
