**DATE:** 10/04/17

**APPLIES TO:** This service bulletin applies to 2018 model year, K2 and K3 model motor home chassis built between January 17, 2016 and June 6, 2017.

**CONDITION:** 5A and 10A Circuit Breakers Installed incorrectly

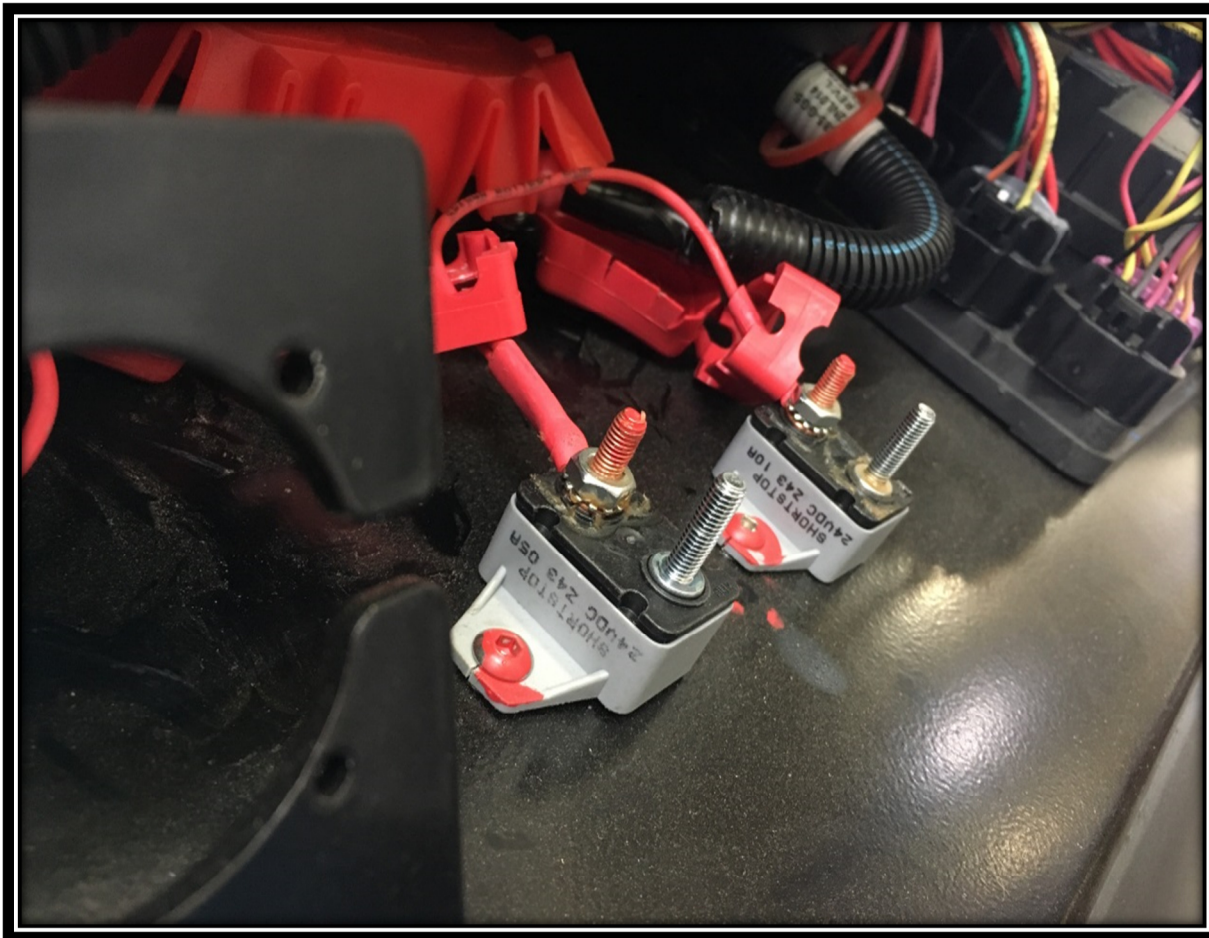
**FIG. 2-1**

1. Inspect the service center located on the passenger side of chassis behind the tag axle. This area will have two gray circuit breakers with red rubber two post caps. Important: Please disengage power to the circuit breakers by switching 120a breakers to "off".
2. Lift the caps to read the small black font for the 5A or 10A identification. For incorrect orientation Refer to FIG. 2-1.

3. If the breakers are incorrectly positioned, please remove and reposition in the correct location identified on the 4618-NN2 installation. Refer to FIG.-3-1. Important: Follow torque guidelines referenced at the bottom left corner, which should be 15 lbf-in. for these Allen screws.
