Shock Absorber, Inspection  
CHU, CXU, GU, LEU, LR, MRU, TD

## **FSB 761-002, Shock Absorber, Inspection**

**(October 2017)**

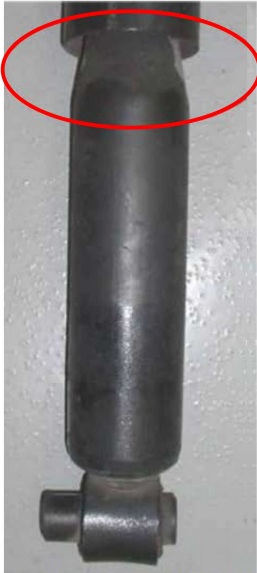
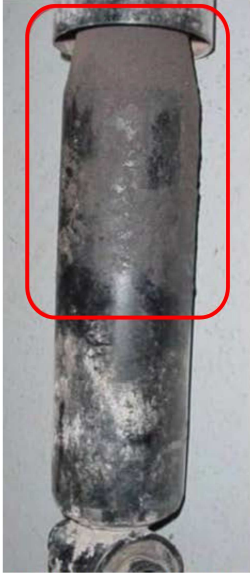
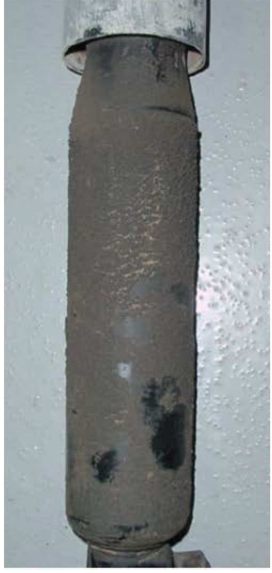
<b>Not Accepted as Warranty Failure</b>			
<b>SYMPTOM: Misting</b>	<b>Light Misting</b>	<b>Medium Misting</b>	<b>Heavy Misting</b>
<p>Precipitation of oil mist on the outside of the shock is visible. Appearance may be deceptive.</p>	<p>Light Oil Film on the Upper Shock Body  <b>NO Action Required</b>  <b>Do Not Remove</b></p>	<p>Medium Oil Film on Upper Half of the Shock Body  <b>NO Action Required</b>  <b>Do Not Remove</b></p>	<p>Heavy Oil Film Extending to the Bottom of the Shock Body  <b>NO Action Required</b>  <b>Do Not Remove</b></p>
<p><b>Cause:</b></p> <p>High operating temperatures results in oil mist and precipitation. A certain degree of vapor is therefore normal and actually a necessity for the lubrication of the rod seal.</p>

<p><b>Note:</b> The inspection must not be conducted after driving in wet weather or a vehicle wash. Shock needs to be free from water.</p>	<p>W7128505</p>	<p>W7128506</p>	<p>W7128507</p>

<b>WARNING</b></p> <p>Allow the shock absorber to cool after operation. The shock absorber may be hot to the touch and cause personal injury.</p> </div> <p>After the complete extension of the shock, touch the upper area of the reservoir tube (smaller diameter) with a dry finger. If the finger remains dry, the shock is not leaking. If in doubt, wipe the shock clean and check again after a few days of operation. If oil is only visible around the bottom it likely comes from an outside source.</p>

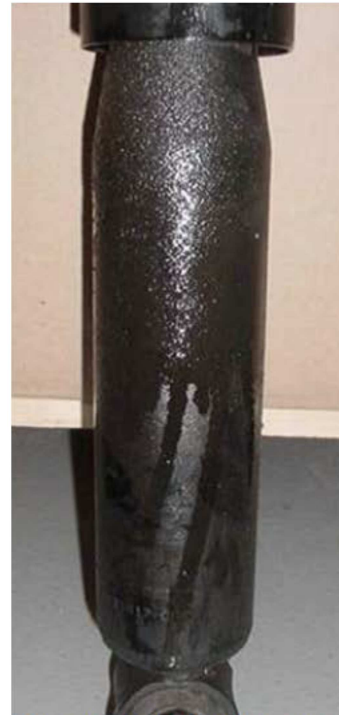
W7128508

Symptoms of leakage include loss of oil, loss of the damping function or loss of ride control of the vehicle. The reservoir tube (smaller diameter) is predominantly covered with oil.

Damaged or overheated seal.

The shock is considered as a leaker if a dry finger gets wet of oil when touching the shock at the upper area of the reservoir tube (as in previous "Finger Test").

After the finger test, the shock can exhibit a glossy film of oil / dirt, or an oil droplet formation on the reservoir tube.

**Leaking**

Oil Leak Path Lines Visible on the Shock Body  
**Action Required**  
**Replace Shock Absorber**

Replace leaking shock.
