Technical Bulletin

87 17 03 March 9, 2017 **2040184** Supersedes Technical Bulletin V871610 dated July 7, 2016 to update to the latest software level and update model year 2017 ending VIN range.

Climatronic with Heat Pump - Sporadically Too Low Heating or Cooling Performance

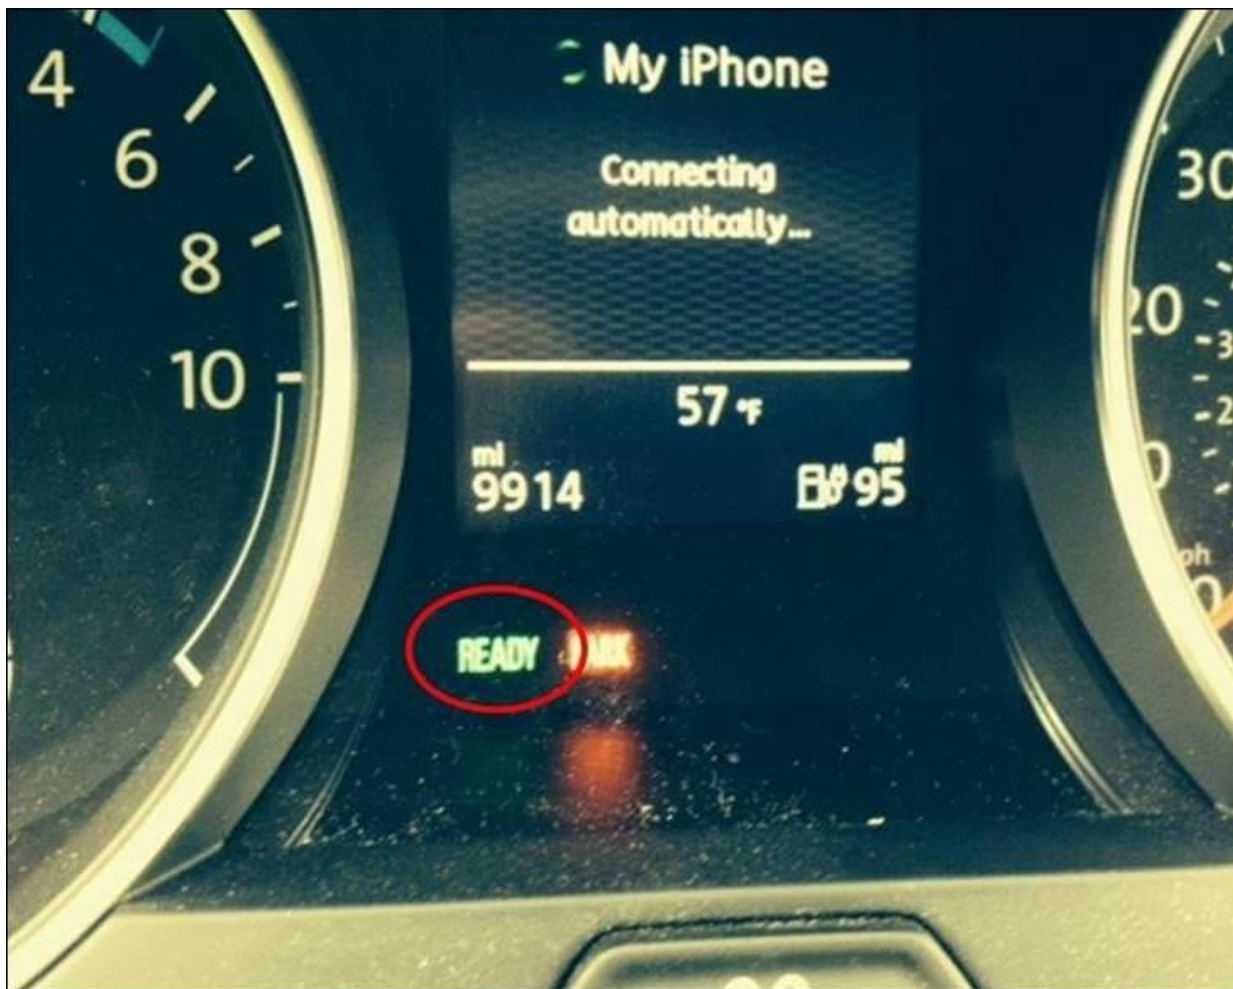
Figure 1

After the software update is complete an initial run of the compressor must be carried out according to the Guided Functions. The start switch must be ON, brake pedal depressed and electric motor indicator in the instrument panel in READY status (Figure 1). The initial run of the compressor will not complete without READY status illuminated.
