Technical Bulletin

24 17 03 March 6, 2017 2045138 Supersedes V241702 dated February 15, 2017 to remove engine coolant in required parts table.

MIL ON DTCs P2004, P2014 and or P2015 Stored in ECM Fault Memory

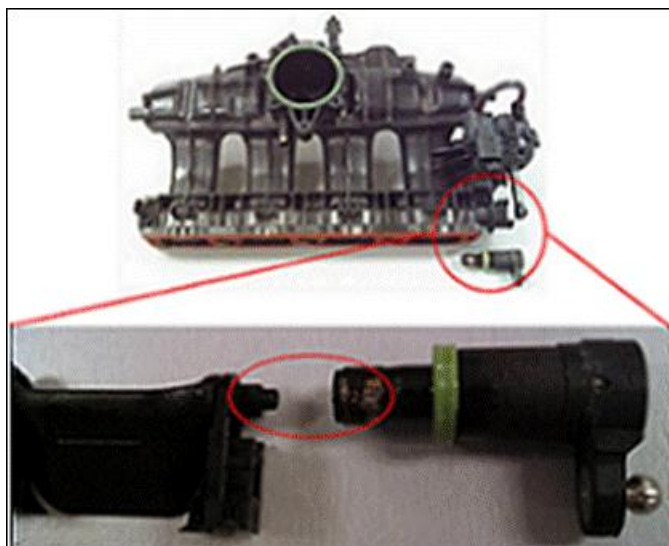
The intake manifold flap can separate internally and will not operate correctly with the regulator valve. See Figure 1. and 2. for an example of a damaged flap disassembled.

Check intake manifold flaps and if necessary replace intake manifold.

If the carrier plate can be pulled out, the flap has separated and the intake manifold must be replaced. See Repair Group 24 Multiport Fuel Injection in Elsa.

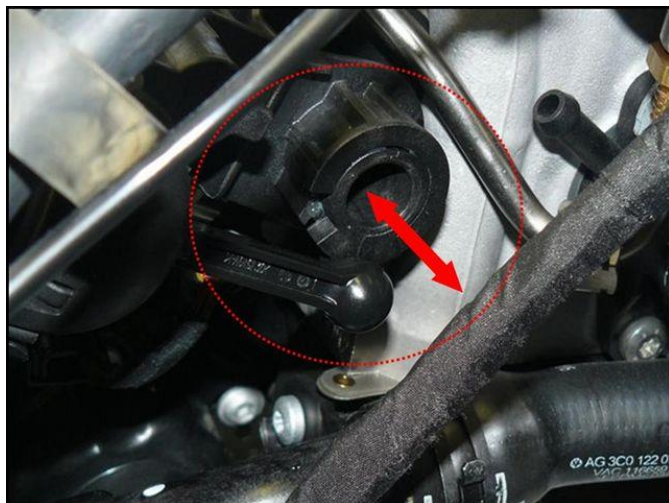
Figure 3.

- Remove the engine cover. See Repair Group 10 Engine Assembly in Elsa.
- Move the carrier plate by hand in an axial direction (Figure 3, red arrow) to check if the carrier plate can be pulled out.

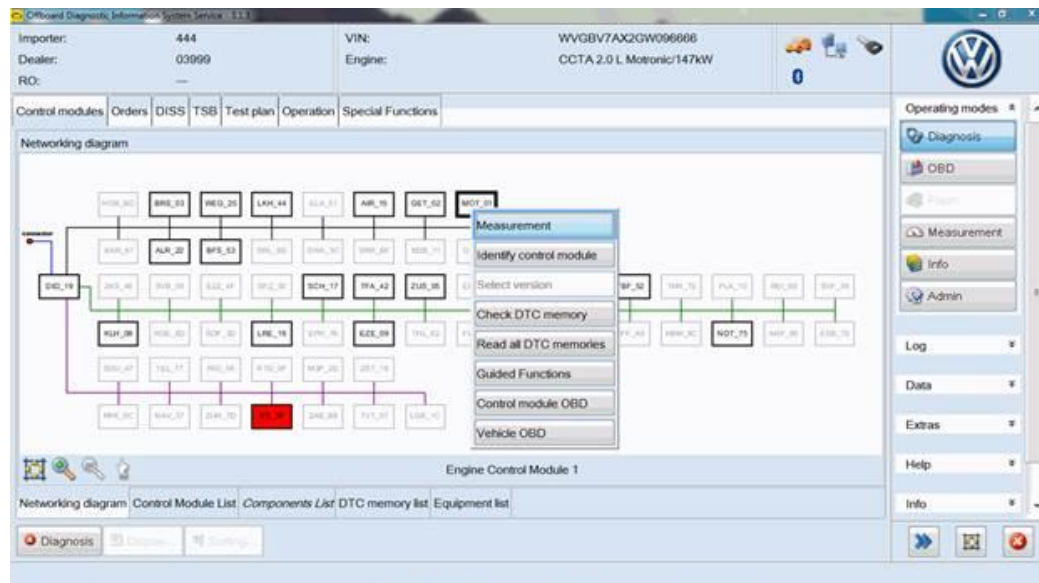
Figure 4

- Check the diagnostic limits of the flap with the ODIS tester.
- Under Motor, select Guided Functions (Figure 4).
