Technical Bulletin

Model(s)	Year	Eng. Code	Trans. Code	VIN Range From	VIN Range To
(A5) Jetta, Rabbit, GTI, Passat, Passat Wagon, Eos	2006-2008	2.0L (BPY)	All	All	All
All	2008-2009	2.0L (CCTA, CBFA)	All	All	All

01 17 05 March 9, 2017 2018652 Supersedes T. B. V011612 dated July 19, 2016 to update the part table.

MIL ON, DTCs P1545, P0121, P0123, P0221 or P0222 Stored in ECM Fault Memory

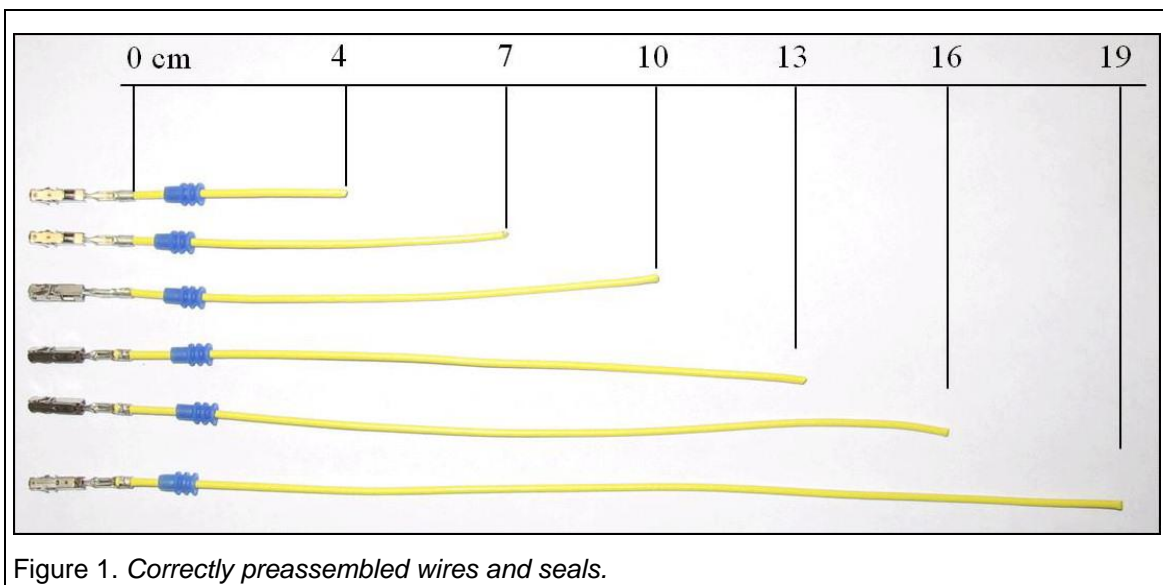
Figure 1. *Correctly preassembled wires and seals.*

- Lengthen wires and preassemble seals according to Figure 1.

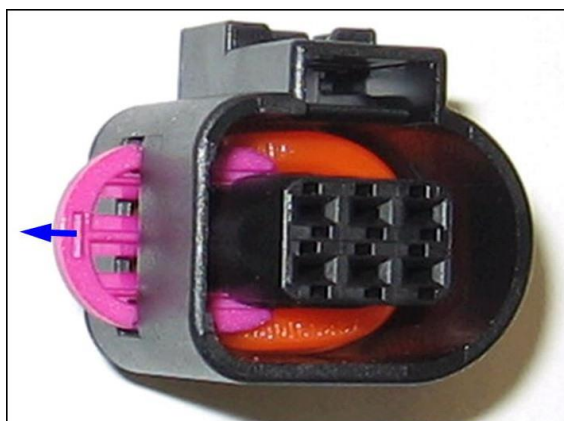
Figure 2. *Slot to be used to remove lock.*

- Release lock on new wiring harness end connector housing using small flathead screwdriver. Use slot marked in Figure 2.
- Insert all terminals into housing until they audibly click.
- Reinstall lock.

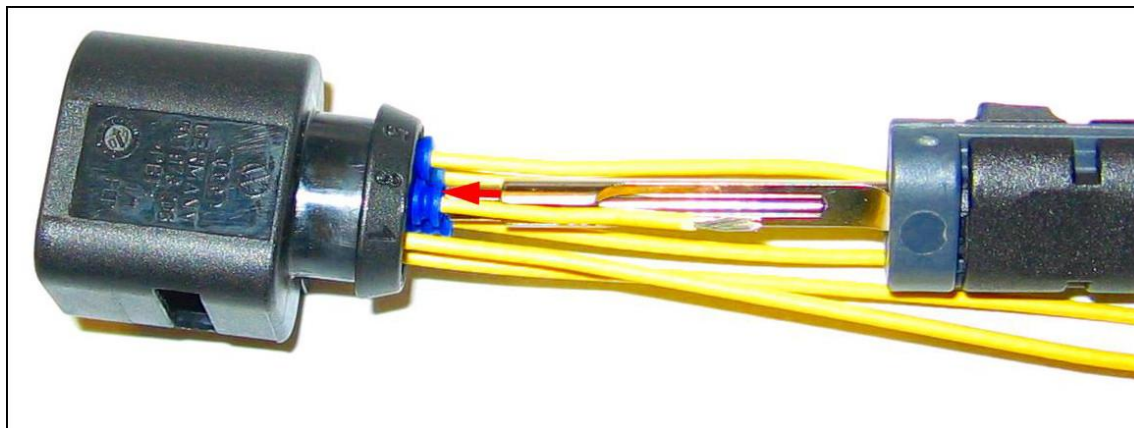
Figure 3. The single wire seal, slid as far as the stop

- Using an appropriate assembly tool, slide the single wire seal up repair wire until it contacts housing. Continue to slide seal into housing as far as the stop (Figure 3).

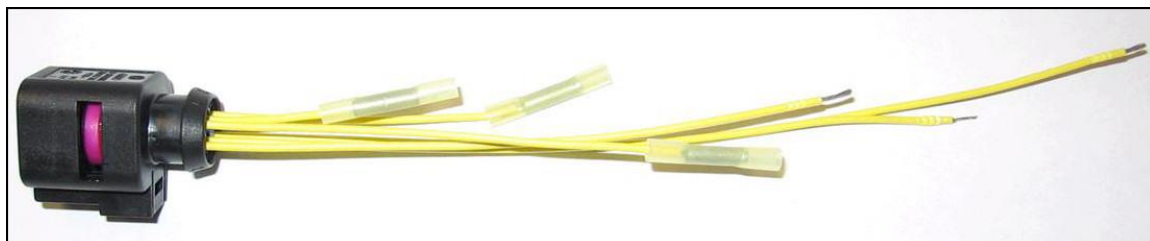
Figure 4. Crimp connectors installed on wire ends

- Strip wires 6-7mm using tool VAS 1978/3. Install crimp connectors using crimping pliers (base tool) -VAS 1978/1-2 with head VAS 1978/1-1 (Figure 4).
- Remove car harness insulation to appropriate length (approximately 24cm).
- Lay new harness beside old harness. Cut original wires to fit new harness.
- Twist wires 3 and 5 and 1, 2, 4 and 6 as they were originally.
- Crimp connections.
- Use shrink tip (VAS 1978/15) with hot air gun 220 V/ 50 Hz (VAS 1978/14) to complete installation of shrink tubes.
