## Technical Tip

<b>Topic</b>	37-17-01TT - Mechatronics Unit or Transmission Replacement Tips (including DTC P309D) after the K0 Clutch Line is Opened for Service
<b>Market area</b>	United States 444 Volkswagen of America, Inc. (6444)
<b>Brand</b>	Volkswagen
<b>Date</b>	March 24, 2017

### Mechatronics Unit or Transmission Replacement Tips (including DTC P309D) after the K0 Clutch Line is Opened for Service

Model(s)	Year	Eng. Code	Trans. Code	VIN Range From	VIN Range To
Jetta Hybrid	2013-2016	1.4L CNLA	7 spd. DSG (OCG)	All	All

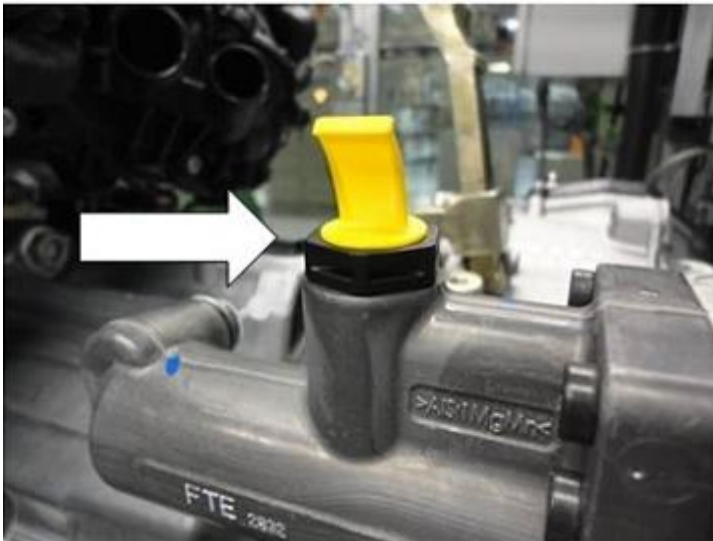
Figure 1

When replacing the DQ200 7 speed DSG transmission, the transmission may arrive with a yellow and black plastic cap installed on the K0 clutch actuator, as shown in figure 1.

This plastic cap should be removed and replaced with the aluminum cap found in the original K0 clutch actuator, as shown in figure 2.

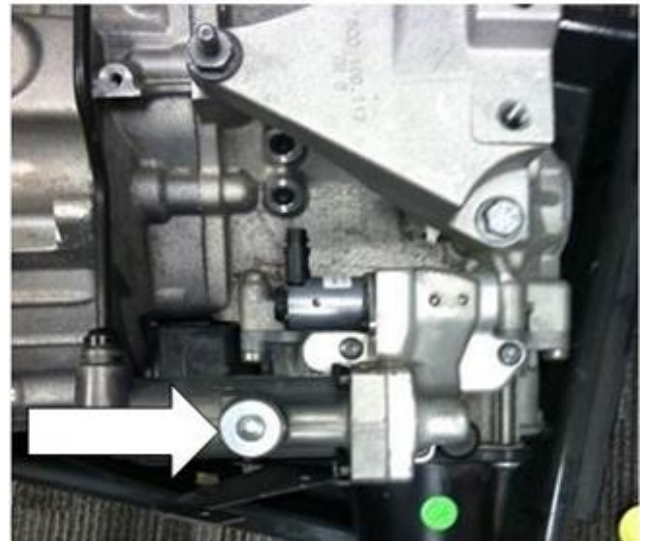
Figure 2

1. If this cap is not transferred, fault code P309D may set in the transmission control module (TCM).
2. If the K0 aluminum cap was transferred over and P309D sets, or if there are issues with the Guided Functions K0 clutch bleed, perform the following steps:
  - a) All faults have been cleared through Vehicle OBD
  - b) High Voltage connectors must have an audible click when secured
  - c) Parking brake is in the "OFF" position
  - d) All 4 passenger doors and hood remain closed during the basic settings
  - e) Trunk is "Open" with a battery maintainer installed on the 12v battery

The yellow and black plastic cap should be reinstalled in place of the aluminum cap on the original transmission.
