**Subject:** ISX15 CM2350 Fuel Pump Tappet ATC for HOGAN

**Number:** Atc1958

### **DESCRIPTION:**

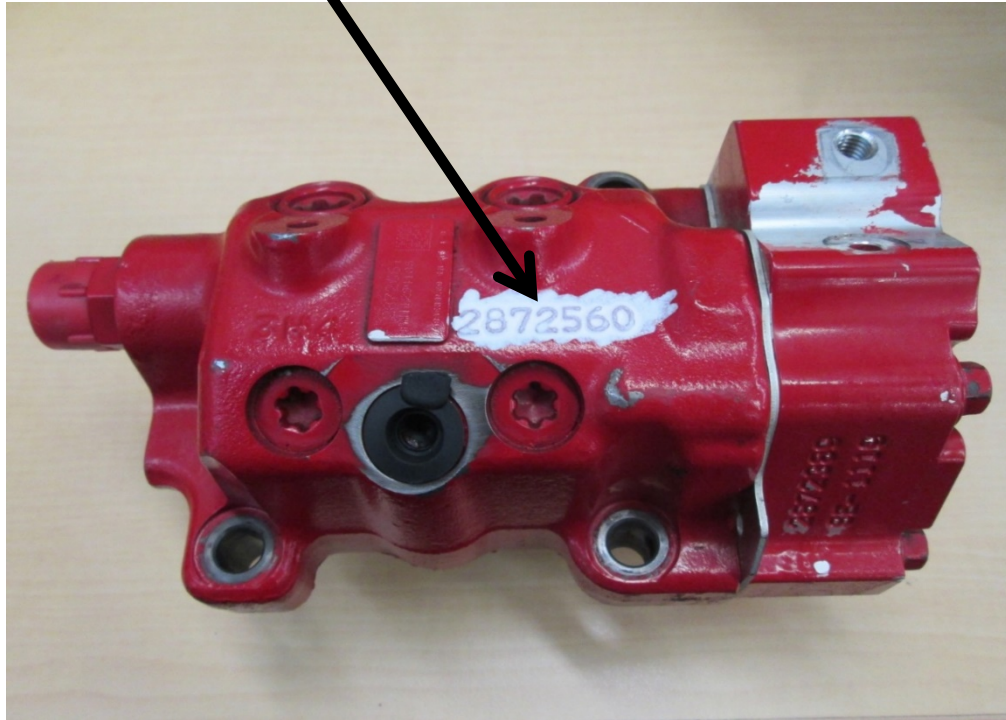
Mark the Fuel Pump Head forging number with a white paint marker after completing the repair.

- 3. Mark the fuel pump head forging number with white paint, as illustrated in Attachment C, to signify completion of this field action.
  - 4. File one claim for only the applicable parts and labor listed in this field action.
