Preliminary Information

PIP4495E Cylinder Head Tick Noise And Or Damage - Possible Plugged Oil Feed Orifice

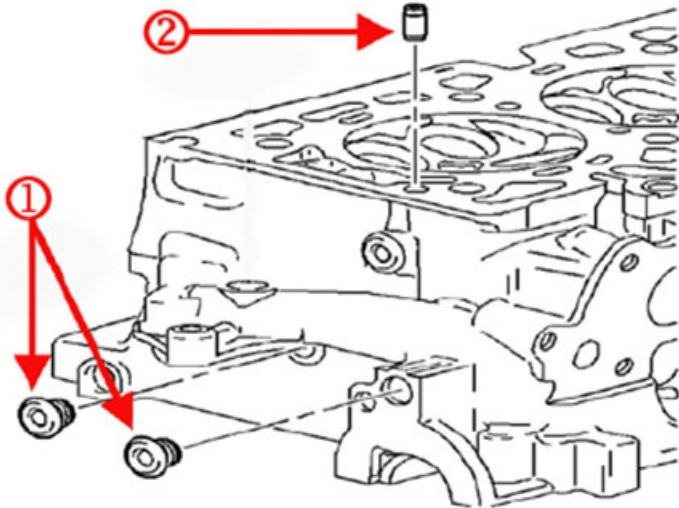
2. Check the upper end oil pressure by attaching another oil pressure gauge to one of the oil gallery plug ports on the back of the cylinder head (1).

- 5.2 If the upper end oil pressure is near 0 PSI/KPA but the lower end oil pressure is within SI specification, the oil feed orifice (2) is most likely plugged with debris. Please note that it is not uncommon for the upper end oil pressure of a normally functioning engine at idle to measure as much 35% less than the bottom end oil pressure. This is due to the large amount of oil pressure bleed off that normally occurs in the valve train, combined with the small size of the oil feed orifice (2).

- If you suspect a plugged oil feed orifice after performing the test above, remove the cylinder head and visually inspect the oil feed orifice (2) for debris. If debris is present, it can normally be cleaned out to repair the noise. Please note that the orifice is not available separate from the cylinder head and cannot be inspected/cleaned without cylinder head removal.

Notice: The oil gallery plug port threads (1) on the back of the cylinder head are M12x1.75 and it is unlikely that a related oil pressure gauge adapter will be found at a hardware or auto parts store. The 509376 Kent Moore Fitting that comes with the Engine Preluber Kit (EN-45299/J-45299) will screw into the head and may be adapted to some oil pressure gauges. Or, there are also several online retailers that can supply a fitting that will work as an adapter - the male end has to be M12x1.75 while the female end has to be 1/8"x27 NPTF so a standard oil pressure gauge hose can screw into it. It has also been found that some automotive gauge companies, such as Auto Meter, offer the necessary adapter/fitting (M12x1.75 / 1/8"x27 NPTF) for \$5-\$20. Some technicians have also reported success in making a temporary fitting out of an oil pressure sender body.

Important: To prevent future concerns, care must be taken not to use excessive amounts of engine sealant during internal engine repairs, use the proper oil filter that is listed in the parts catalog, and change the engine oil/filter according to the schedule in the owner's manual.
