Preliminary Information

PIT5533A Creek Click Pop Crack Type Noise From Front Suspension/Frame Area While Making Turns

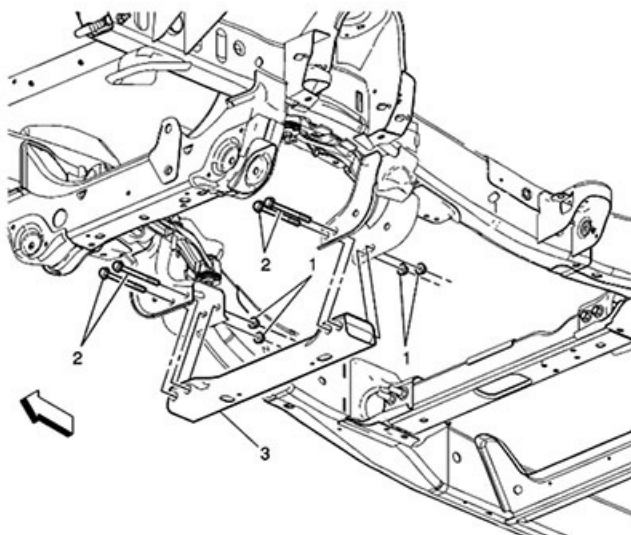
Correction 1

Brand:	Model:	Model Years:	VIN:		Engine:	Transmissions:
			from	to		
Cadillac	Escalade	2015 - 2018	All	All	All	All
Chevrolet	Silverado	2015 - 2018	All	All	All	All
Chevrolet	Suburban	2015 - 2018	All	All	All	All
Chevrolet	Tahoe	2015 - 2018	All	All	All	All
GMC	Sierra	2015 - 2018	All	All	All	All
GMC	Yukon	2015 - 2018	All	All	All	All
Involved Region or Country:		North America				
Condition:		Some owners may comment of a creek, click, pop, crack type noise from the front suspension or front frame area while making tight turns. It may also be noted the noise can be felt in the foot well area.				
Cause:		<p>It has been found that this type of noise could be caused by either insufficient torque of the front suspension:</p> <ul style="list-style-type: none"> - Frame crossmember - Lower control arm bolts

To correct this concern loosen and then re-torque the four front frame crossmember bolts/nuts:

1. First Pass: 70 Nm (52 lb ft)
2. Final Pass: 110 degrees
