Preliminary Information

PIT5359B Radio Back Lighting Stays On After Key Off / Dead Battery / TCCM Repeat Failure

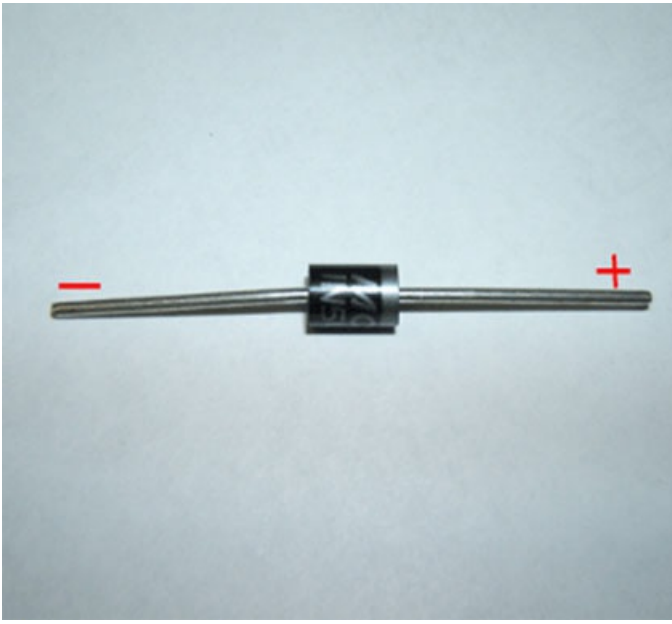
To prevent damage to any of the sensitive electronic components on the bussed circuit, the solenoid/relay **MUST** have the control circuit suppressed with a diode. The diode will prevent the voltage spikes from being transmitted onto the Run/Crank circuit.

Install a diode, P/N 12112422, across the coil of the solenoid. It is important that the striped end of the diode be connected to the positive terminal of the coil and the other end of the diode be connected to ground.

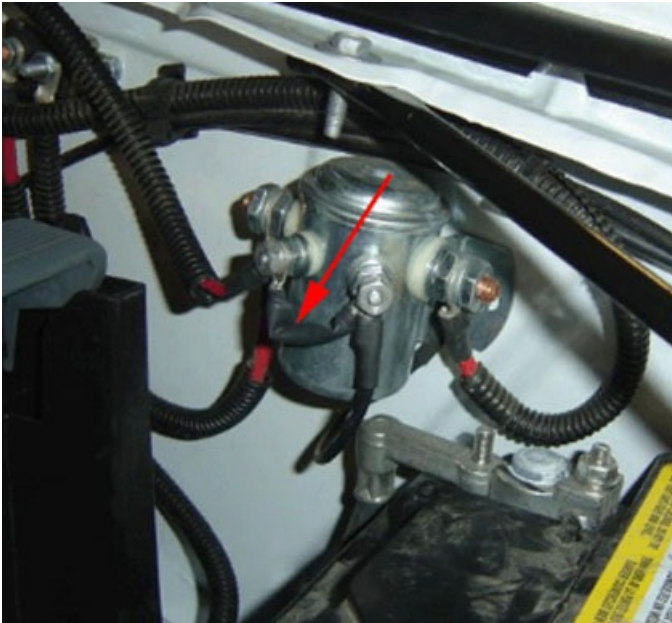
Important: Be sure to insulate the diode with heat shrink tubing before installing as shown in the picture above.

Notice: Some solenoids/relays may only have a positive post and will get their ground through their mounting bracket. In this case, the striped end of the diode is to be connected to the positive terminal and other end should be connected to the ground of the solenoid/relay.
