Preliminary Information

PIC5822D Water on Floor and/or Carpet

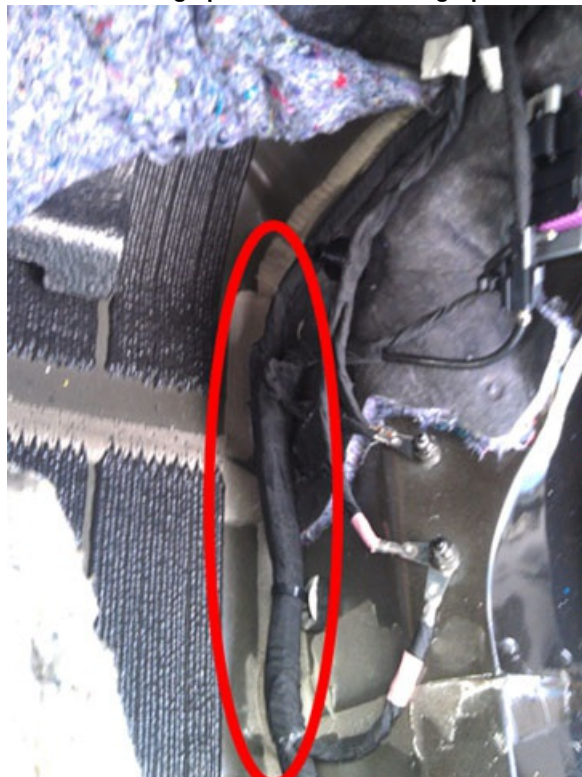
Technician should pull back carpet and insulator as shown in pictures below for the suspect side of the vehicle (passenger side shown). Remove the front wheelhouse liner and spray water into the wheelhouse of the affected side and check for water in the area indicated in photo shown below.

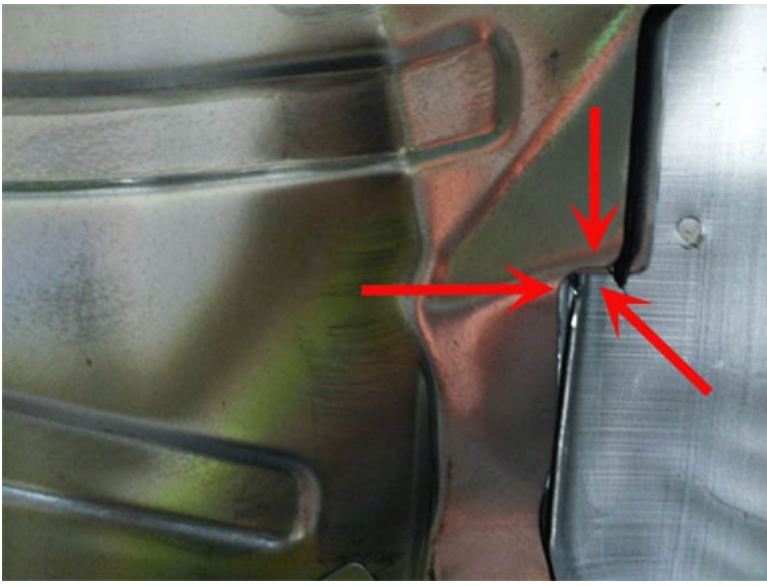
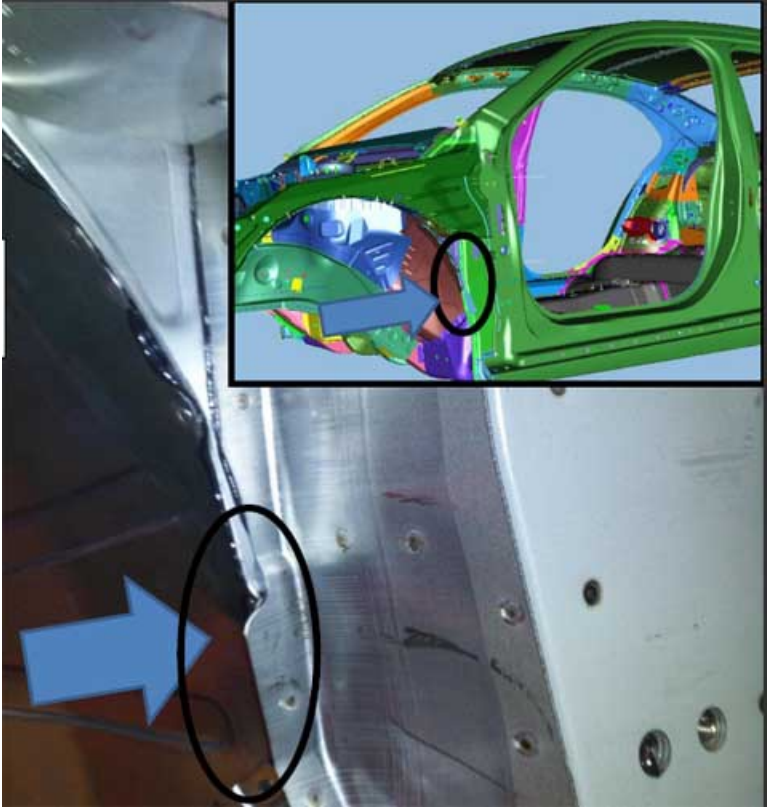
Water will enter around applied sealer as cavity fills. The front wheel house flange may have a void in the sealer. Seal the void using a thumb grade sealer (service manual calls for "heavy-bodied caulking material") pushed into the void from the wheel opening. For location of flange please reference the graphics below.
