Preliminary Information

PIP5468D Check Engine Light On with Leaks in the Charge Air Cooler System.

Models

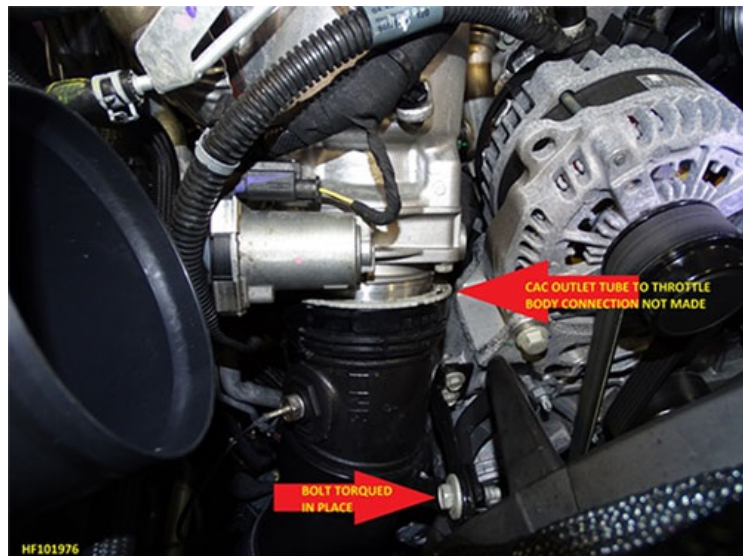
Check for non-secured connection of the charged air cooler pipe at the intake air flow valve (throttle body).
Check for proper alignment of the charged air cooler pipe bracket and bolt hole.

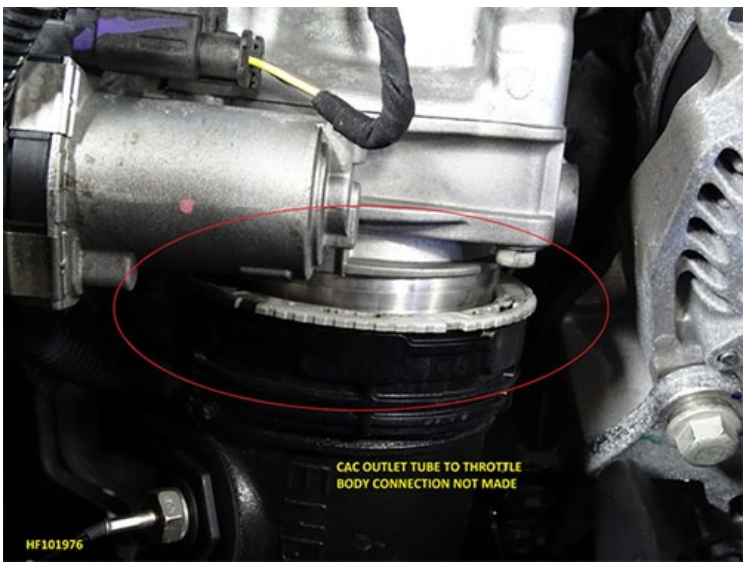
Non-secured connection.

If P2463 was not set and a charge air cooler leak or disconnect was found, after repairing charge air cooler connections, command Diesel Particulate Filter (DPF) Regeneration Enable with the scan tool before returning the vehicle to the customer.

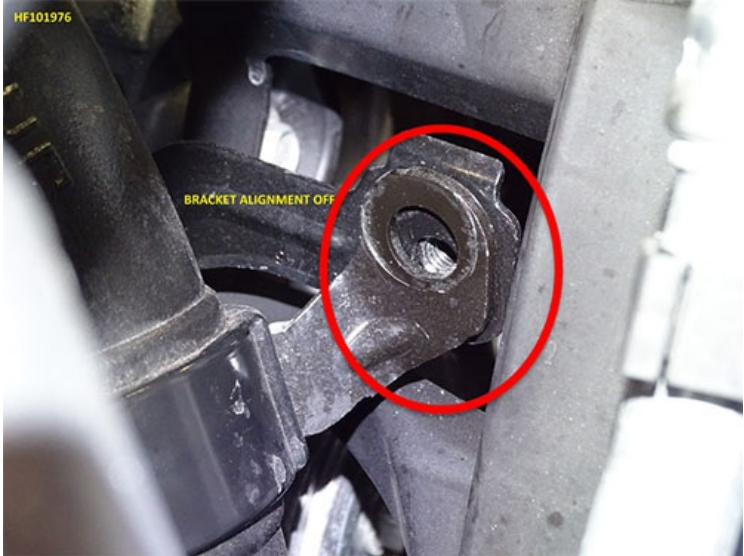
Mis-aligned charged air cooler pipe bracket and bolt hole after the charge air cooler outlet hose is connected properly to the throttle body.
