Preliminary Information

PIP5468E Check Engine Light On with Leaks in the Charge Air Cooler System.

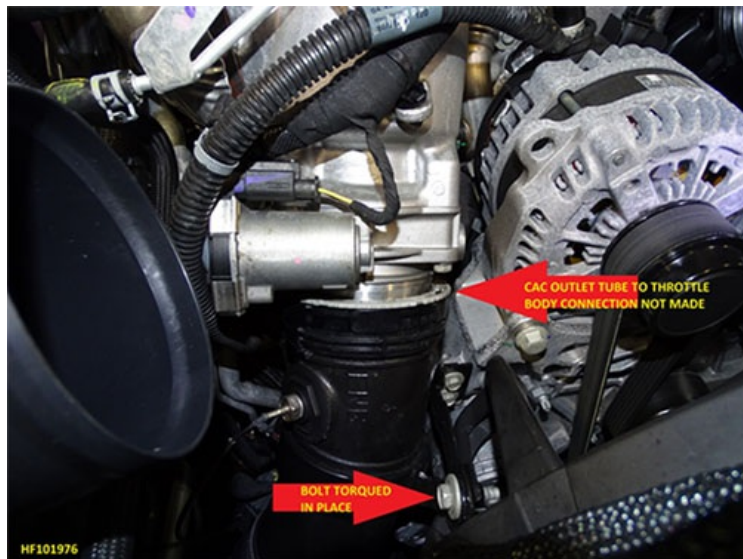
Check for non-secured connection of the charged air cooler pipe at the intake air flow valve (throttle body).
Check for proper alignment of the charged air cooler pipe bracket and bolt hole.
