# Preliminary Information

PIC6285A Diagnostic Aid for DTCs P1AEE and P1AEF, Control Module Hybrid/EV Battery System Voltage High Voltage (Over-Voltage)

**Models**

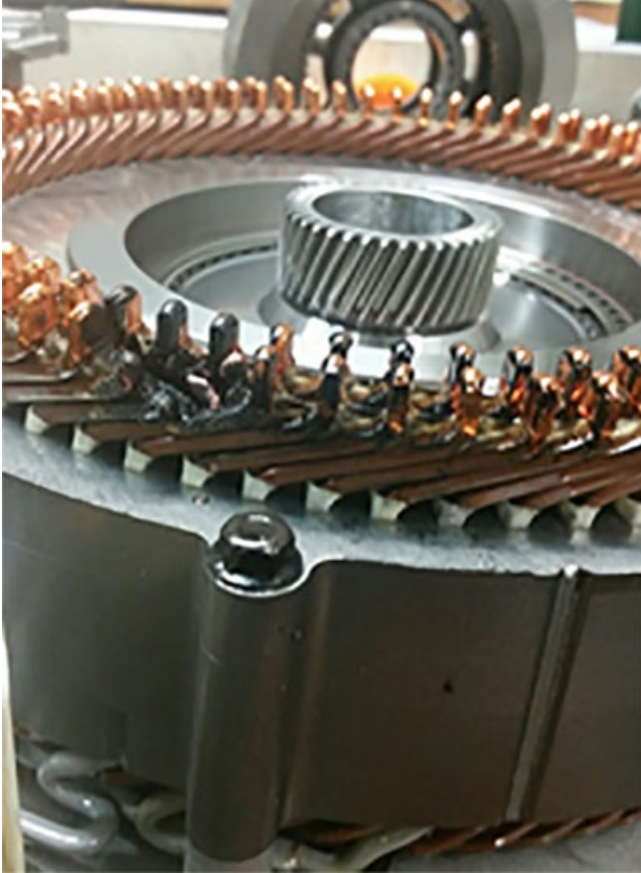
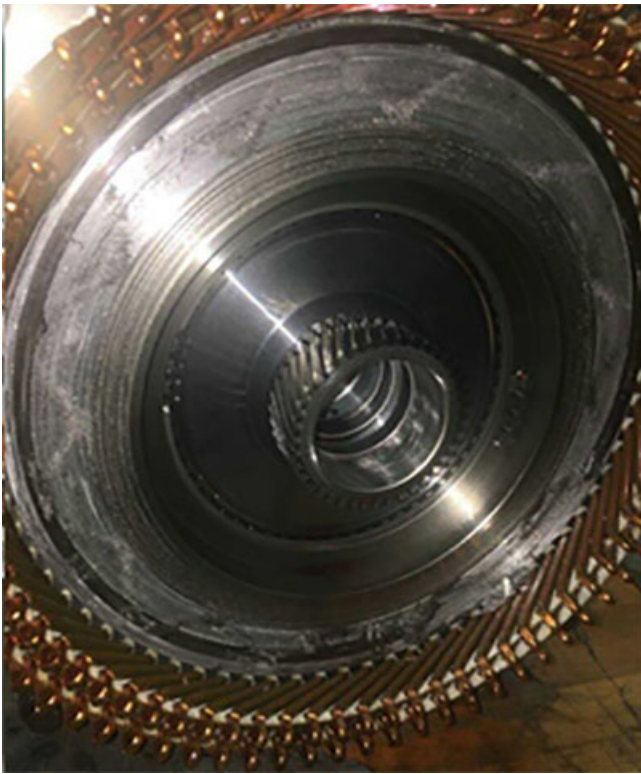
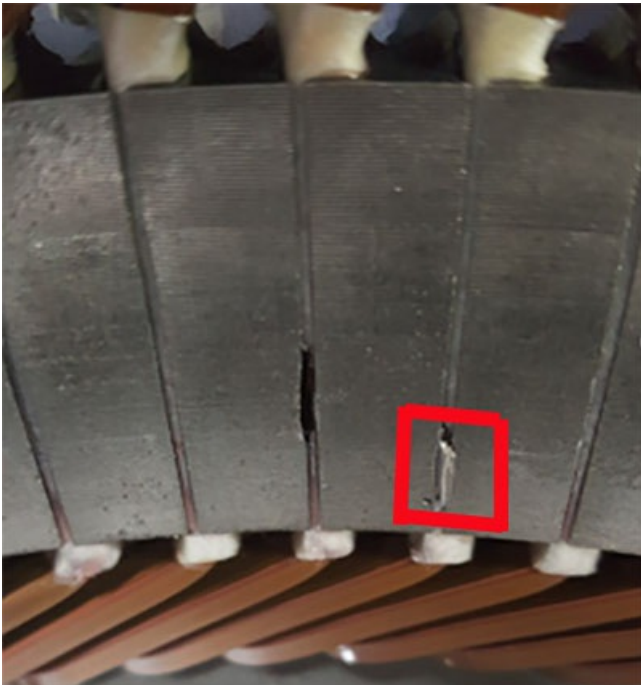
**Category 1: P1AEE and P1AEF were caused by a loss of isolation condition in the vehicle**

If one of these parameters is 0 volts in the freeze frame, then it is likely the vehicle has a loss of isolation condition. If accompanied by DTCs P1AF0/P1AF2/P1E22 or P0C01/P0C04, then the loss of isolation will be located within the transmission, usually due to debris in the motor stators from a failed internal component. Without the accompanying DTCs, the loss of isolation could be anywhere within the high voltage system, but the transmission is still suspect. Use the *Loss of Isolation on the High Voltage Main Bus* procedure in SI to help pinpoint which subsystem is causing the loss of isolation. Using the vehicle data to help determine the loss of isolation is

Examples of debris causing stator problems:

**Note: Any loss of isolation will not self-heal and needs to be repaired for vehicle safety. Clearing codes without repair is not an acceptable remedy of this category due to the vehicle hazards created by P1AEE and P1AEF.**

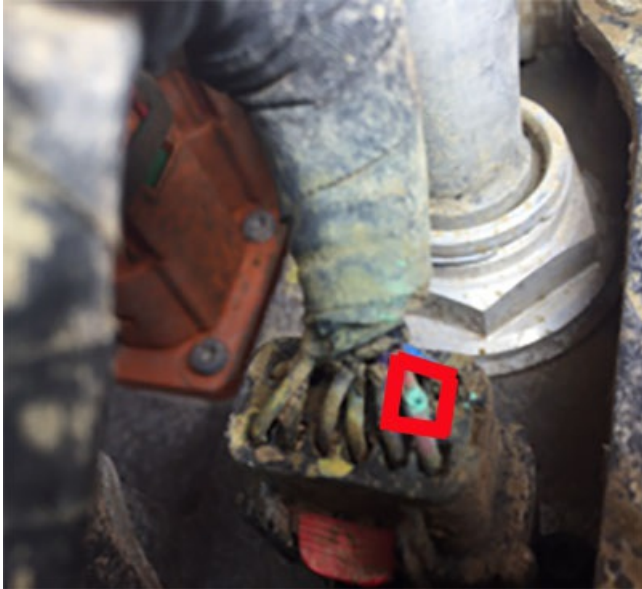
If the value for Negative Supply Isolation Voltage in the freeze frame is within 40 volts of 165v, then the high voltage contactors in the battery opened unexpectedly while the vehicle was driving. The vehicle may also have a P0AA1 and P0AA4 set for this category. If the HPCM2 also stored DTC P0A0C at the same time as P1AEE and P1AEF, then follow published Service Information for P0A0C first. The HPCM2 has direct control of the contactors. Issues with the HPCM2 or wiring could lead to P1AEE and P1AEF. Inspect circuits 3961 and 3959 for contactor control as well as B+ 5240 and ground circuit 2050 (G302). Any compromise in these circuits may cause the contactors to open unexpectedly. If no trouble is found, replace the K114B HPCM2 module for a possible internal fault with contactor control.

Example of connector X357 with stone impingement and corrosion on wiring:

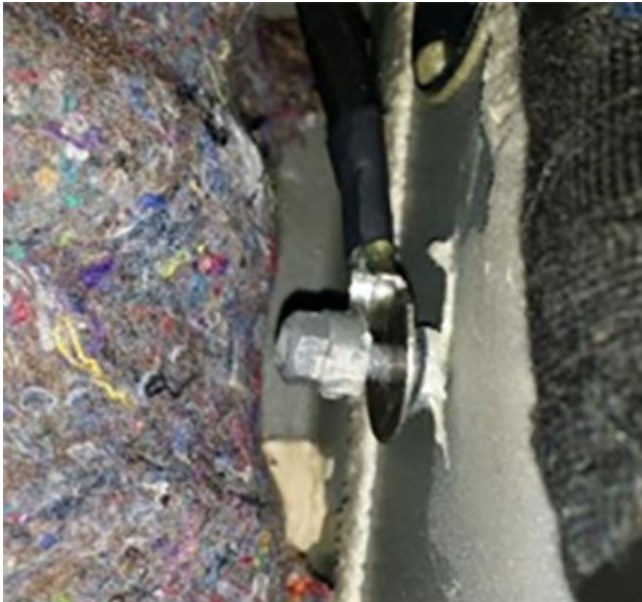
Example of loose ground G302:

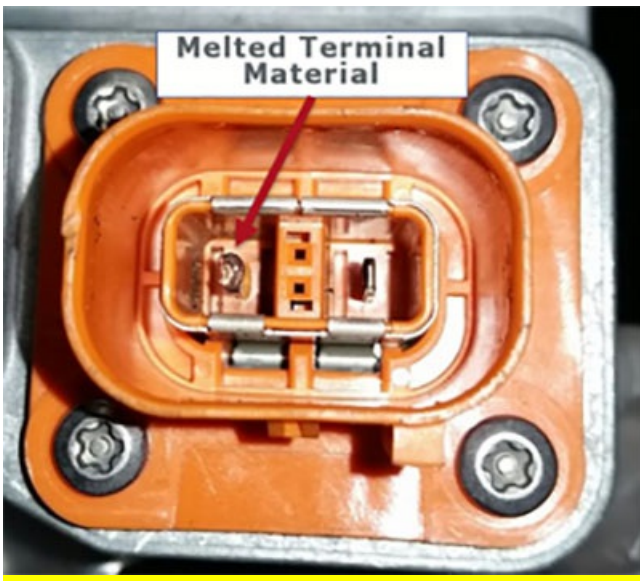
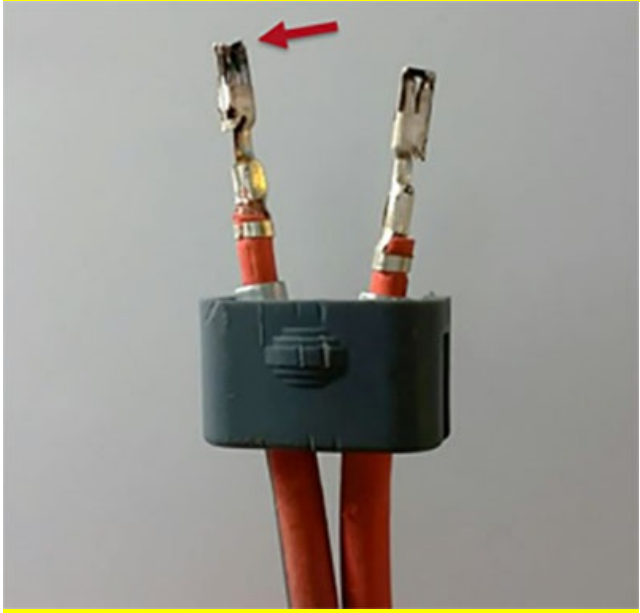
This is expected to be a less common category for P1AEE and P1AEF. If one of the parameters is near but not equal to zero, properly inspect each of the orange high voltage connectors on the vehicle for a loose connection on the high voltage bus.

Example of a loose connector X2 at the K10 Coolant Heater Control Module:
