Preliminary Information

PIC5955A 4ET50 Electric Drive Unit Service Rotor B Replacement

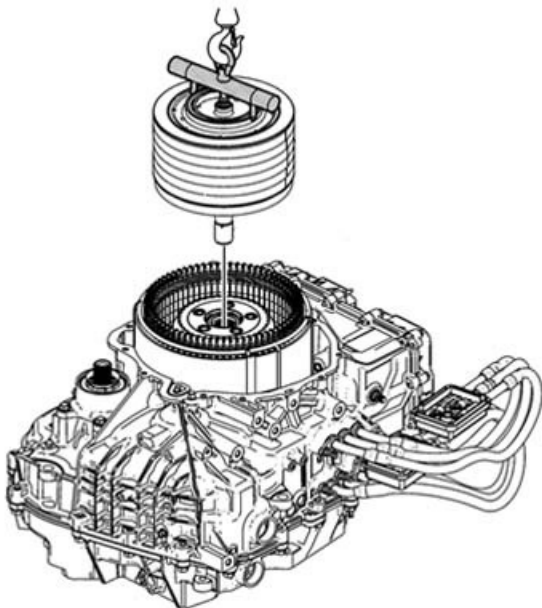
The proper way to address a Rotor B bearing noise is to perform a bearing only replacement per P/I #[PIP5081](#). This can be done on-car. If this is a repeat repair, and TAC recommends a Rotor B replacement, this must be done off car per S/I.

When replacing the Rotor B Assembly, it is imperative that the technician follows SI (Document ID: 3641026) exactly step by step. The transmission must be removed from the vehicle. Attempts to try this as an on-car procedure will result in subsequent failures and possible transmission damage. Damage or repeat repairs due to not following publish procedures will not be covered by warranty.
