Preliminary Information

PIC6275A Intermittent P018B, P0AC4, U18A2, P16E0, Stall, or Reduced Power Message, Cause by a loss of power to the fuel pump drive control module

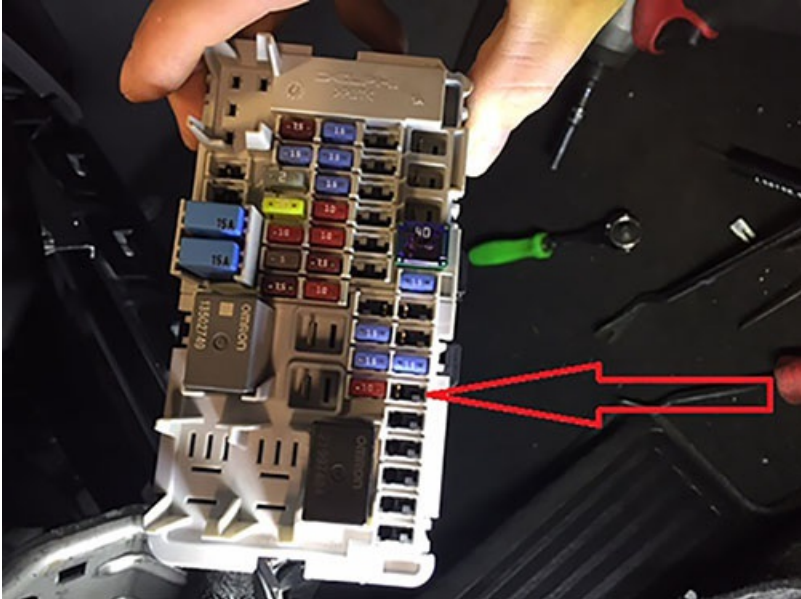
If you have a concern related to the K111 Fuel pump drive control module. Check the X51A Instrument panel fuse panel for a lose terminal to fuse F9DA.
This is could be causing an interment power issue on ckt 1540, Please drag test Terminal 51 at the fuse block using the right test lead.

If a lose terminal is found, Replace it with the right terminated lead listed in SI (Service Information).
