Preliminary Information

PIP5421E Malfunction Indicator Lamp Illuminated With DTC P0300

Brand:	Model:	Model Years:	VIN:		Engine:	Transmissions:
			from	to		
Chevrolet	Malibu	2016 - 2017	All	All	1.5L LFV	All
Involved Region or Country	China, Europe, International Operations (GMIO), Korea and North America.					
Additional RPOs:	LFV					
Condition	Some customers may comment on a rough running engine with the Malfunction Indicator Lamp on. Upon inspection, a technician may find DTC P0300 set along with a misfire and low compression in one or more cylinders.					
Cause	This condition may be caused by a damaged piston requiring replacement of all four piston and rod assemblies with an updated part number.

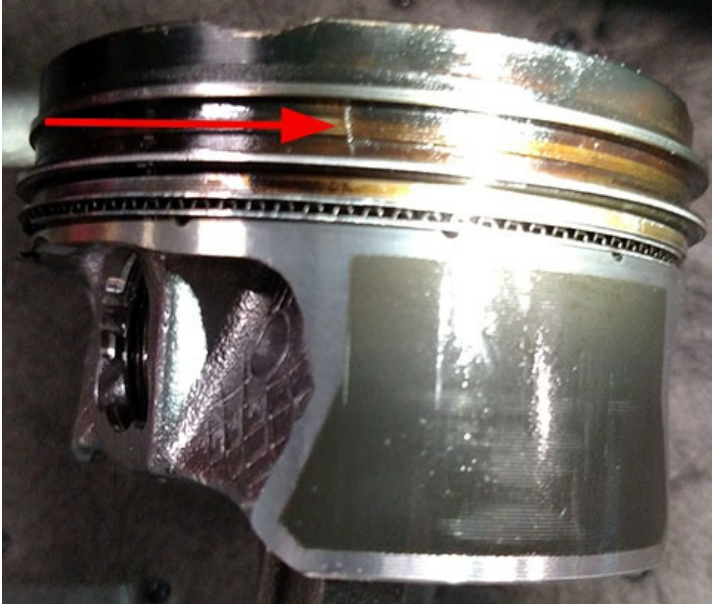
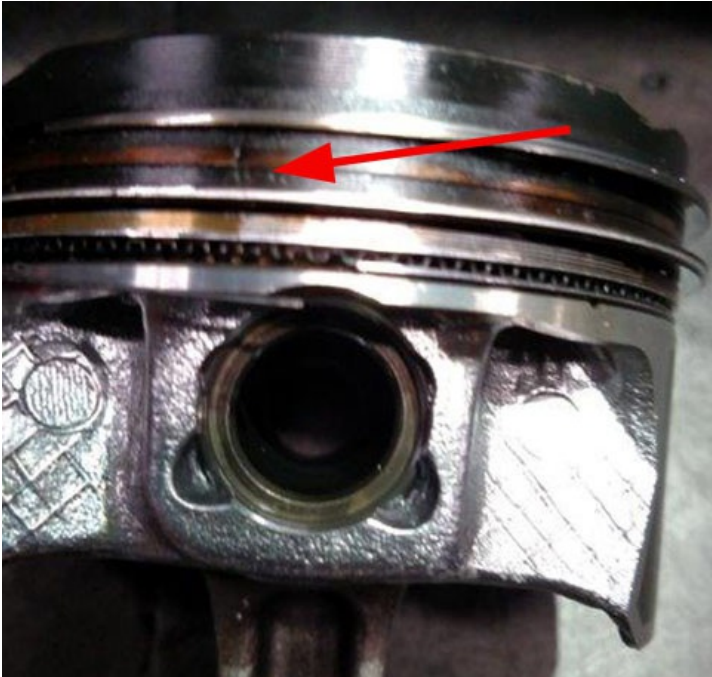
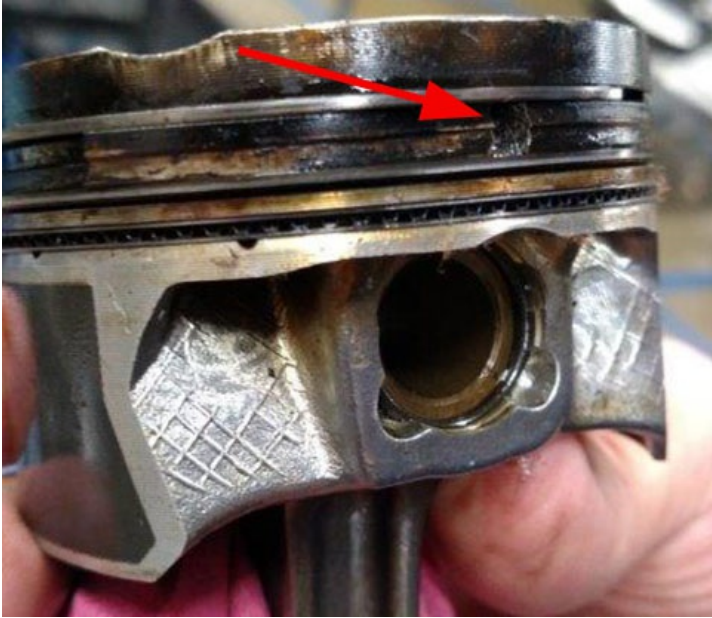
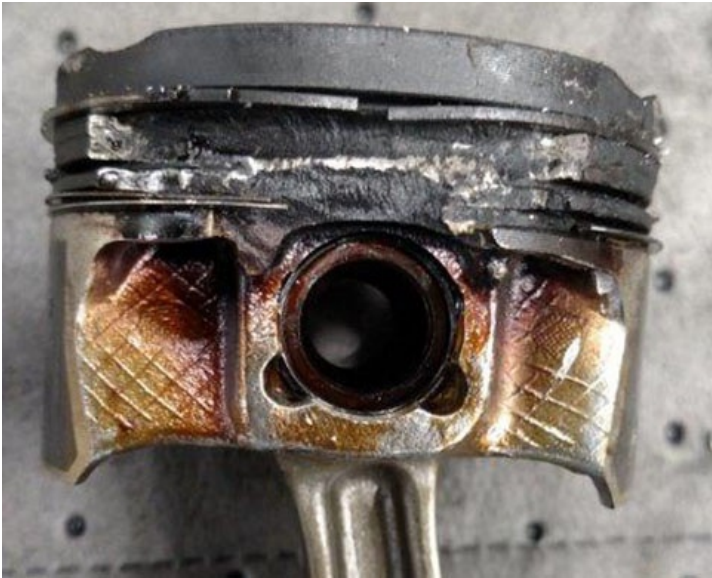
Shown below are examples of pistons with varying levels of damage.

If the cylinder wall surface has not been compromised, replace all four piston and rod assemblies.

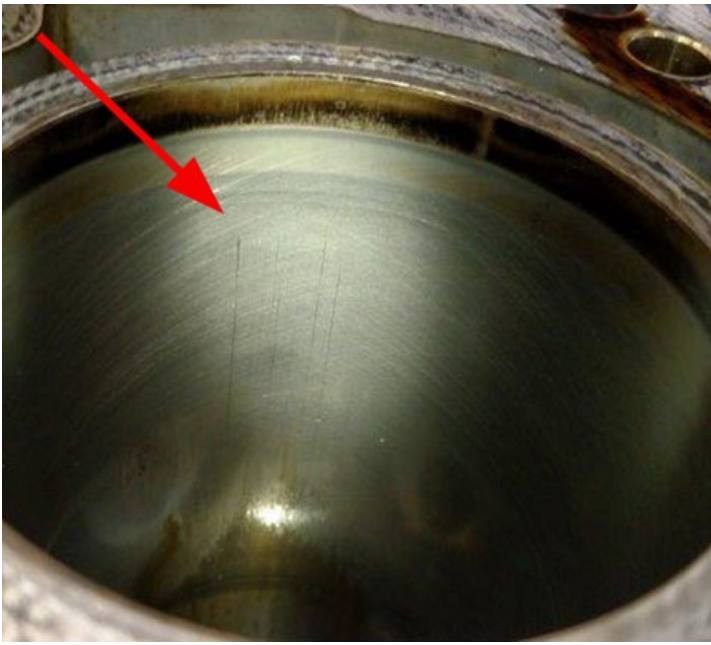
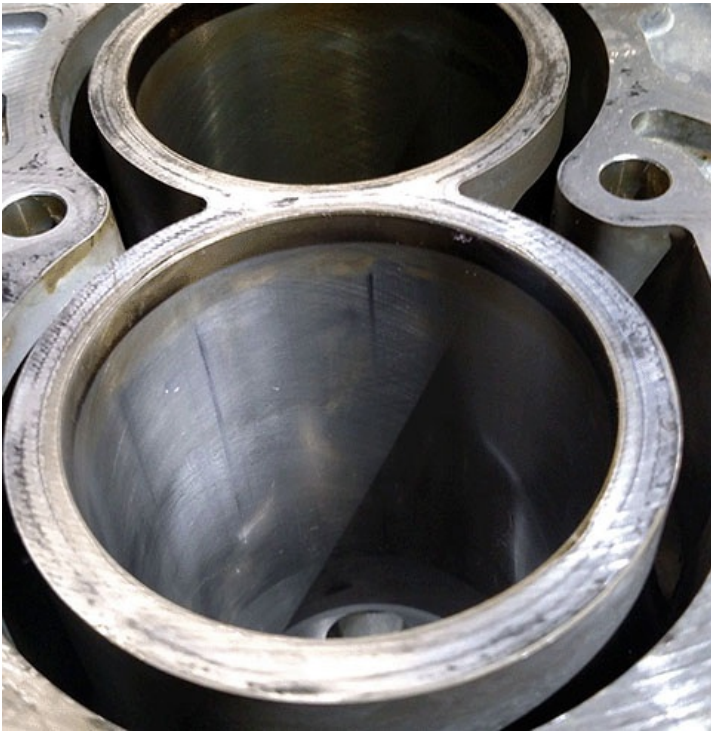
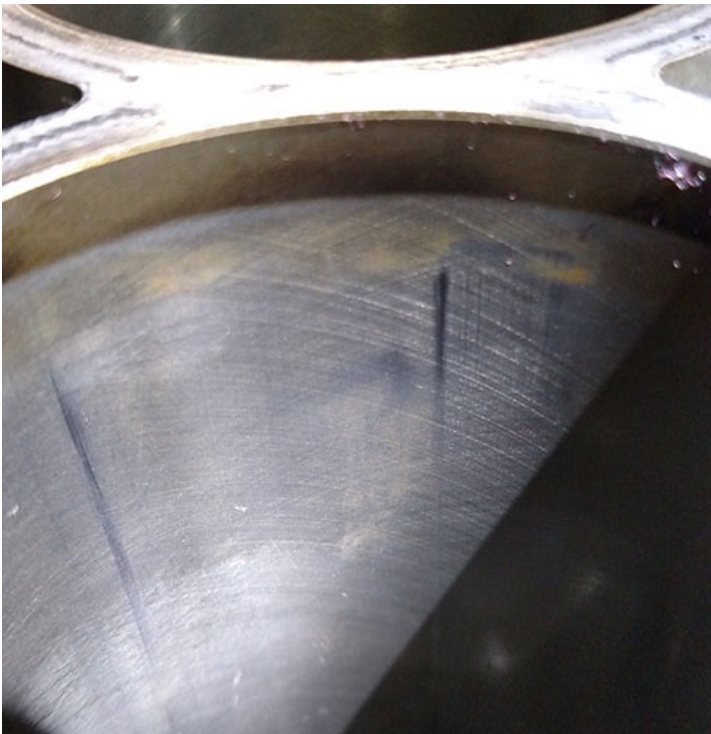
Shown below are several examples of light vertical marks visible on the cylinder wall.
In these examples, none of the marks in the cylinder walls could be felt with the finger tip or nail and engine replacement is not recommended.

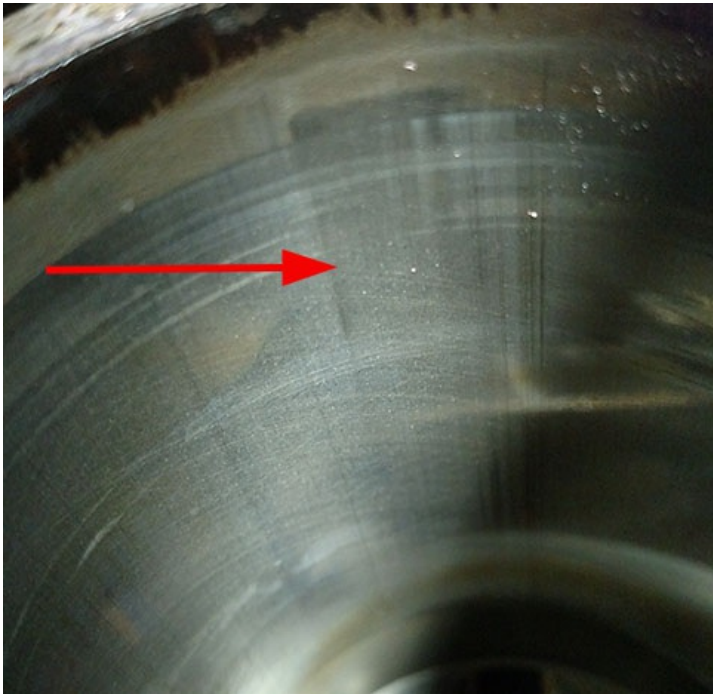
Shown below is an example of a damaged cylinder wall.
In this example the scuffing is wide and has removed the crosshatch from the cylinder wall in the area above the arrow.
This would result in oil consumption and requires engine replacement.
