# Preliminary Information

## PIP5490C Malfunction Indicator Lamp Illuminated With DTC P0300

Brand:	Model:	Model Years:	VIN:		Engine:	Transmissions:
			from	to		
Chevrolet	Cruze	2016 - 2017	All	All	1.4L LE2	All
Buick	Encore	2016 - 2017	All	All	1.4L LE2	All
Involved Region or Country	Europe, Holden, International Operations (GMIO), Korea, North America and South America					
Additional RPOs:	LE2					
Condition	Some customers may comment on a rough running engine with the Malfunction Indicator Lamp on. Upon inspection, a technician may find DTC P0300 set along with a misfire and low compression in one or more cylinders.					
Cause	This condition may be caused by a damaged piston requiring replacement.

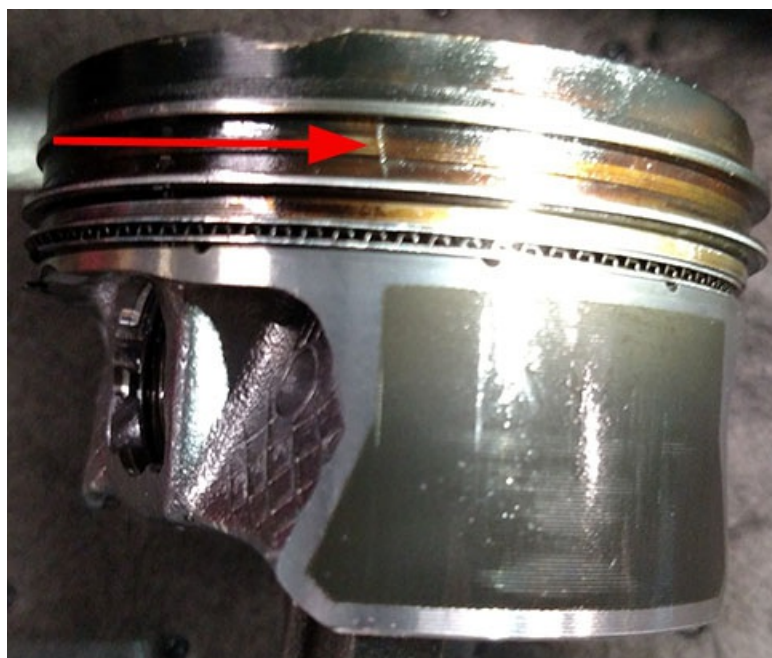
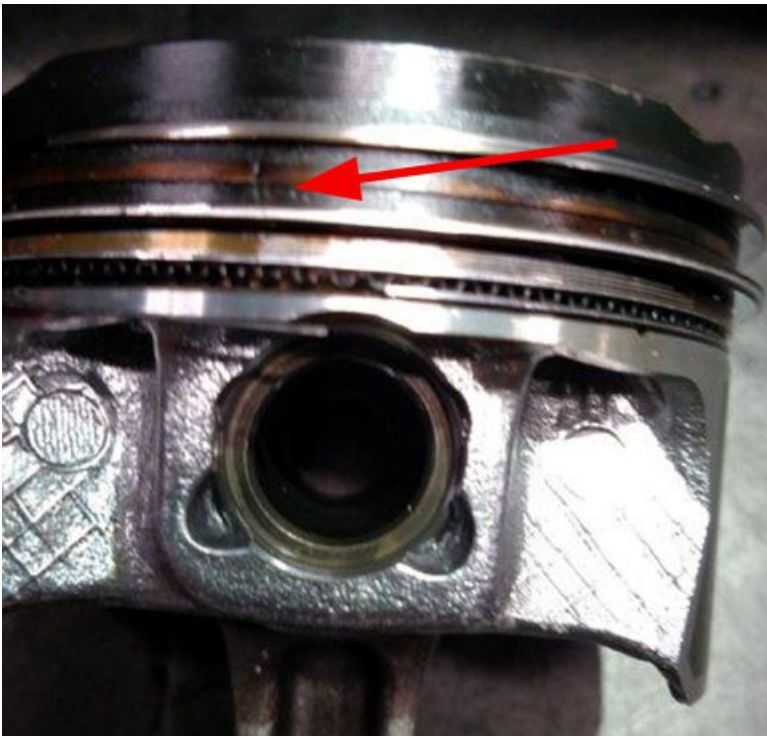
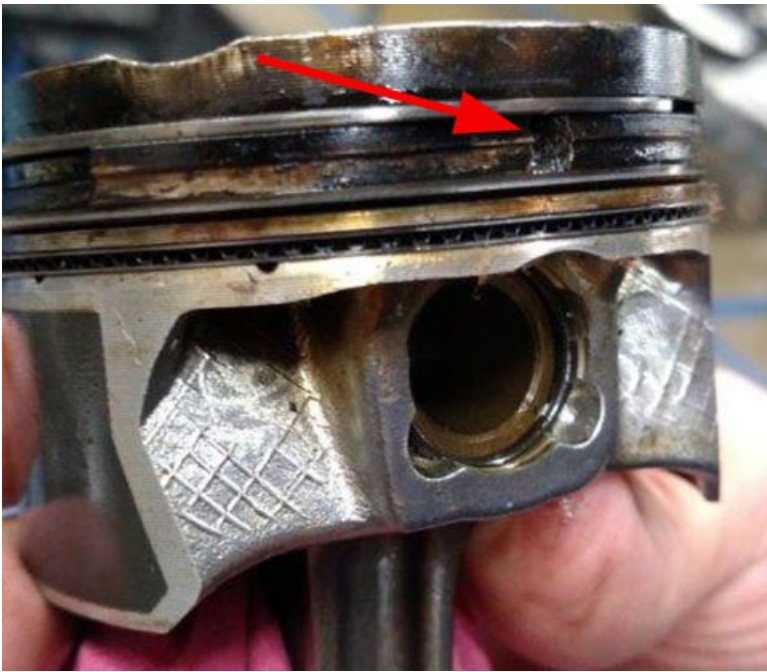
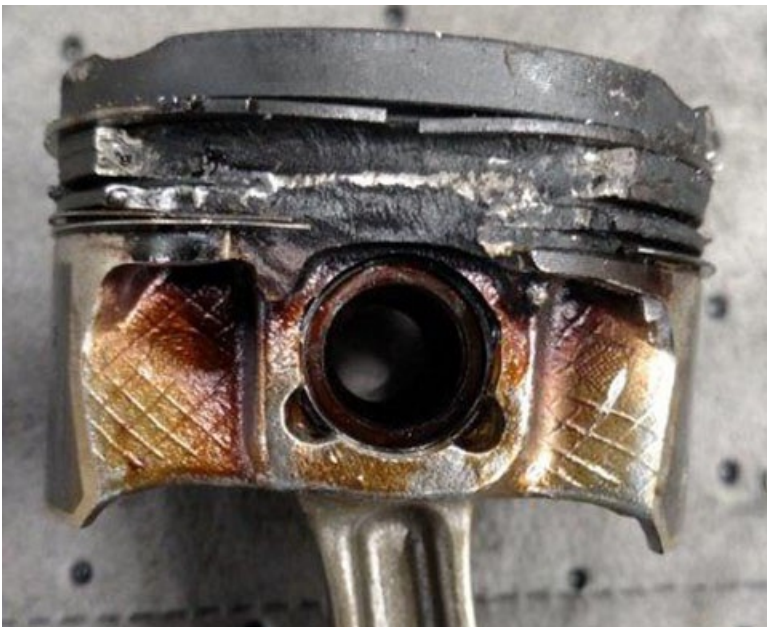
Shown below are examples of pistons with varying levels of damage.

If the cylinder wall surfaces have not been damaged, replace all four pistons and fill the crankcase with current specification Dexos oil. (refer to latest version of Corporate Bulletin Number [16-NA-367](#)).

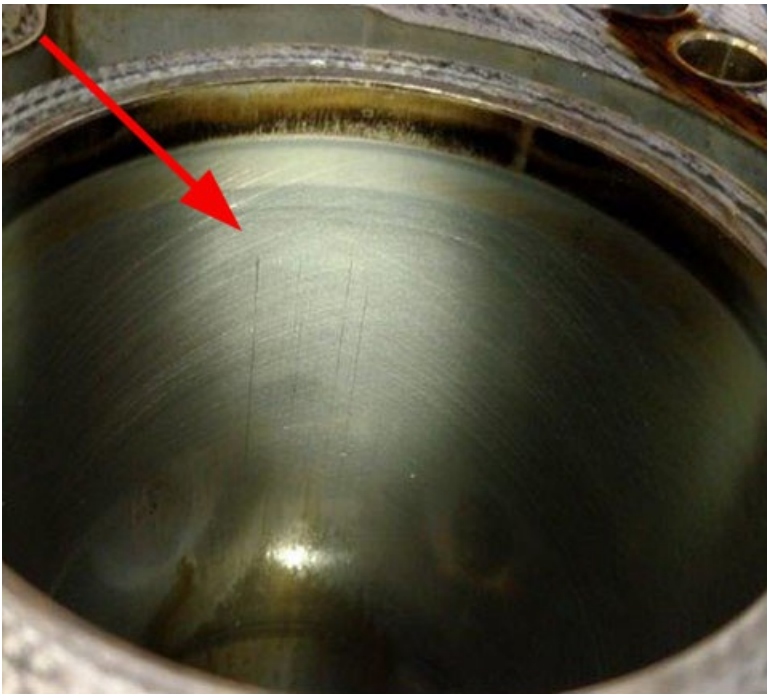
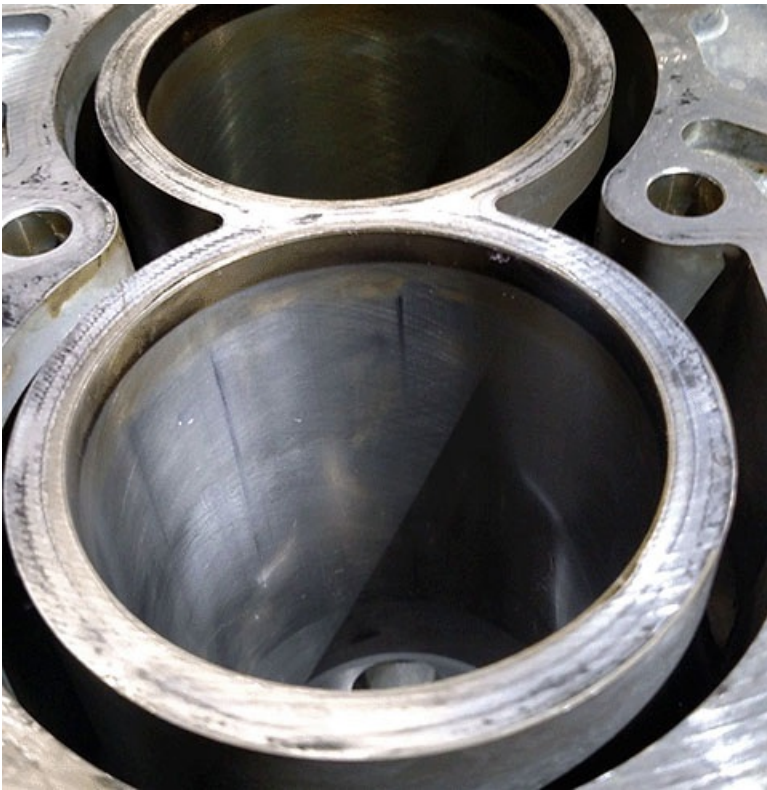
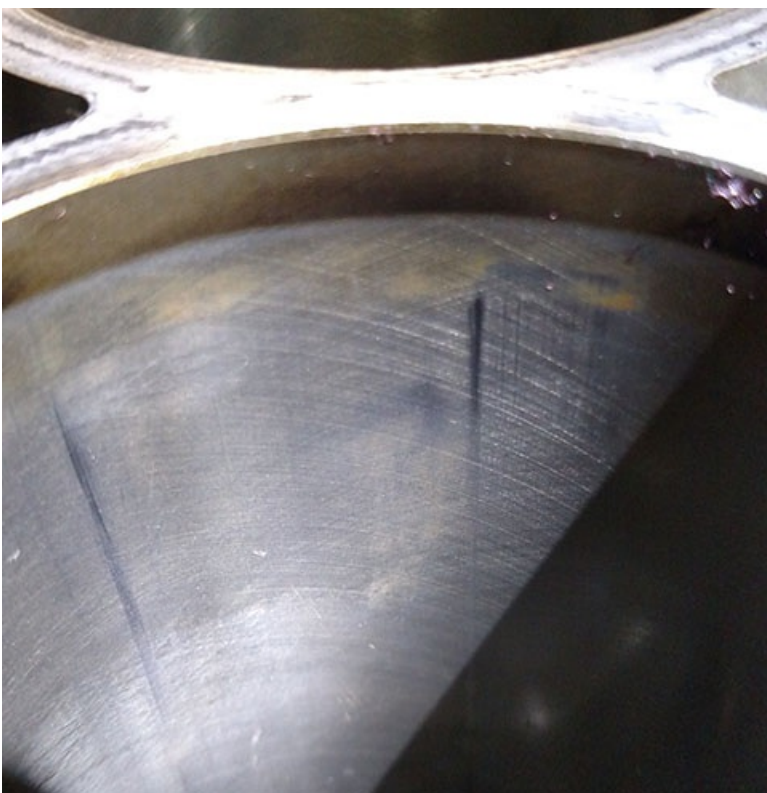
Shown below are several examples of light vertical marks visible on the cylinder wall. In these examples, none of the marks in the cylinder walls could be felt with the finger tip or nail and engine replacement is not recommended.

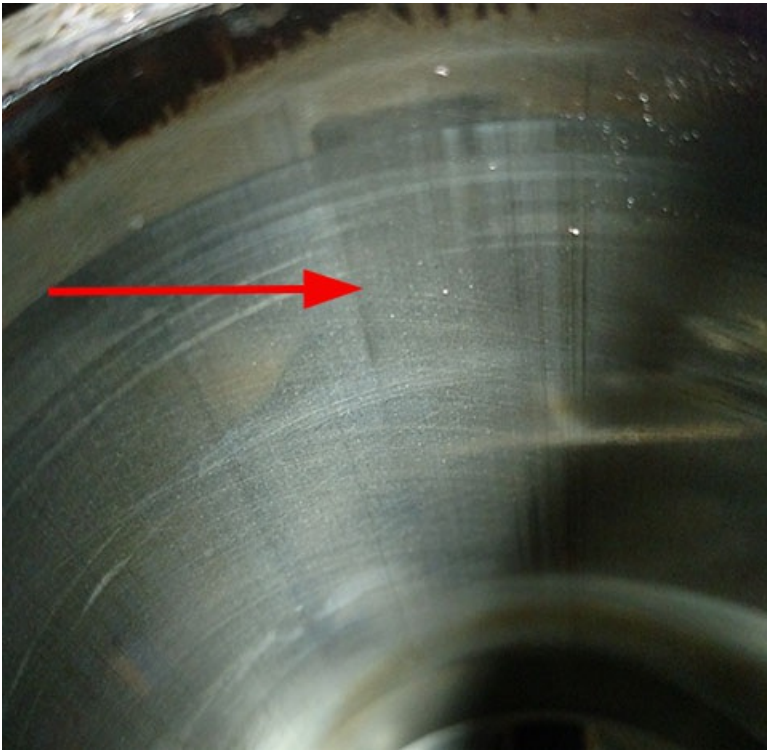
Shown below is an example of a damaged cylinder wall.  
In this example the scuffing is wide and has removed the crosshatch from the cylinder wall in the area above the arrow.  
This would result in oil consumption and requires engine replacement.
