# Preliminary Information

## PIP5049A Difficult To Get Into Or Out Of Gear Excessive Free Play In The Shifter

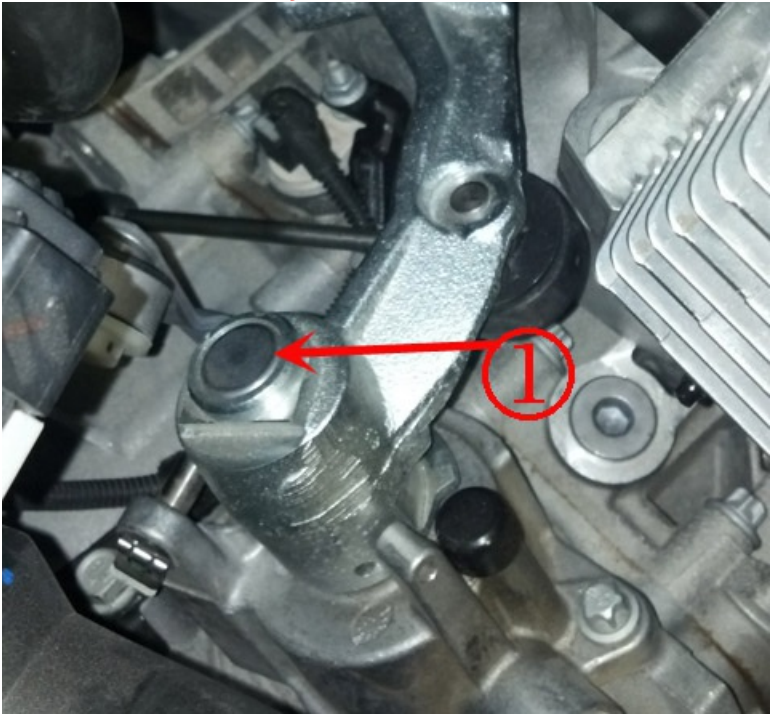
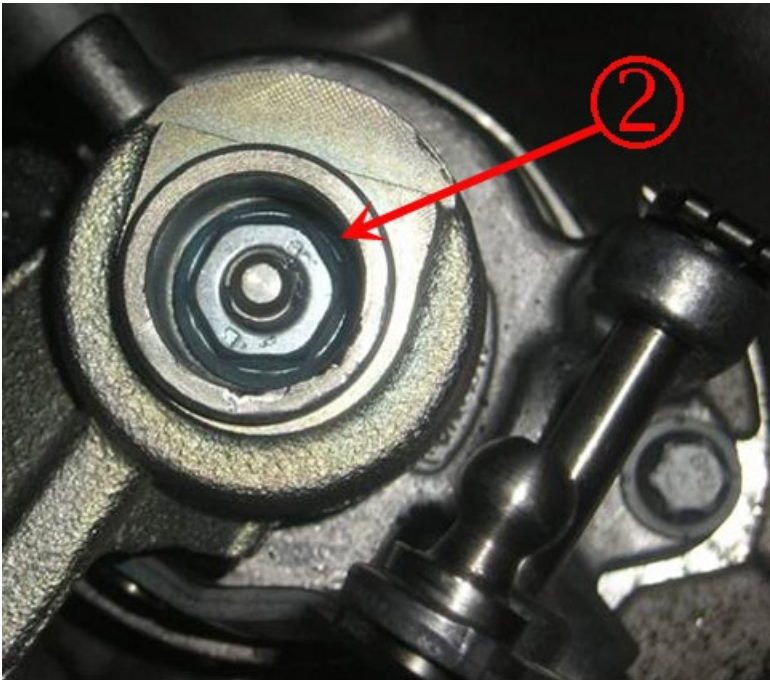
Some customers may comment that there is excessive play in the shift lever, difficult to get into or out of gear, hops out of gear or cannot get into any gear. The play in the shifter would be consistent but the other comments may be intermittent.

This condition can be caused by a nut that has come loose on the shift tower (see Item 2 located under plug item 1). To verify this condition from inside the car, shift the transmission into any gear with the engine off. Then check the shift tower for play. The shift tower should not move loosely when the transmission is in gear. Any excessive movement that can be felt at the shift tower could be the result of a loose nut. Do not tighten the nut or attempt to repair the shift tower assembly. Replace the shift tower assembly with current part number in the parts catalog.

See: Shift Control Housing Replacement in Service Information.

Note: The vent assembly is in the shift tower and will need to be transferred from the original tower to the new tower.
