# Preliminary Information

## PIC6194D (Malibu HEV) High Voltage Drive Motor Battery TAC Restriction and Exchange Program

Brand:	Model:	Model Years:	VIN:		Engine:	Transmissions:
			from	to		
Chevrolet	Malibu	2016 - 2018	All	All	LKN	MKE

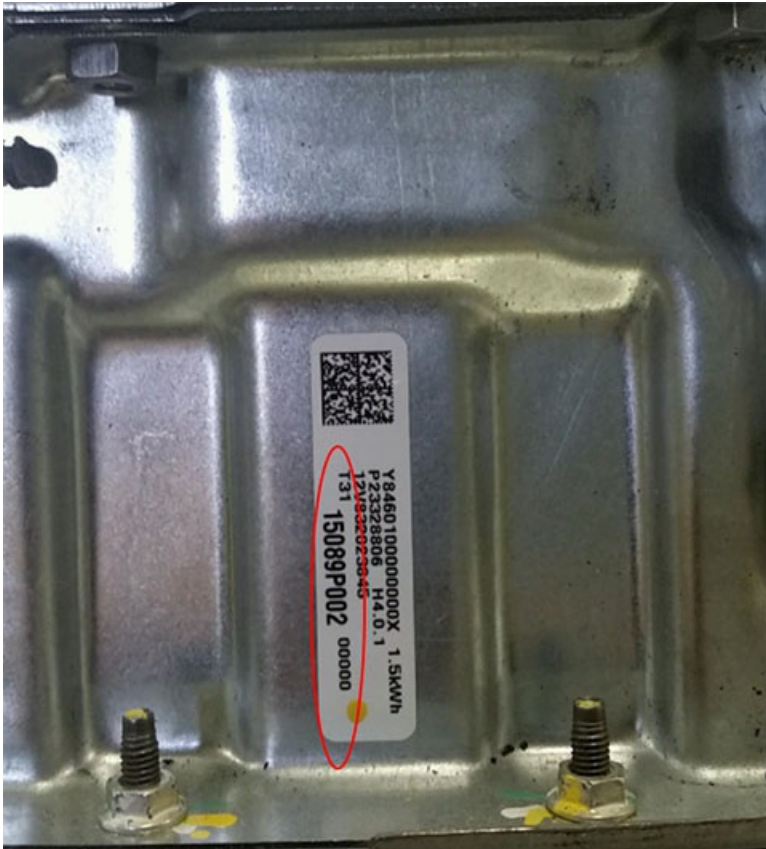
- 6.1 The battery has a battery identification tag that is located on the side of the battery. Locate the tag and record the 16 digit battery identification number (BIN). The BIN is the bottom most number on the label and it starts with a "T" indicator (See Photo Below). If the battery is not out of the vehicle yet, you can find the BIN by installing the MDI and using GDS 2. Access the Hybrid Powertrain Control Module 2 data list and look under the identification information section and the sixteen digit number will be listed under the parameter: Hybrid/EV Battery Pack Identification Number.
