# Preliminary Information

PIP5493D Misfire with DTC's P0300, P0301-P0306

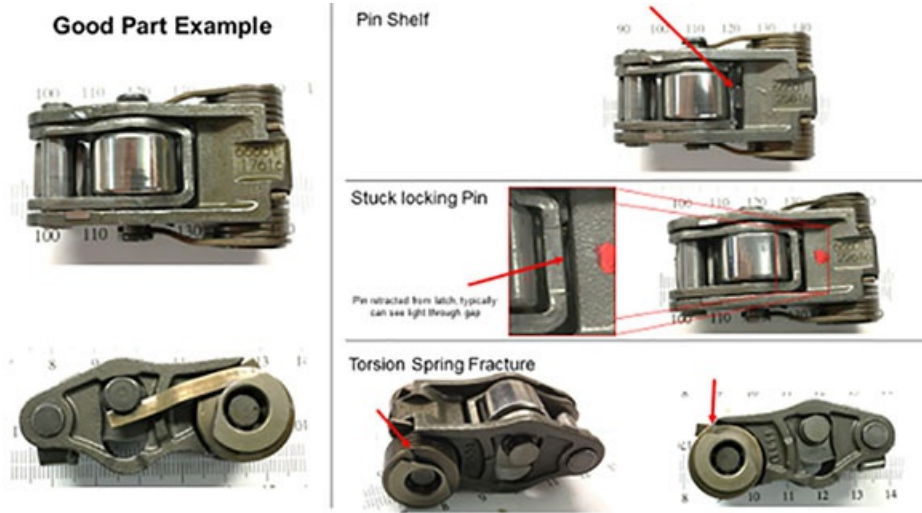
2) Inspect for broken or dislodged SRFFs (rockers arms) per the pictures below.

While inspecting the rockers it will be necessary to rotate the engine over by hand to ensure that the rockers are opening the valves.

If any one of the SRFF's are damaged it will be necessary to replace all four on the affected cylinder.

- 4) If any broken parts are found during inspection replace all damaged parts. It will also be necessary to replace the AFM OCV in the camshaft cover for both banks.
- 5) If vehicle was built before November 1, 2017 Call TAC to get sorted parts sent to replace the effected exhaust shla's/ lifters on the cylinder that was misfiring.

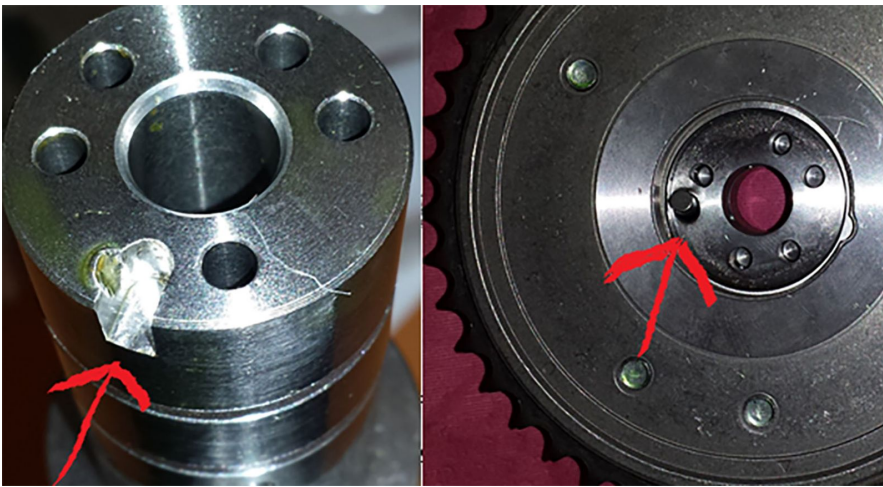
3) Remove the camshaft actuators on the bank that is misfiring and inspect the end of the camshafts and the pin in the actuators for being bent example shown below.
