Preliminary Information

PIP5498C SES Lamp P050D P0300 Setting On A Cold Start And/Or a Run Rough Warm with No codes

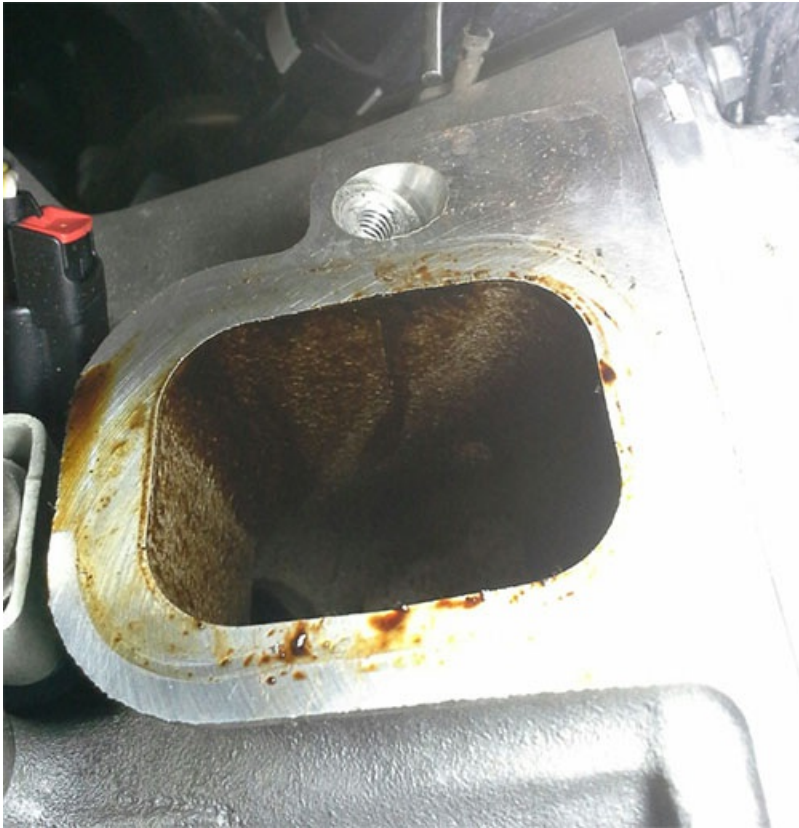
If the head casting line is the concern the intake port will be wet with a coolant oil mix.

This could be the cause of a running rough warn concern with or without codes.

The location of where the coolant is running down in the port will also look washed down.

If this is found the cylinder head will need to be replaced.

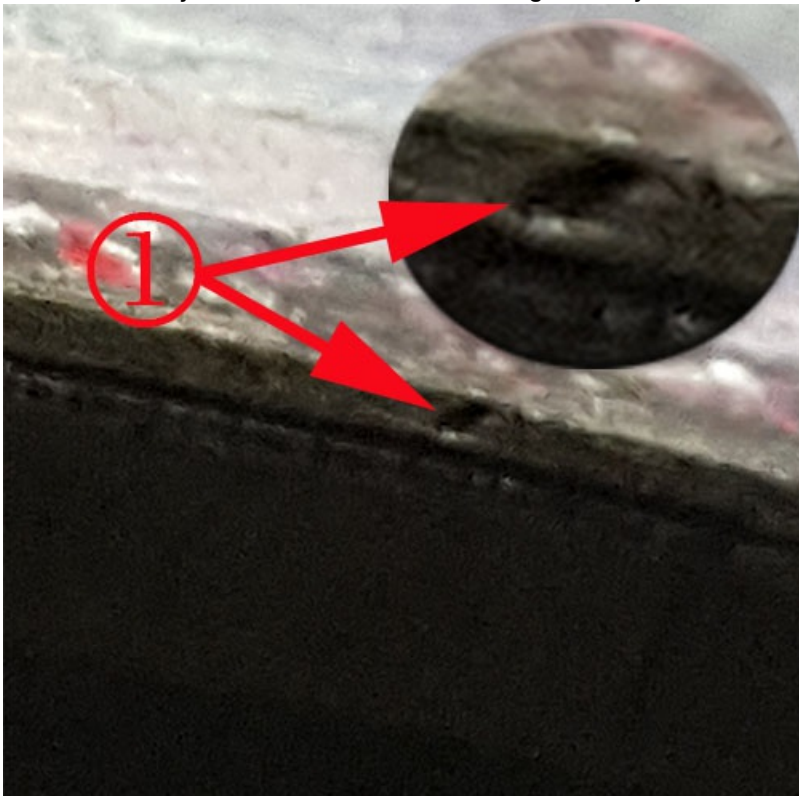
For coolant entry at the liner to deck face casting of the cylinder bore.

It is hard to see the actual source (pin hole) but it usually streams down the liner so that you can see it with a borescope.(Sometimes) The top of the piston will be steam cleaned.

Do not confuse residual fuel on the piston crown / surface as coolant. Some fuel residue may be present and can be mistaken as coolant (reason for the cooling system Dye to be added). Use black light to confirm the liquid is coolant. If this concern is present, do not replace the cylinder head because that will not repair this concern. Call PQC per the latest version of [16-NA-338](#), if required, reference this PI and replace the engine.
