2016-2018MY
Optima (JFa)

PS524

OPTIMA TRUNK TORSION BAR ADJUSTMENT

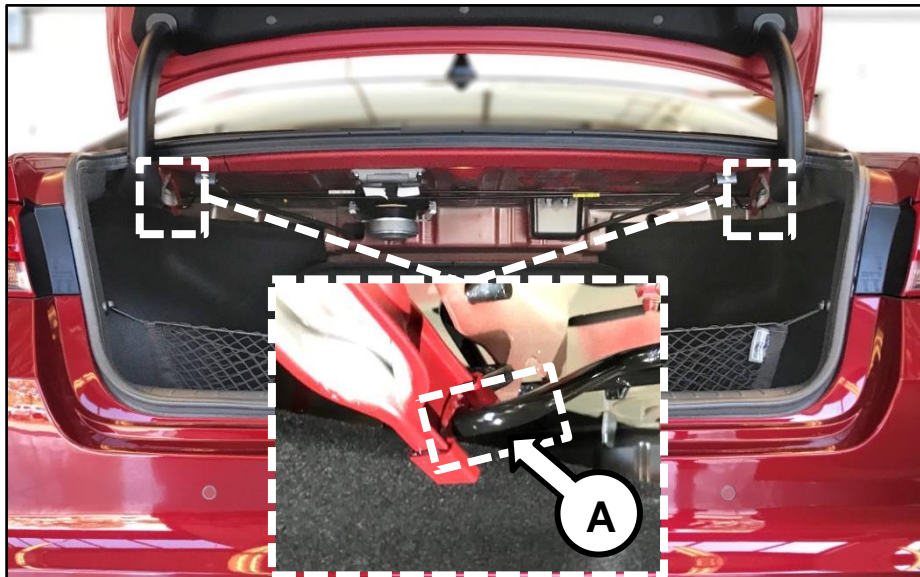
On some 2016-2018MY Optima (JFa) vehicles, there may be a concern with the trunk not opening as designed when using transmitter key fob or Smart Trunk feature. This may be caused by improper assembly of the trunk torsion bar (A) and trunk lid hinge. Follow the procedure below to correct this concern.

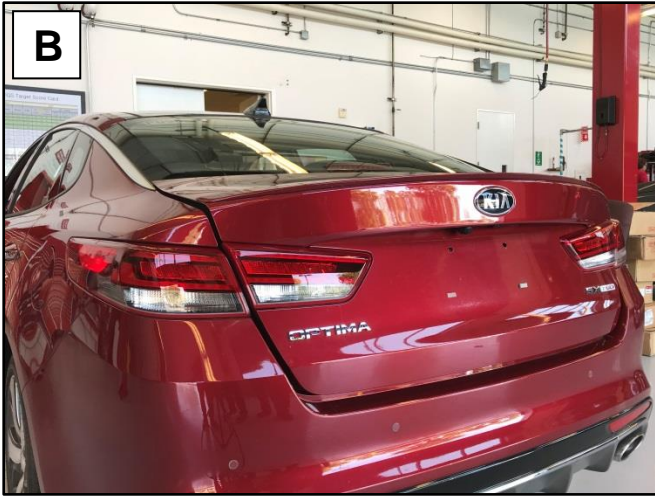
Trunk opening height not as designed.

1. Verify concern is still present (B) with multiple attempts of opening trunk with key fob or Smart Trunk feature (to avoid influencing the trunk lid's "lift", do not test using release handle).
2. Inspect torsion bar at both sides of trunk lid hinge and ensure bar is centered.
3. If torsion bar is not centered (C), lightly tap on the bar at the hinge with a rubber mallet until proper position is shown (D).

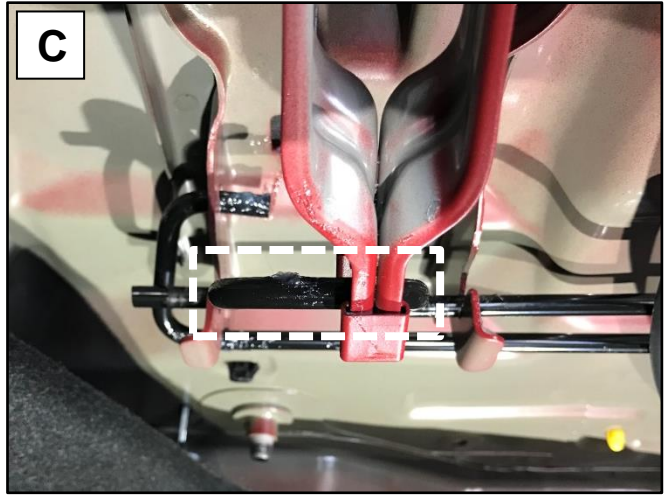
Trunk torsion bar not centered.

Do not use excessive force when centering the torsion bar as it can result in damaged components. Slight tapping is sufficient in performing this adjustment.

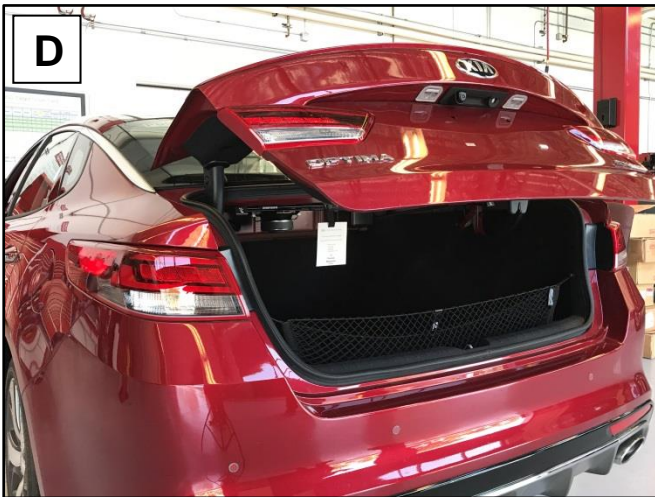
Trunk opening height as designed.

4. Confirm repair is effective (E) with multiple attempts of opening trunk with key fob or Smart Trunk feature (to avoid influencing the trunk lid's "lift", do not test using release handle).

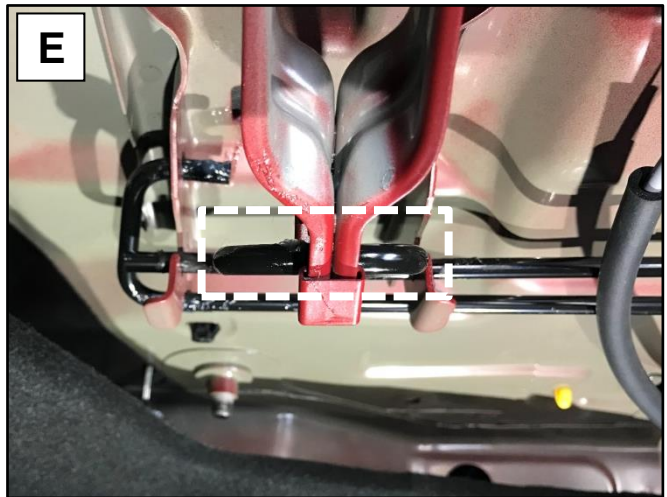
Trunk torsion bar centered.
