GROUP BOD	MODEL 2011-2015MY Optima (TF) 2011-2016MY Optima (TF HEV)
	NUMBER 172	DATE October 2017
TECHNICAL SERVICE BULLETIN		
SUBJECT: OUTSIDE REAR COMBINATION LAMP WATER INTRUSION

Outside Rear Combination Lamps

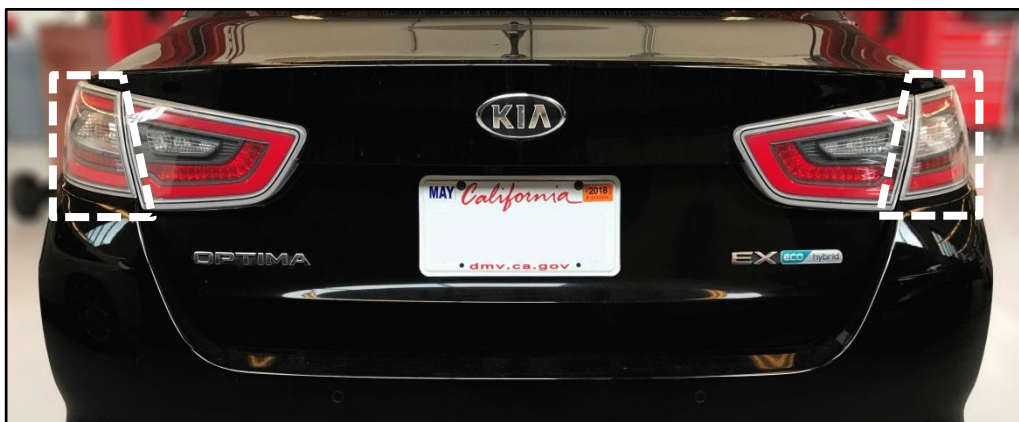
This bulletin provides the procedure to replace the outside rear combination lamp pads on some 2011-2015MY Optima (TF), produced from August 12, 2010 through July 23, 2015, and some 2011-2016MY Optima (TF HEV) vehicles, produced from February 15, 2011 through July 22, 2015, which may exhibit evidence of water intrusion in the outside rear combination lamps. Follow the procedure outlined in this bulletin to replace both left and right outside rear combination lamp pads with improved parts.
