## In This Issue

## Vehicle Technical Info

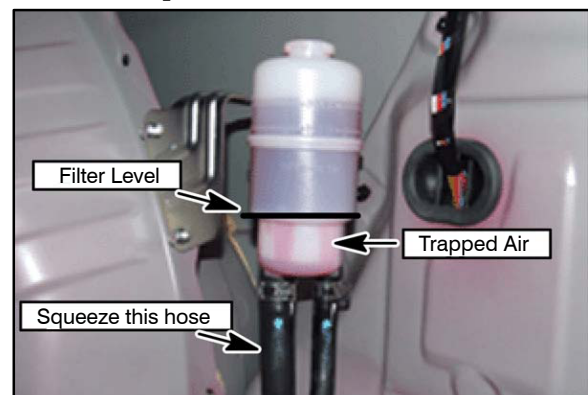
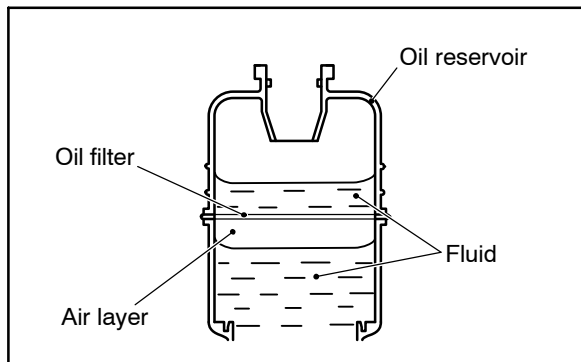
2. ATF is not filling the area below the filter in the AYC/ACD reservoir. If the bottom 1/3 of the reservoir is not filled with fluid (see photo and diagram below) after pouring ATF into the AYC/ACD reservoir, squeeze the large inlet hose several times. This will help displace the trapped air and fill the lower 1/3 of the reservoir prior to bleeding the system. If trapped air is not removed, it may be drawn into the hydraulic system during bleeding.

**NOTE:** It is recommended that you remove the inner trunk panel to view this area of the reservoir.

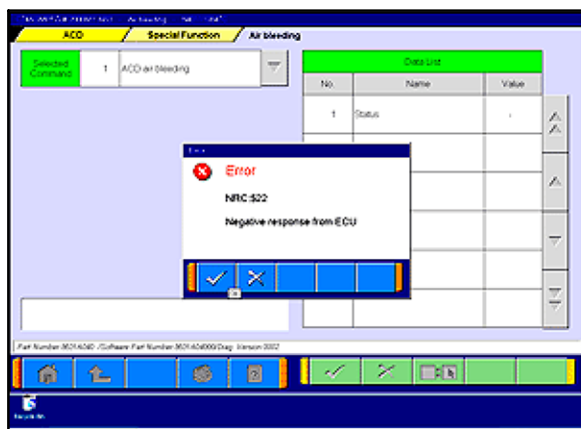
3. If you encounter a negative response message from MUT3 SE while attempting to start the bleeding procedure for the AYC/ACD pump, check the steering wheel position. The steering wheel must be at the straight ahead position for the activation procedure to begin.

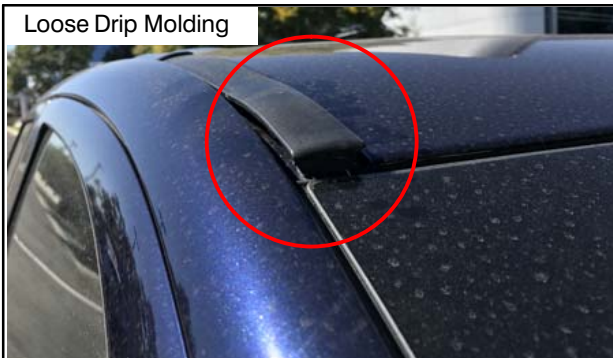
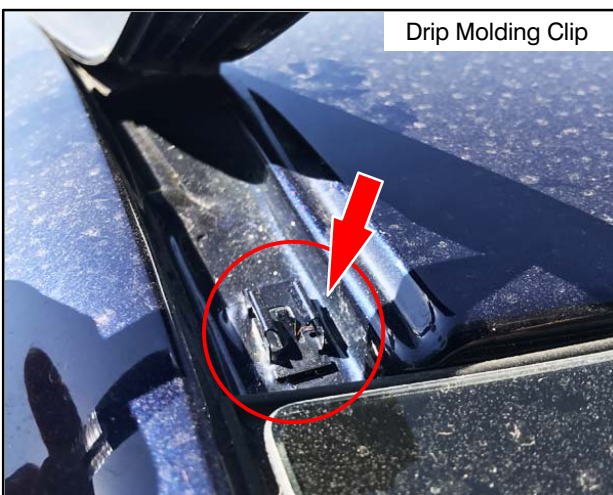
Before replacing any drip moldings for complaints of drip moldings being loose, please take photos of the loose drip molding, the roof area, and the drip molding clip. Post the photos in the PRC.

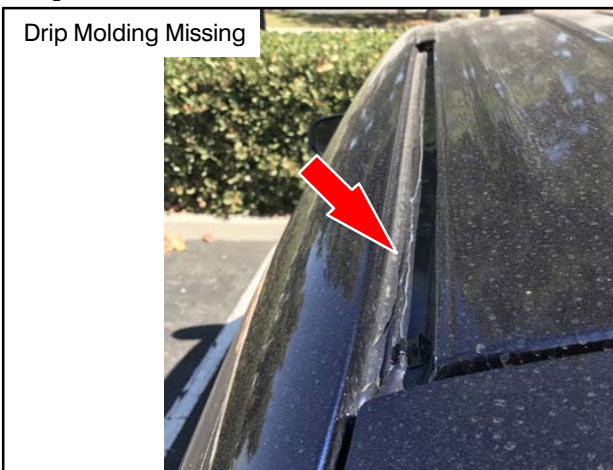
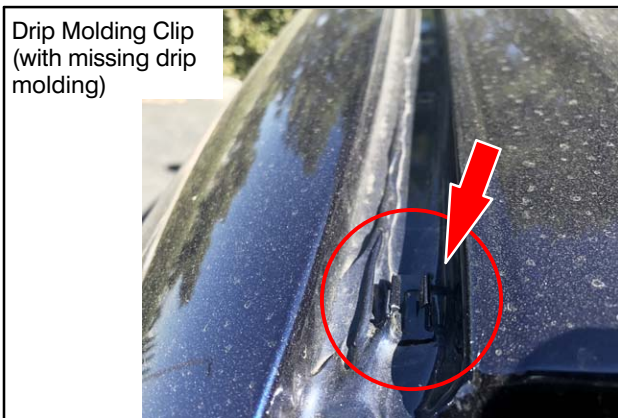
Drip Molding Clip  
(with missing drip  
molding)

For those cases where the drip molding is missing altogether, proceed with taking photos of the roof area and drip molding clip(s) and post the photos in the PRC.

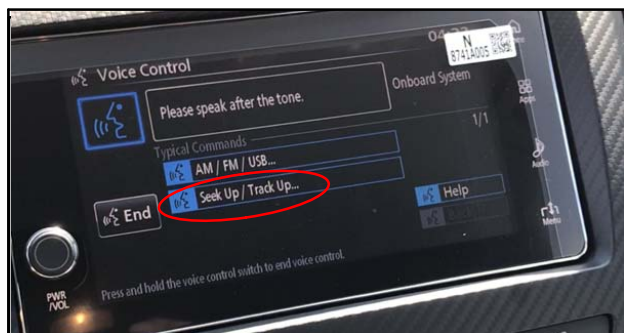
After pressing and releasing the steering wheel SPEECH button to initiate voice command through the Smartphone Link Display Audio (SDA) system (with 7-inch touchscreen), saying an incorrect voice command will generate an SDA system response of "the volume is too loud, please try again." This phenomenon is frequently noticed on the initial screen that comes up after initiating voice command, as shown in the following photo. The "Seek Up" command (radio station change) should only be used when in FM/AM mode, and "Track Up" only when in Bluetooth® audio/iPod® mode. Saying a command that is not listed in the SDA screen can also generate the same system response. Always refer to pages 88-90 of the Smartphone Link Display Audio owner's manual for the correct voice command list.

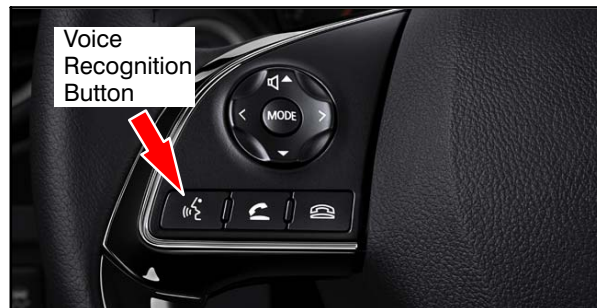
The Smartphone Link Display Audio (SDA) system (with 6.5-inch touchscreen and CD player) on the models listed above may display the message "This function is not supported" when a customer pushes the voice recognition button on the steering wheel controls.

Dealers should explain that this system does **NOT** have the voice command feature, even when a phone is paired. To initiate a call, the user must press the phone icon on the display screen. When a paired phone is connected to the SDA via a cable, and Apple™ Carplay or Android Auto is operating, the voice recognition button on the steering wheel will enable voice recognition, but **ONLY** through the phone's own voice command function (provided the phone is equipped with that feature).

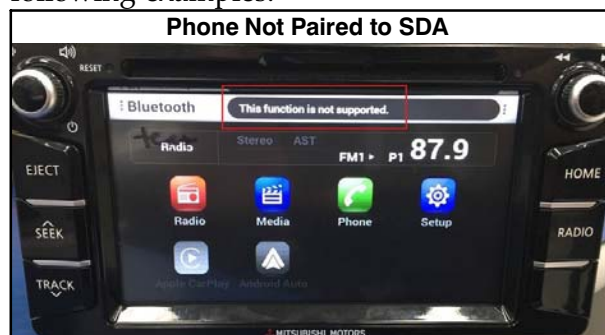
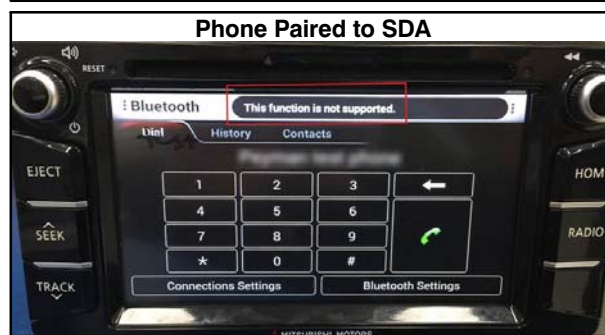
This can happen whether or not a phone is paired to the SDA (without a cable), as shown in the two following examples.
