SERVICE BULLETIN

Classification: AT15-015h	Reference: NTB15-086h	Date: October 16, 2017
------------------------------	--------------------------	---------------------------

2013-2014 ALTIMA; MIL ON WITH DTC P0776, P1715 MAY HAVE HESITATION AND/OR LACK OF POWER

APPLIED VEHICLES: 2013-2014 Altima (L33) with 4-cyl engine only

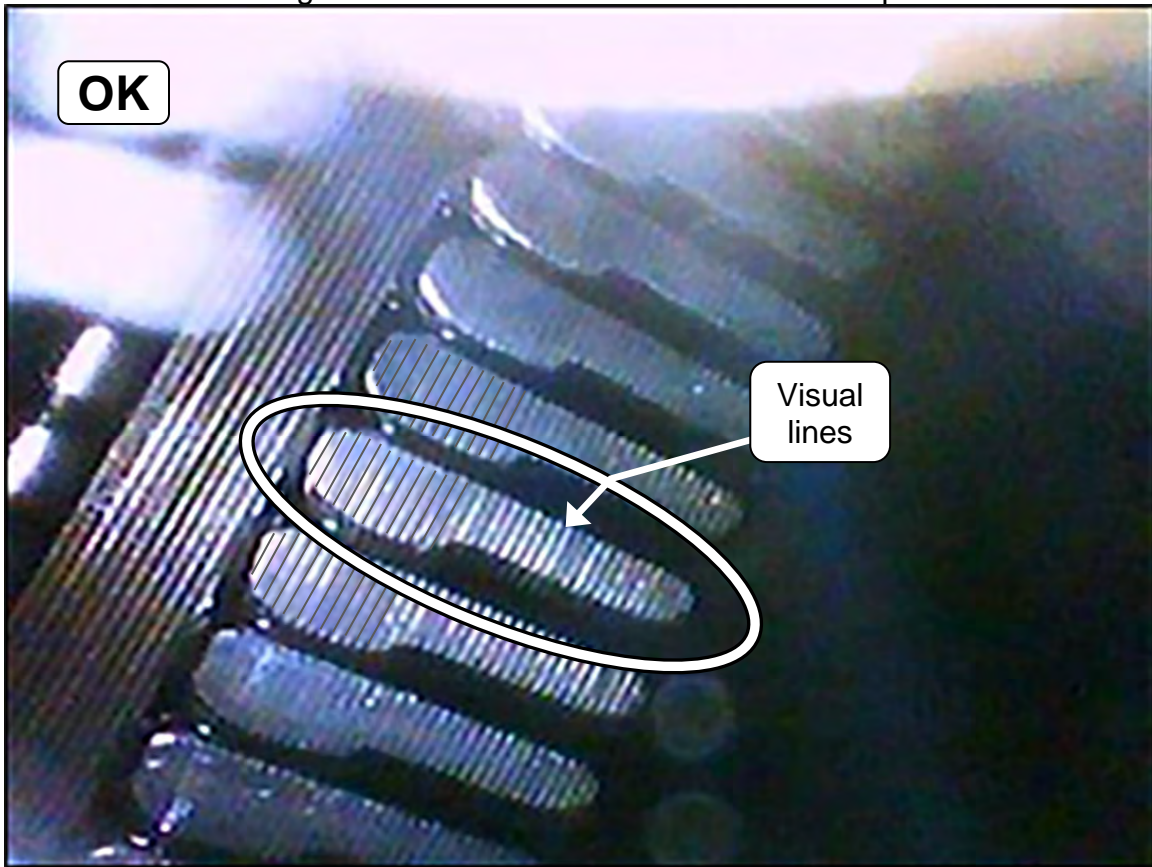
Figure 11: Belt is OK

- The required video must show clear evidence of belt slippage and be 15 seconds or less.
5. If the belt inspection result is OK, replace the valve body.

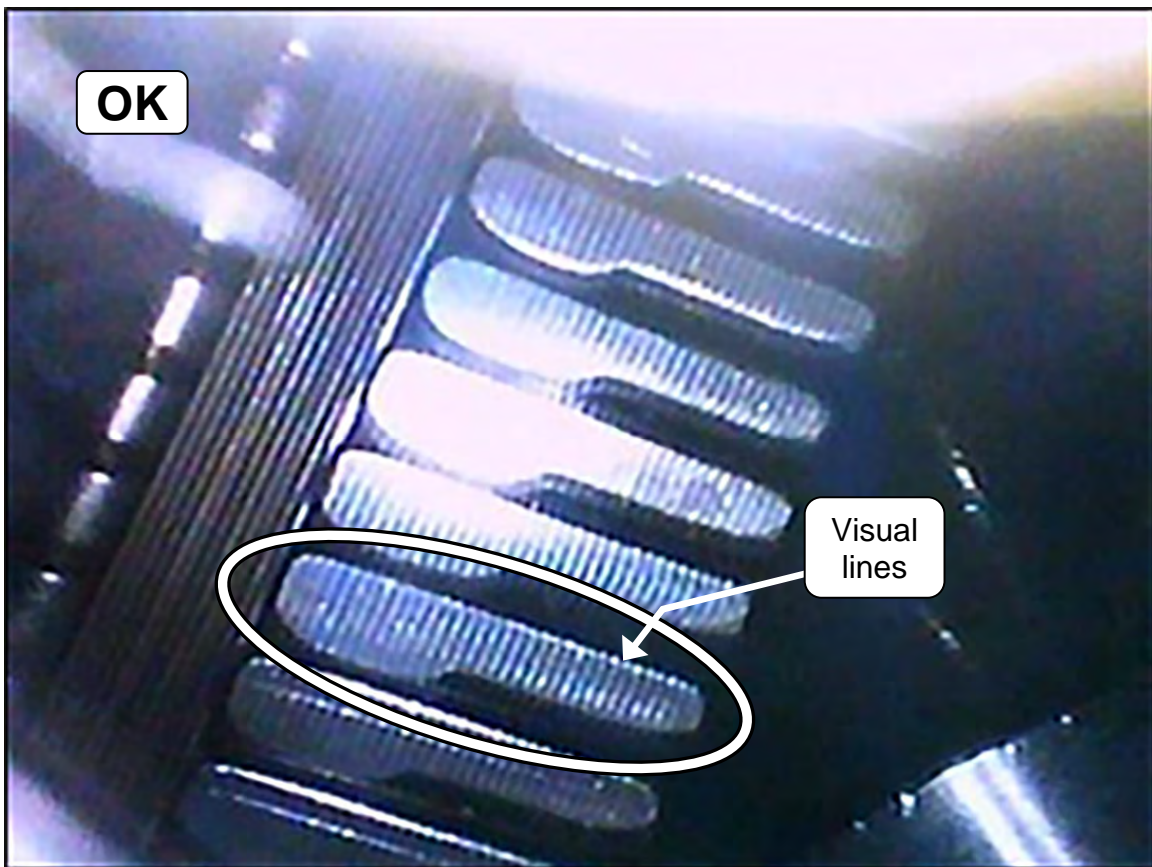
Figure 12: Belt is OK

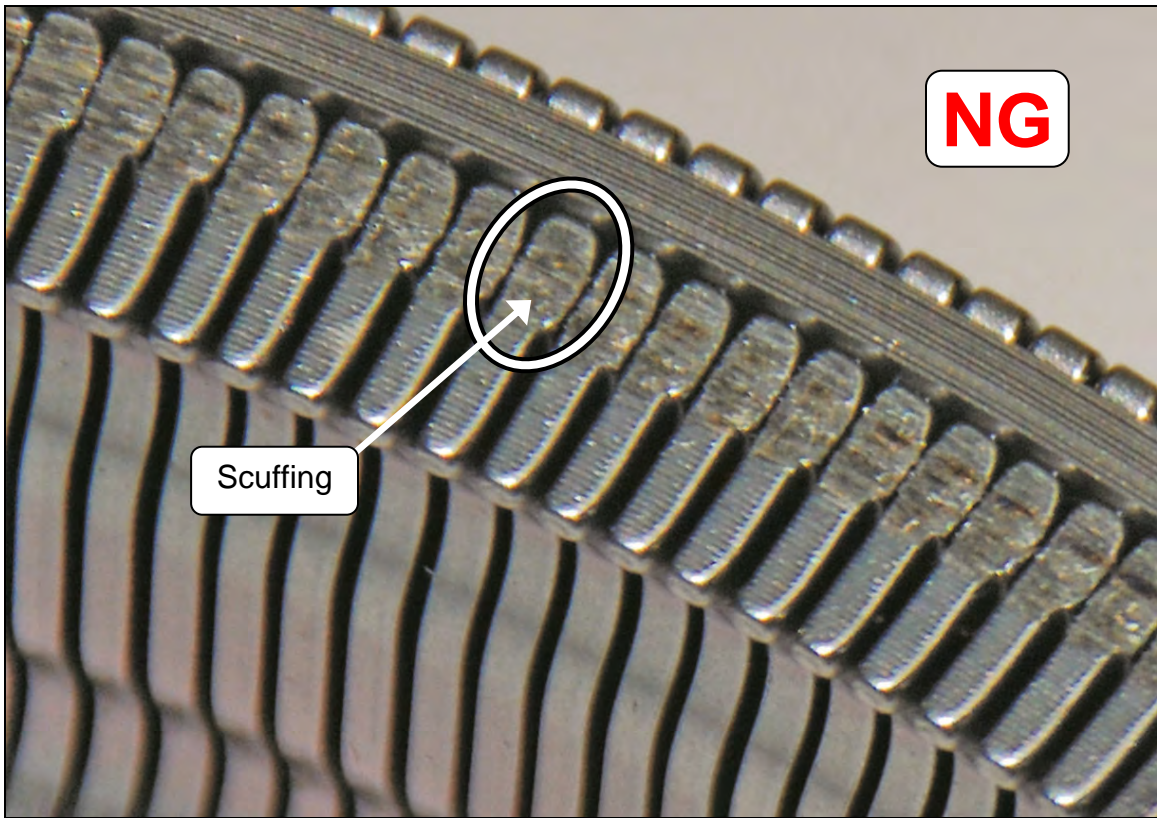
Figure 13: Example of NG belt

- See page 12 for **Control Valve (Valve Body)** installation.
 - See page 17 for **TCM Reprogram and Additional Service**.
6. If the belt inspection result is NG, replace the CVT assembly.

- Get authorization to replace the CVT assembly (see page 28).
 - Make sure to perform step 4e on page 6.
 - For CVT assembly replacement, refer to the appropriate ESM, section **TM – Transaxle & Transmission / RE0F10D**.

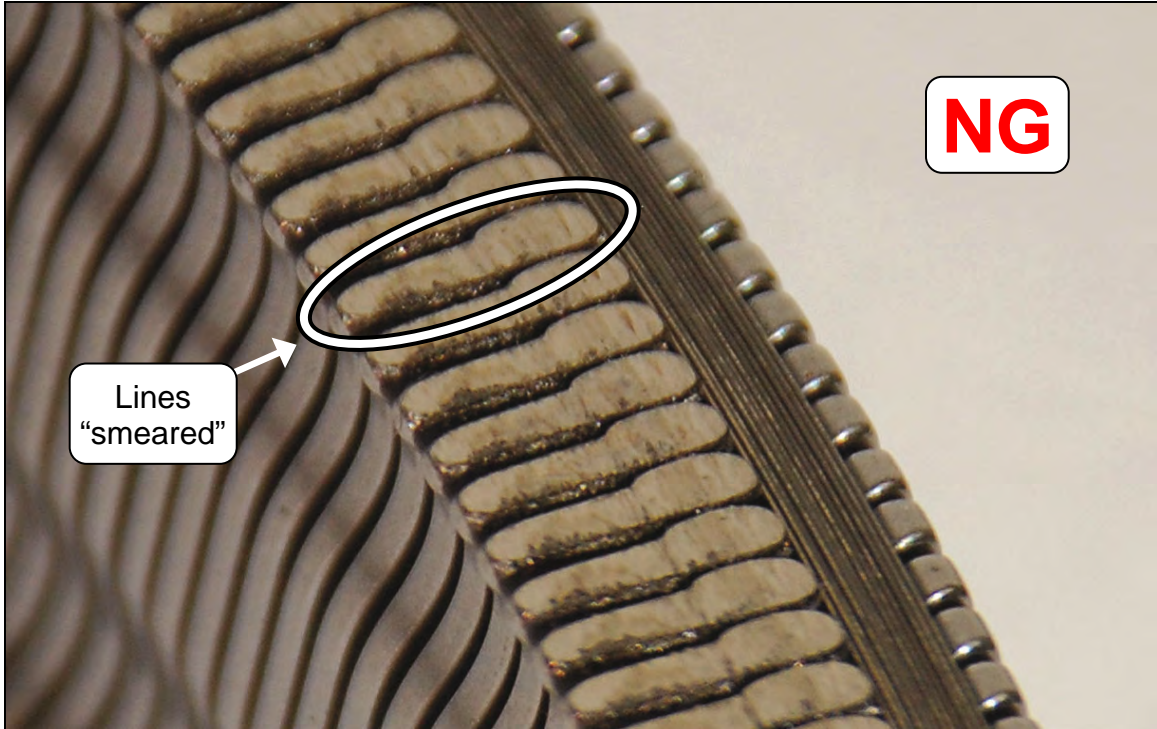
Figure 14: Example of NG belt

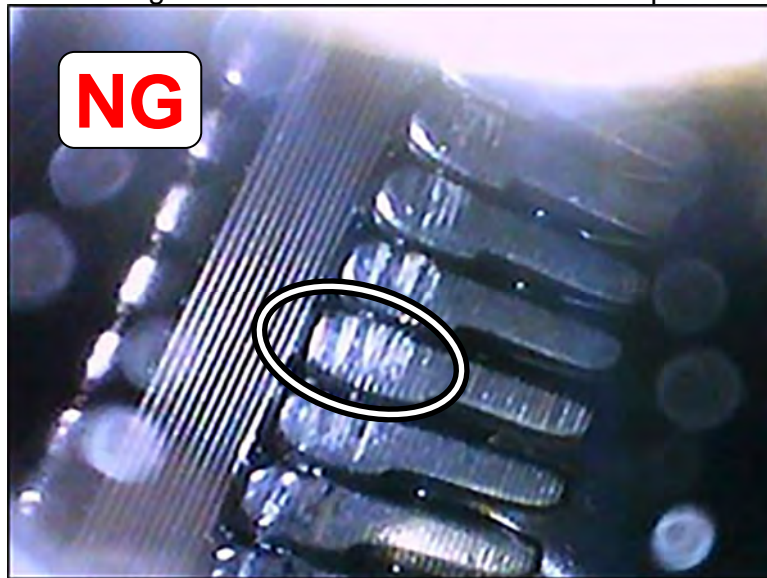
Figure 15: Example of NG belt

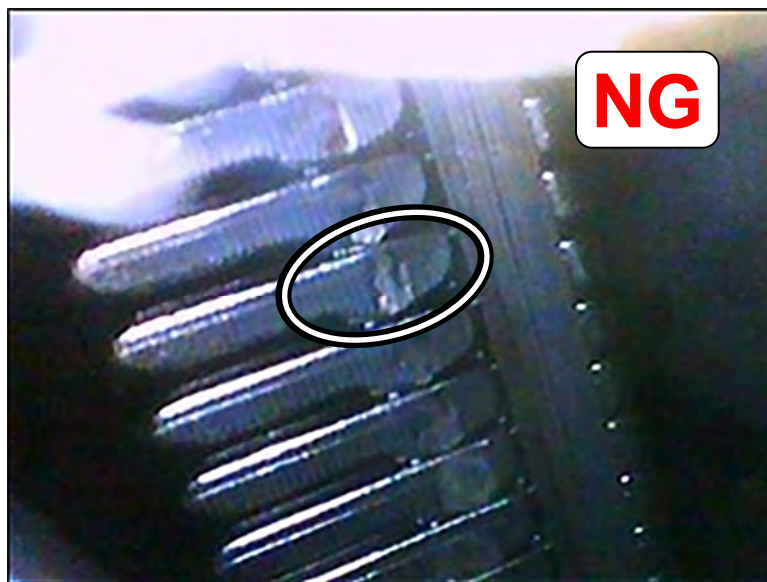
Figure 16: Example of NG belt

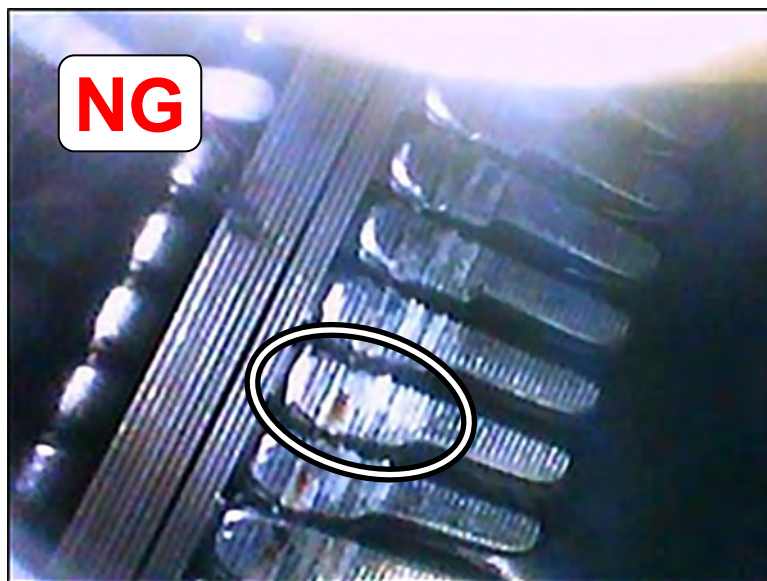
Figure 17: Example of NG belt
