**TECHNICAL INSTRUCTIONS  
FOR  
SPECIAL SERVICE CAMPAIGN H0P  
INSTRUMENT PANEL WIRE MODIFICATION  
CERTAIN 2017 MY YARIS (A/T)**

**Updated 10-20-17**

In the subject vehicles, an incorrect instrument panel wire harness may have been installed during the vehicle assembly process. The incorrect instrument panel wire harness may not be compatible with the Pre-Collision system front sensor. As a result, the Automatic High Beam and Pre-Collision system may be inoperative.

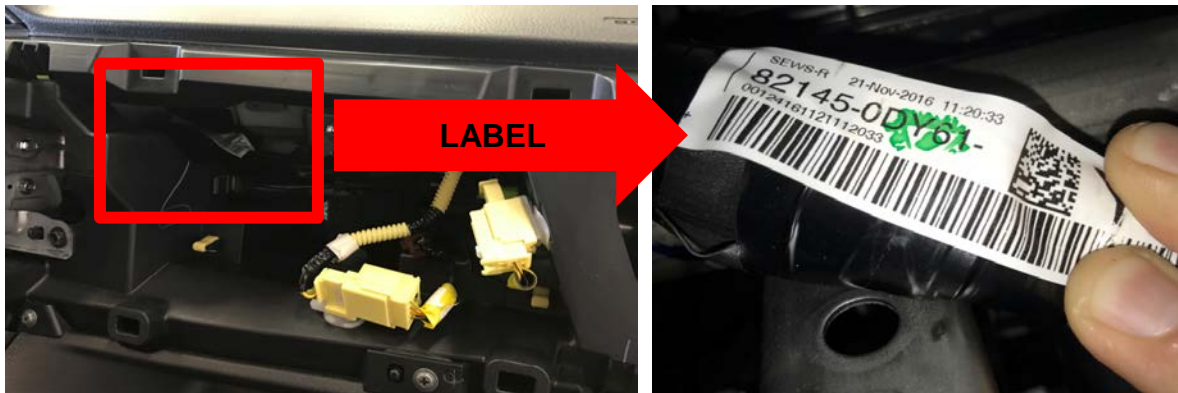
##### a. Modify only the following wire harness

- 82145-0UB21
- 82145-0DY61
- 82145-0DY71

**Do NOT modify any other wire harness with a part number different than the ones listed above (ex. 82145-0DY60.)**

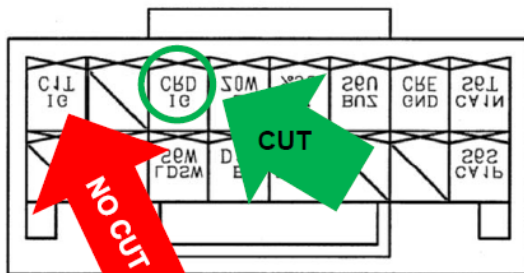
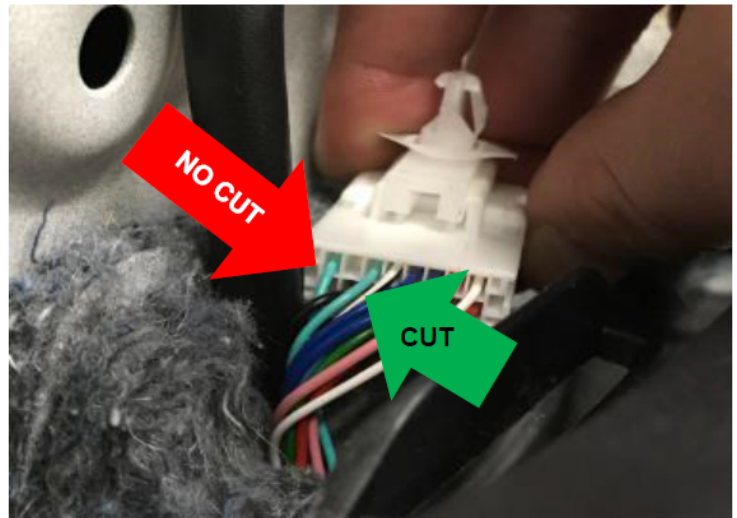
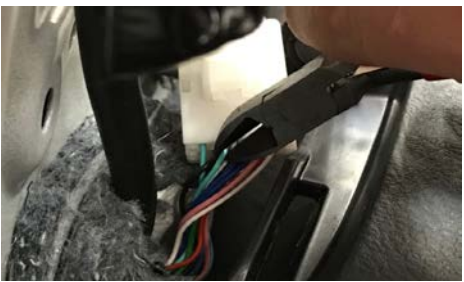
View from back of connector  
once rotated to  
proper orientation

**There are 2 light green wires! Make sure to cut wire that is more toward middle of connector.**

- b. Cut the light green wire if the instrument panel wire as close to the connector as possible

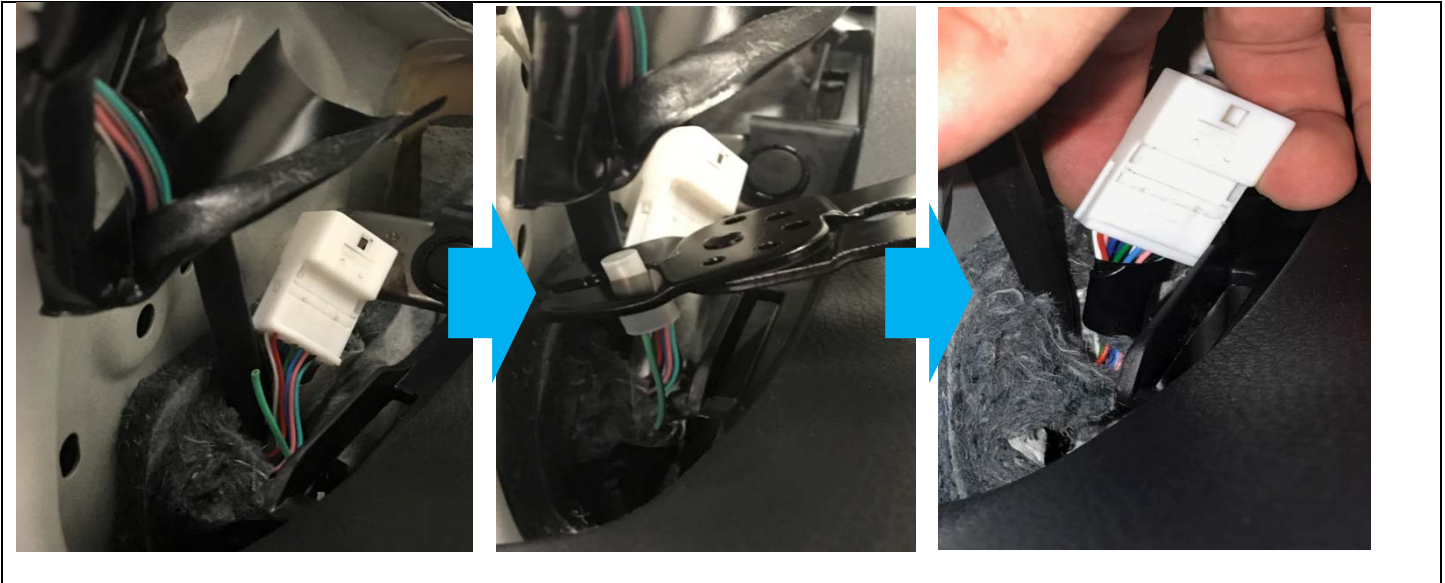
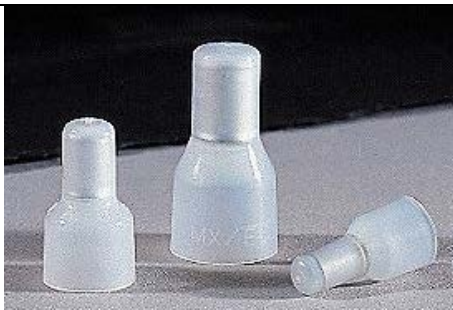
This wire is B+ 12V supply. It must be securely capped and taped to instrument panel wire bundle to avoid shorting.

- c. Cap the top of the cut wire and crimp it. Securely fasten the cut wire to the instrument panel wire with the vinyl tape
