# Technical Service Bulletin

<b>Subject:</b> NOISE FROM FRONT DOOR PANEL WHEN PLAYING AUDIO SYSTEM	<b>Bulletin No.:</b> 09-012/17
	<b>Last Issued:</b> 10/03/2017

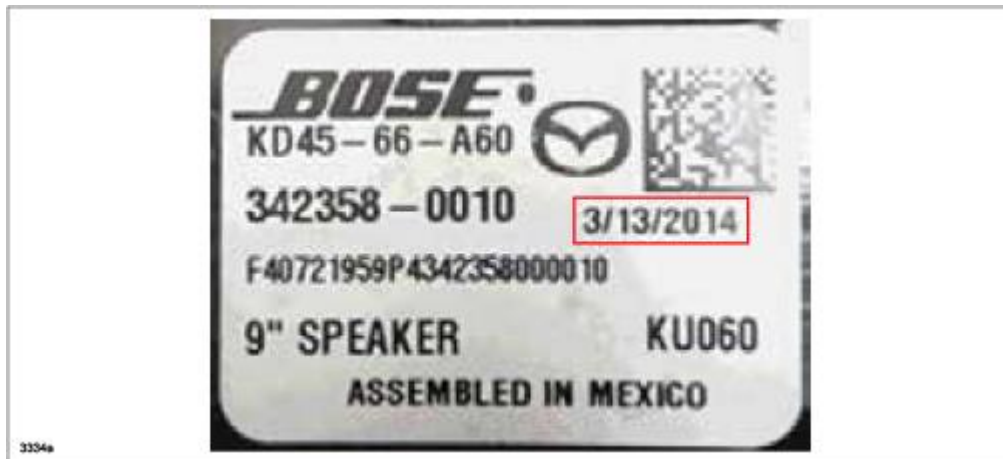
Verify the date on the speaker according to the production date shown on the label.

Example: 3/13/2014 = MM/DD/YYYY

This TSB does not apply if the date on the speaker is 11/13/2015 or later. Diagnose the problem according to the instructions on MGSS.

1. Verify customer concern.
2. Check if the noise occurs when the bass is turned up.
  - If the noise occurs with the bass turned up, replace both speakers according to the instructions on MGSS "FRONT DOOR SPEAKER REMOVAL/INSTALLATION".
