# Technical Service Bulletin

<b>Subject:</b>  <b>CREAKING NOISE FROM FRONT LOWER ARM BUSHING / CLUNKING NOISE FROM FRONT SHOCK ABSORBER COIL SPRING WHEN DRIVING OVER BUMPS</b>	<b>Bulletin No.:</b> 02-007/17
	<b>Last Issued:</b> 10/06/2017

APPLICABLE MODEL(S)/VINS  
2016-2017 CX-9

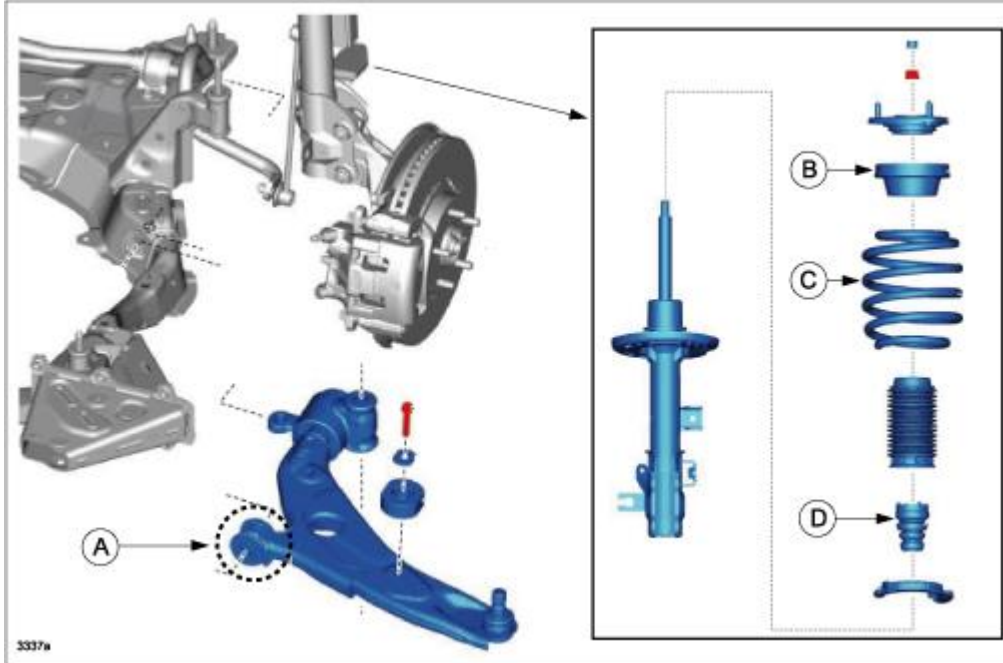
1. A creaking noise from under the front of the vehicle (front lower arm bushing) when driving over bumps at approximate 12 - 25 mph (20 - 40 Km/h). The noise occurs when the road surface is wet or after the vehicle has been washed. The noise becomes more noticeable as the bumps get higher. The creaking noise is caused by the front lower arm bushing (A) making a stick-slip noise during wet road conditions.
2. A clunking noise from the front coil spring when driving over bumps. The clunking noise is due to stick-slip between the front strut bearing (B) and the coil spring (C).
3. A popping noise from the bump stopper (D) when driving through gutters.

1. The coating treatment of the lower arm bushing has been changed to reduce friction and prevent stick-slip.
2. Protectors have been installed onto the coil springs to prevent stick-slip.
3. No mass-production change is scheduled for the bump stopper, however, a modified service part has been established.
