# Technical Service Bulletin

SCBS / SBS, LAS / LDWS, MASTER AND/OR HBC WARNING LIGHTS
ON WITH DTC U3000:98 STORED DURING HOT WEATHER

**Bulletin No.: 15-006/17**

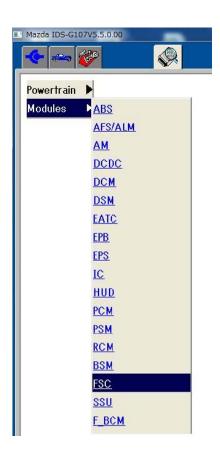
"C\_SCORE" has to be 174 or higher to perform the FSC reprogramming.

4. If the FSC seems to be hot (approx. 60 °C [140 F] or higher), cool it down by parking in the shade with the ignition OFF.

**NOTE:** If the FSC is hot, the FSC reprogramming process may fail. The FSC temperature can be monitored by the data logger function of the M-MDS.

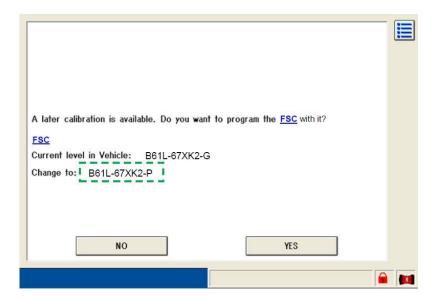
If the message "No later calibration is available on the system for this FSC" is displayed, the FSC is already at the latest calibration. "Current level in Vehicle" will show the new file name.

If "Current level in Vehicle" does not show B61L-67XK2-G, -I, -K or -M, this reprogramming process does not apply. Confirm if the part number is B61L-67XCX-B.

NOTE: The calibration level does not match to the part number level.

Click "YES" and follow the M-MDS instructions to reprogram the FSC.
