# Technical Service Bulletin

WHITE STAINS UNDER POWER DOOR MIRROR

Bulletin No.: 09-041/17

2013-2016 CX-5 vehicles equipped with power door mirrors with VINs lower than JM3KE\*\*\*\*\*\*921726 (produced prior to Dec.21, 2016)

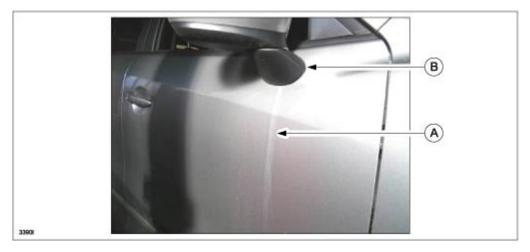
Some vehicles may exhibit a white stain (A) running down the front door(s), which originates from under the outer door mirror. This is caused when water (containing white corrosion) is generated inside the door mirror base (B), then drains down the door panel causing a poor appearance concern.

The door mirror base was originally designed to drain water to the outside of the door. The shape of the door mirror base gasket has been modified to drain water to the inside of the door. Replacing the gasket should eliminate this concern.
