Technical Service Bulletin

Mazda North American Operations
Irvine, CA 92618-2922

Subject: IMPROPER BSM OPERATION WHEN PASSING OR WHEN ADJACENT VEHICLE DRIVING AT SAME SPEED	Bulletin No.: 15-005/17
	Last Issued: 10/27/2017

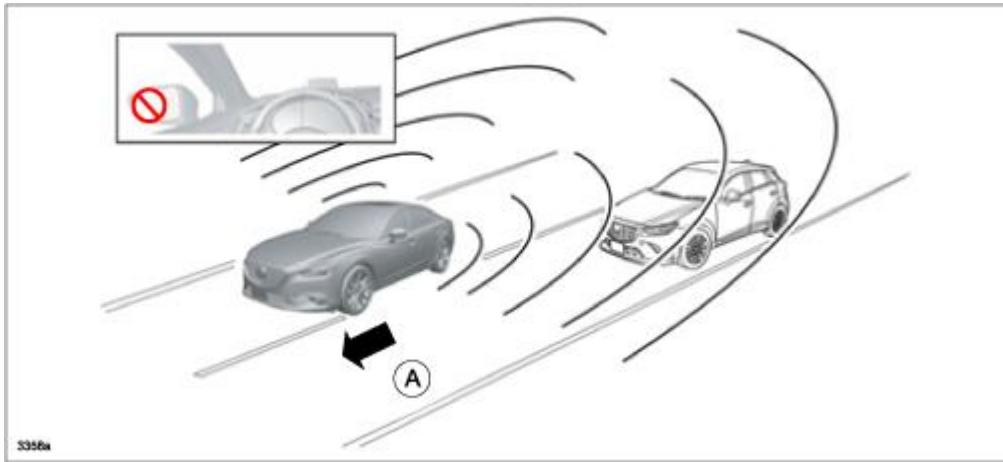
- Customer vehicle (A) is slowly passing other vehicle, even if the vehicle is still in the alert area.

Customers who have owned previous Mazda vehicles are more likely to complain. The BSM control module has been modified to address these customer concerns.

1. Verify customer concern.
2. Replace both BSM modules. Refer to MGSS online:
 - Mazda3 - BLIND SPOT MONITORING (BSM) CONTROL MODULE REMOVAL/INSTALLATION
 - Mazda6 - BLIND SPOT MONITORING (BSM) CONTROL MODULE REMOVAL/INSTALLATION
 - CX-3 - BLIND SPOT MONITORING (BSM) CONTROL MODULE REMOVAL/INSTALLATION
 - CX-9 - BLIND SPOT MONITORING (BSM) CONTROL MODULE REMOVAL/INSTALLATION
 - MX-5 - BLIND SPOT MONITORING (BSM) CONTROL MODULE REMOVAL/INSTALLATION
3. CX-3 only, Insert supplemental document into the owner's manual.
4. Verify repair.

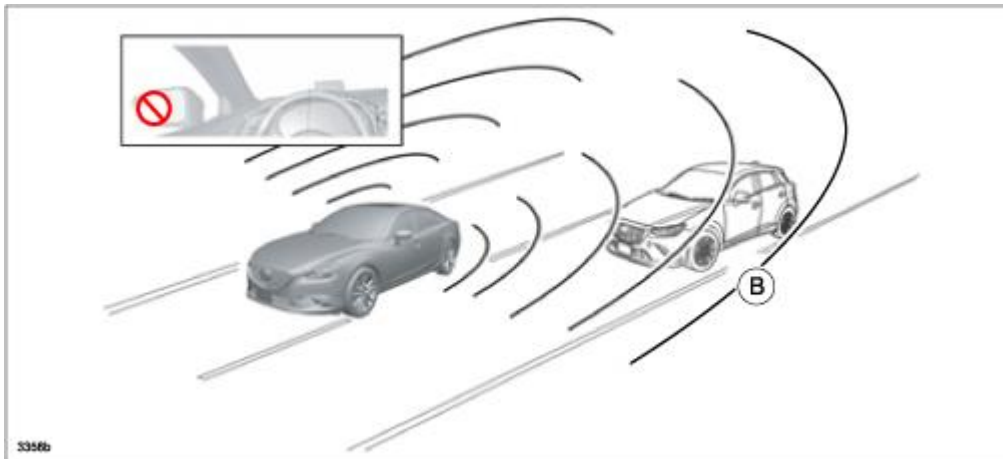
- Adjacent vehicle (B) driving at same speed, even if the vehicle is still in the alert area.
